Resolution Accepting the *Lower Cape Fear Water & Sewer Authority Kings Bluff Regional Raw Water Supply Facilities FY 2020-2021 Annual Inspection Report*

Lower Cape Fear Water & Sewer Authority Kings Bluff Regional Raw Water Supply Facilities

FY 2021-2022 Annual Inspection Report

Kings Bluff Raw Water Pump Station

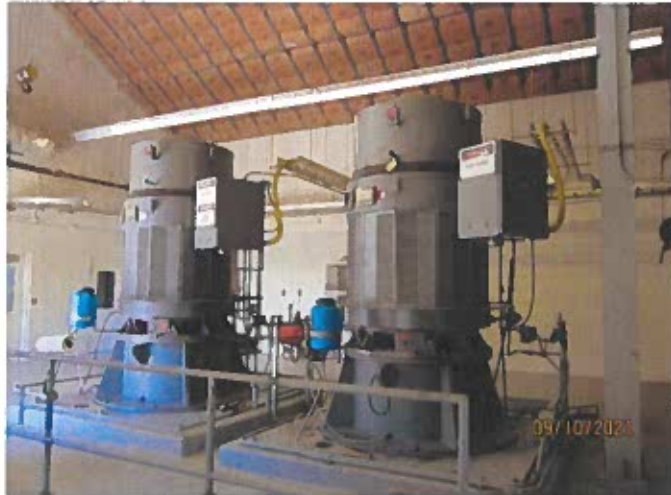
Photograph A – Pump #4 and #5

1,600 HP vertical turbine pumps (installed as part of the 2009 expansion/upgrade of the Kings Bluff facility) were inspected and found to be in excellent condition and meeting the needs of the Authority's customers (See *Appendix F -Photograph A*). During the 2013 inspection it was noted that Pump 4 was experiencing a bearing temperature issue. Subsequently, staff worked directly with Charles Underwood Pump Company to address this issue. The motor was removed for evaluation and no specific issues were found. Staff indicated that both GE (motor Mfr.) and Kingsbury (bearing Mfr.) did not consider the temperature excessive and stated they would be concerned if the temperatures were to increase to a much higher level that what is currently being experienced.

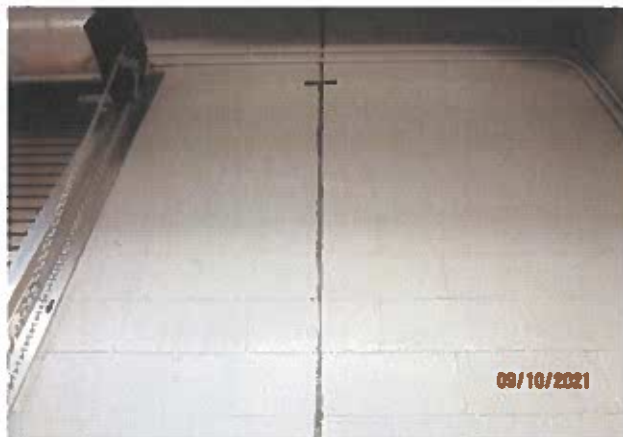
The 1,600 HP pumps are controlled by a separate electrical control room housing variable frequency drives and motor starters. During the 2016 inspection, it appeared that the masonry wall to wall joints located inside the new pump station electrical building had shifted producing cracked paint at the intersection of the walls. The most noticeable crack is located on the masonry wall joint located west of the western most roll up door. Since the 2016 inspection, Engineer reviewed the joints and found that the issue was not structurally detrimental; however, it was recommended that staff should continue to monitor the issue. During this inspection, visual observation indicated that the size of the separation did not appear to have increased (See *Appendix F - Photographs B*). It is recommended that the wall separation continue to be monitored.

Photograph B – Electrical Building Wall Separation (Exterior)

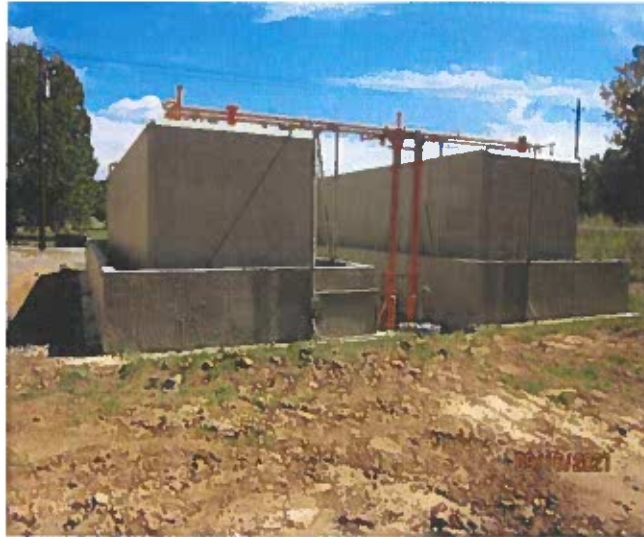
The two 3.0 Mega Watt standby generators are supplied fuel by (2) 12,000-gallon concrete fuel tanks, which are located adjacent to the generator building. The tanks were installed with a 110% secondary containment wall to capture overflow, ruptures or spills of diesel fuel. The external fuel tanks were inspected and found to be in acceptable condition. Rainwater collects in the containment area and is drained by LCFWSA operator after each significant rain event. On both tanks during past inspections, significant efflorescence was noted. During this year's inspection, both tanks were observed to be in excellent condition; although, they were missing the proper signage (See *Appendix F - Photograph C*).

Photograph C – Diesel Storage Tanks

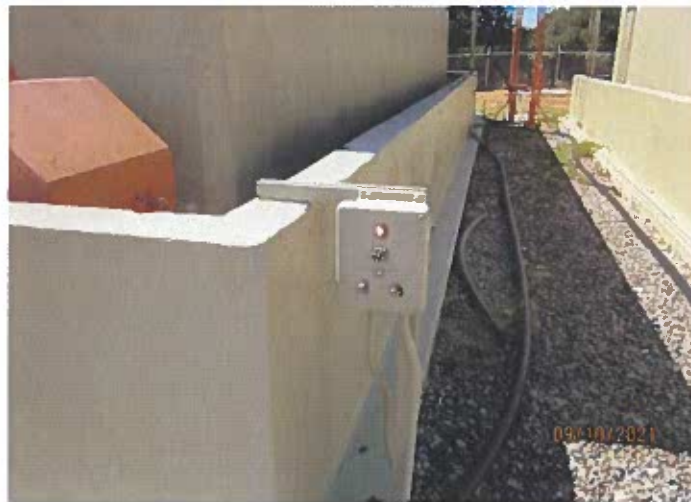
During the 2019 inspection, staff noted that the interior of both fuel tanks have been recently cleaned and fuel treated. As recommended in the 2018-year report, a new interstitial tank leak sensor has been installed on the west tank. During this inspection, one of the two interstitial sensors was in alarm status and requires servicing. (See *Appendix F - Photograph D*).

Photograph D – Alarmed Diesel Tank Leak Panel

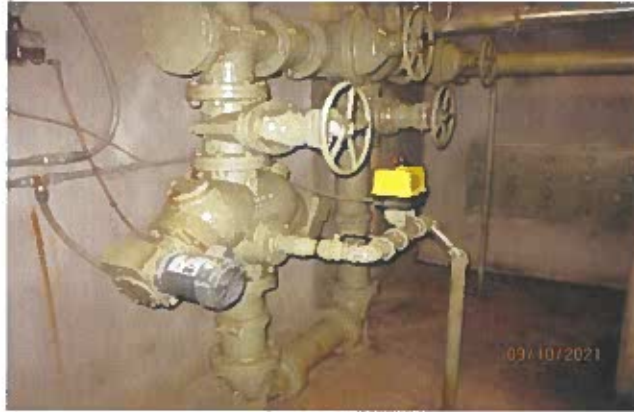
Photograph E – Hellan Strainer

The combined new and old buildings were inspected and found to be in good overall condition. It is noted in this inspection report that the Hellan Strainer backwash drain, located in the new pump station piping gallery, no longer leaks, which was noted during the last inspection. (See *Appendix F – Photograph E*). No major problems were found with the station's structure; however, cracks in the concrete flooring of the pump room remain, but do not appear to be detrimental to operations and both pump station piping galleries need to be cleaned for bugs, debris, etc. All observed issues detailed below are also noted in *Appendix A*:

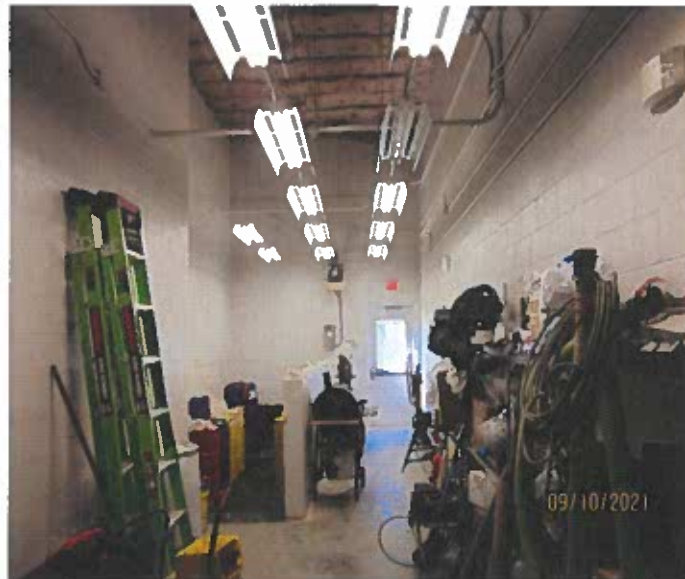
Photograph F – Storage Room

- During the time of the 2011-2012 inspection, O&M staff noted that the containment area provided in the new pump station building for storage of oil floods and then subsides with heavy rains. Staff has addressed this issue by installing a french drain outside of the facility. The drain was placed against the wall and appears to be reducing the hydrostatic water load against the wall. In addition, staff applied another layer of sealant to the interior face of the CMU wall. No water/moisture was present during the inspection and staff reported the drain and sealant appear to be working. During the 2019 inspection, staff indicated they had placed approximately 12 inches on concrete in the pit area and recoated with sealant. During this inspection no evidence of leaking was observed. (See *Appendix F- Photographs F*).

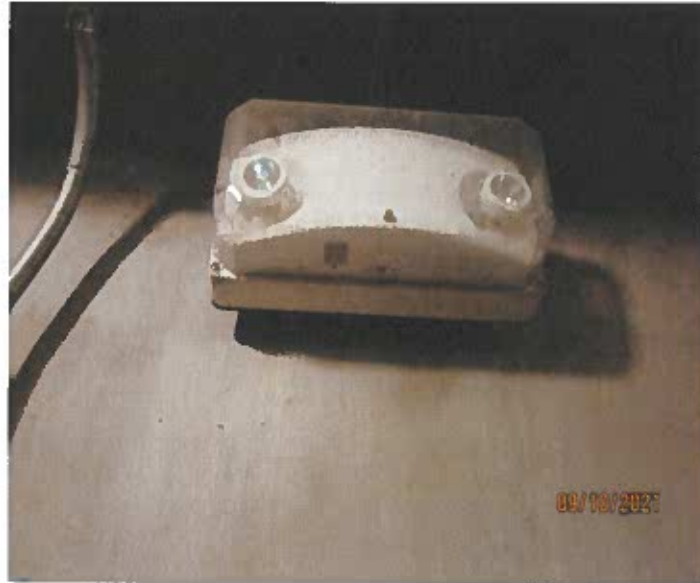
- Also, during this year's inspection, it was noted the emergency light in the new station pipe gallery has a battery failure alarm. Light should be serviced. (See *Appendix F-Photographs G*)

Photograph G – Pipe Gallery Emergency Light Requires Service

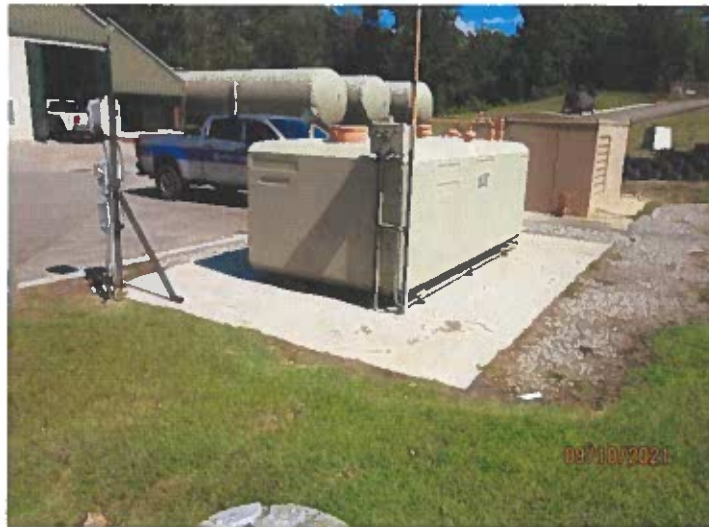
During the 2018 inspection, it was noted that several valve operator wheels were broken. The handwheels were replaced with operator nuts, correcting the problem, as documented in the 2019 inspection. Previously the small generator located in front of the pump station was showing signs of rust likely due to moist conditions that existed prior to plant staff addressing flooding issues. During this visit it was noted that the generator and fuel tank had been painted and there are no signs of rust or corrosion; although, it is missing the proper signage. (See *Appendix F - Photographs H*).

Photograph H - Generator and Storage Tank Require Signage

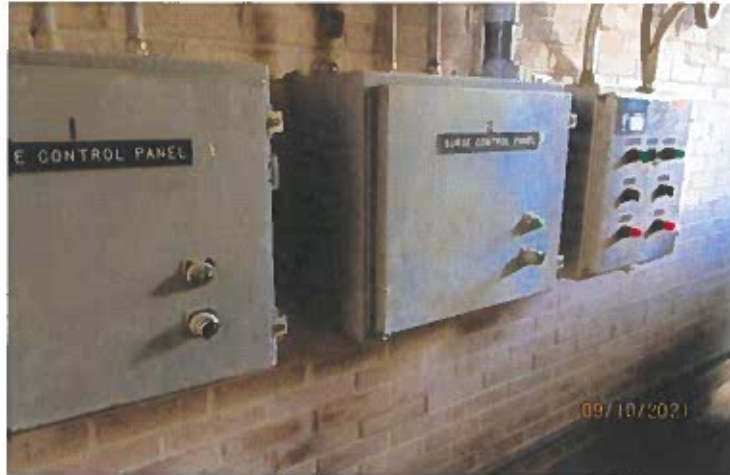
With regards to surge tank control panels located inside the pump station, several indicator lights require replacement. At the time of inspection, surge tanks 1 and 2 had their respective controls turned on however no indicator lights worked thus actual operation could not be confirmed. Previously staff indicated they turned the older systems off because the three control systems would interfere with each other at times. This interference is thought to be a result of all three tanks being manifolded off a single air fill line. As noted previously, both older existing systems were turned on and the third (newer) system appeared to be on; however, the selector

switches for the control solenoids were manually closed using the AOC switches. (See *Appendix F - Photographs I*). It is recommended that the surge system operation be examined, and proper operation confirmed.

Photograph I - All Three Surge Tank Control Panels

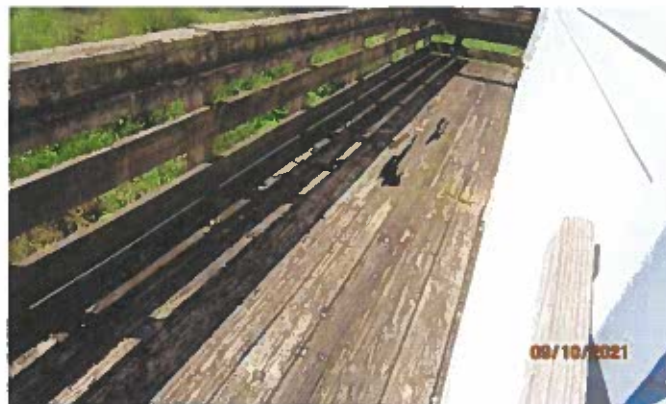
During the 2018 inspection, it was observed that the pier and walkways to the air-backwash control buildings needed repair. Several deck boards and handrails were in poor shape. During the 2019 inspection, it was noted that some repairs had been made (stair and plank replacement); however, more are still required. Further, as noted on previous reports, several areas on the older building's wall panels are still showing signs of rot. As of the 2021 inspection, the dock was in worse condition with some areas being blocked off because the deck was completely compromised. (See *Appendix F - Photographs K and L*). The old backwash building remains in need of repair as wall boards are rotted. The indicator lights need to be replaced in the older buildings. The air valve needs to be cleaned of dust and bugs in the older building (See *Appendix F – Photograph M*). It is noted that the LCFWSA has identified replacement of the pier and air backwash buildings as a future Capital Project, however, it is recommended that the pier and buildings be maintained until such time that project is completed.

Photograph K – Compromised Dock Floor

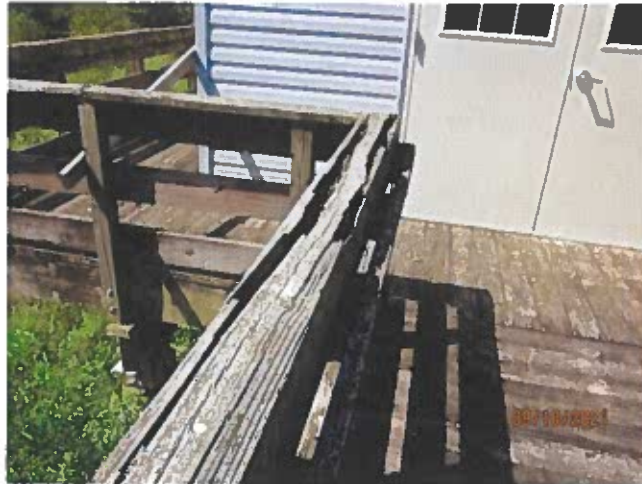
Photograph L- Compromised Dock Handrail

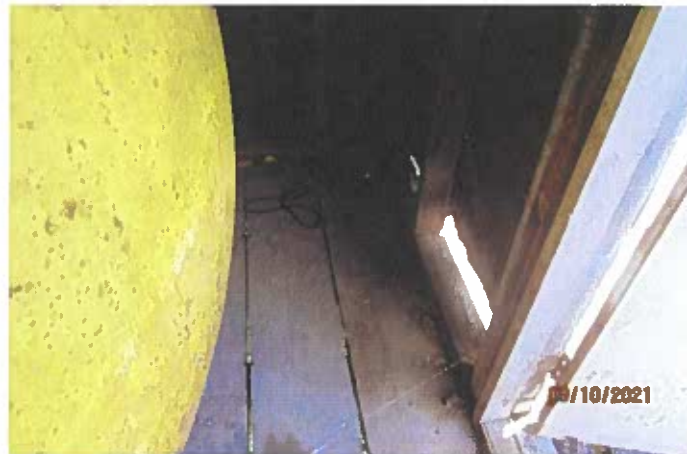
Photograph M- Old Air Tank Building Failed Wall Panels

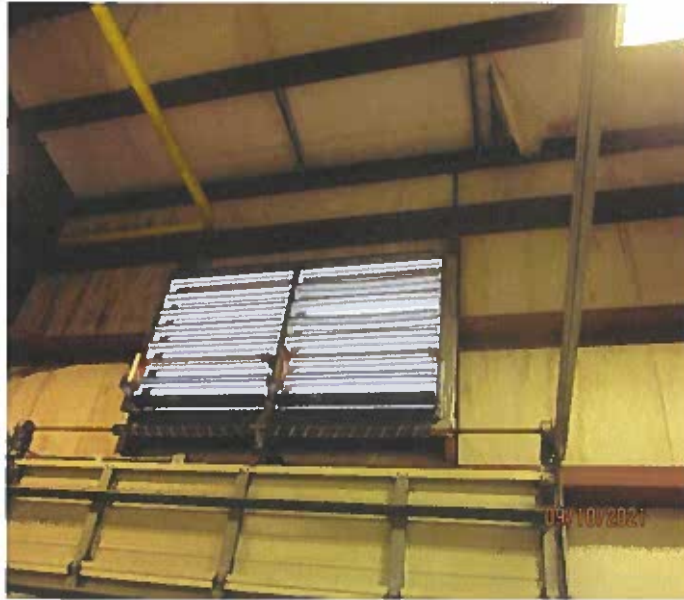
As previously noted during prior inspections, the building interior insulation surface appears to have been affected by the heat making it brittle (*See Appendix F – Photograph N*). Because of this, surface repair tape will not attach thus making tear or rip repairs not possible. Replacement of the insulation should be investigated. The generator radiators were observed to be in good condition.

Photograph N- Generator Building Insulation

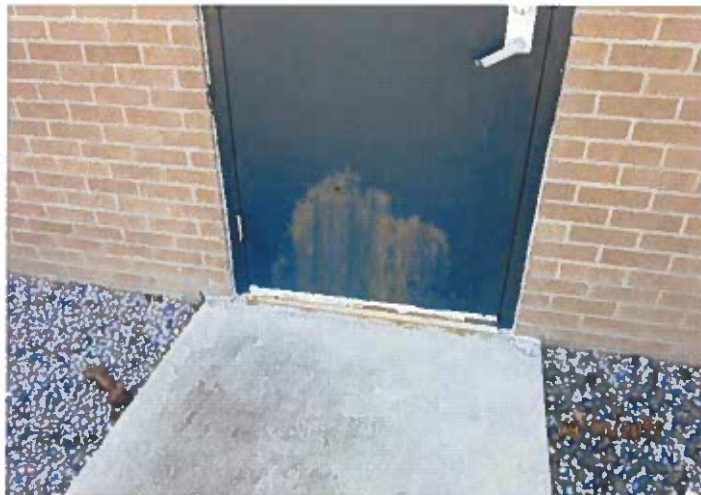
Also, during this inspection, it was noted building doors have rusted to an extent that holes have appeared. It is not recommended that they be replaced at this time however should be monitored and replaced in the future when they are further compromised. (*See Appendix F – Photograph O*).

Photograph O – Generator Building Personnel Doors

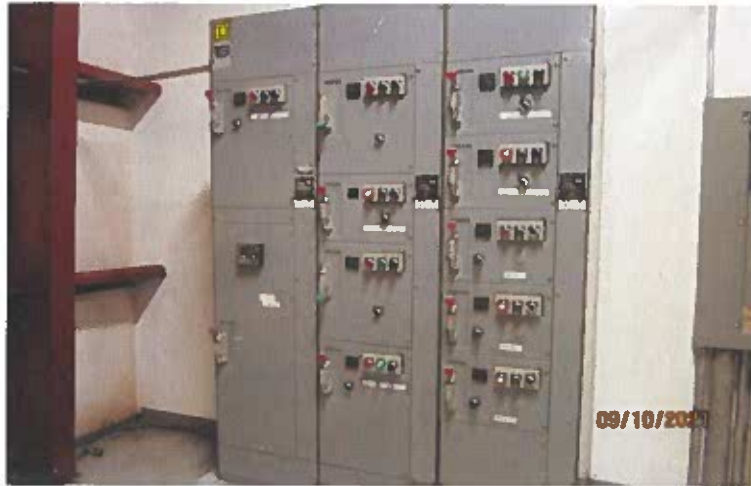
In addition, it was observed that the breaker panel located in the generator room had an excessive amount of failed indicator lights and thus should be serviced. (*See Appendix F – Photograph P*). The Pneumercator alarm panel located in the generator building electrical room is in alarm and shows a leak is present. This issue should be addressed. (*See Appendix F – Photograph Q*).

Photograph P – Breaker Panel in Generator Building

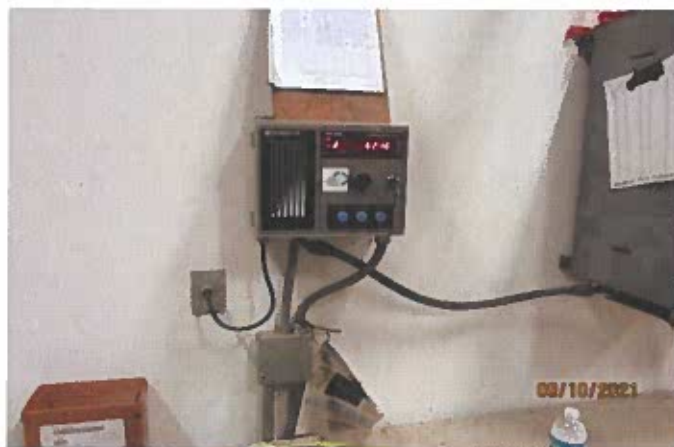
Photograph Q – Pneumercator Panel in Generator Electrical Room

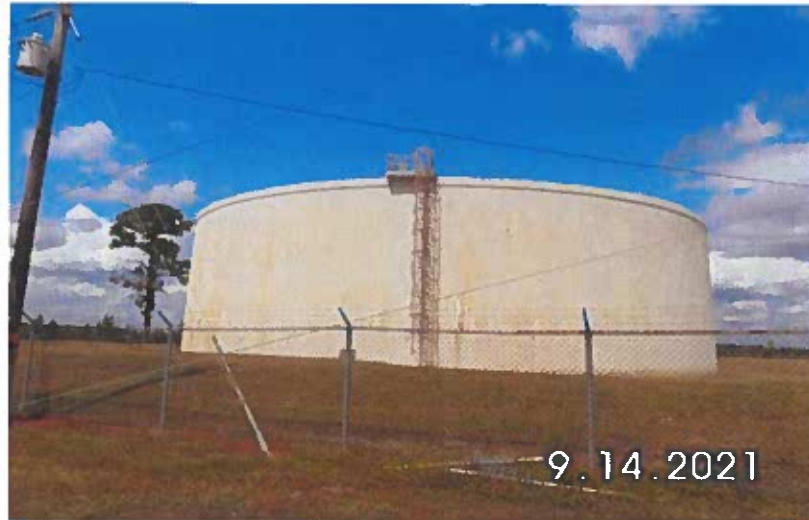
The reservoir is a pre-stressed concrete tank, coated with an external paint system for protection and appearance. There are several places where visible seams on the outside wall of the tank appear to have calcified due to leaks, but no visibly wet seams were noted (See *Appendix F - Photograph O*). During the previous inspections, O&M staff indicated that the *Crom Corporation* (original tank manufacturer) had been contacted to evaluate the seams and provide recommendations for repair.

Photograph O – 3 MG Ground Storage Reservoir

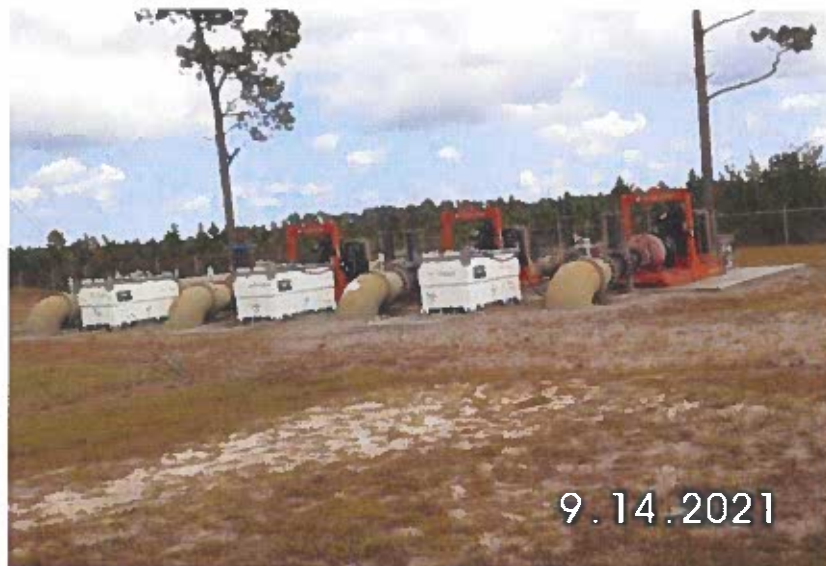
Photograph P – Interim Booster Station

The interim booster station (IBS) was inspected and found to be in excellent condition and no issues were present that required corrective action. It is recommended that O&M staff periodically test the system for functionality and develop/modify protocols as required for maintenance and operation. It is also recommended that the IBS be exercised and tested under actual flow conditions to ensure proper operation when the IBS is required. (See *Appendix F - Photograph P*).

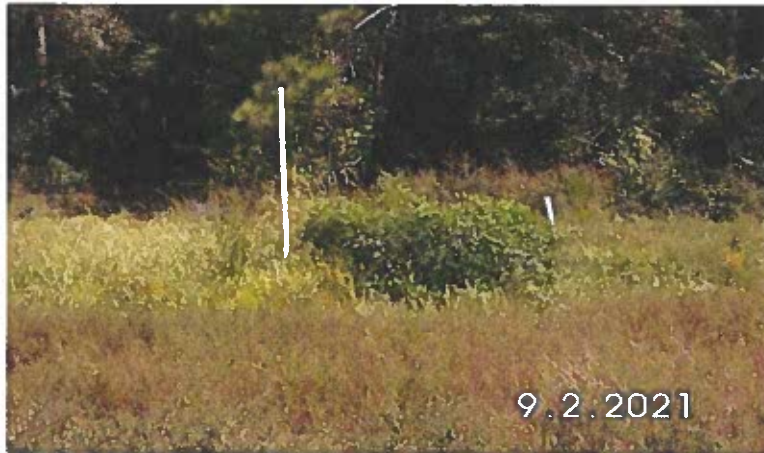
The pipeline right-of-way was inspected and found to be in generally good condition. Several wet areas are frequently inaccessible due to water levels in swampy areas and highly overgrown areas (See *Appendix F - Photograph AA*). It is recommended that these areas be mowed/cleared when possible and inaccessible areas inspected. A large portion of the pipeline right-of-way includes a gravel/soil access road, and farmland or adjacent railroad right-of-way and is well maintained and in good condition. The majority of the right-of-way is well maintained with adequate accessibility. Recent mowing took place in November/December 2020 and is generally in good condition. It was noted that the pipeline right-of-way that traverses the previous DAK facilities is not maintained nor are the access roads through the Dak property used to access the right of way. It is noted that the LCFWSA is investigating/planning for right of way maintenance and it is recommended this area be included as well.

Photograph AA – Overgrown Area along Right-of-Way

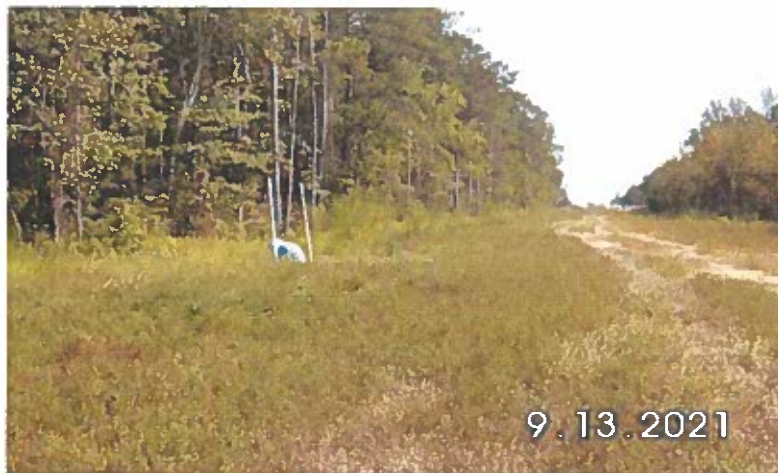
In 2005, all vaults and blow offs were marked in the right-of-way with high visibility 8-foot PVC pipe markers. However, it is noted that the orange paint has faded, and the PVC pipes show signs of deterioration (See *Appendix F - Photograph BB*) and should be replaced and/or repainted. These measures have been successful in eliminating the majority of such encroachments and there have been no major problems.

Photograph BB – Orange Painted Structure Marker Deterioration

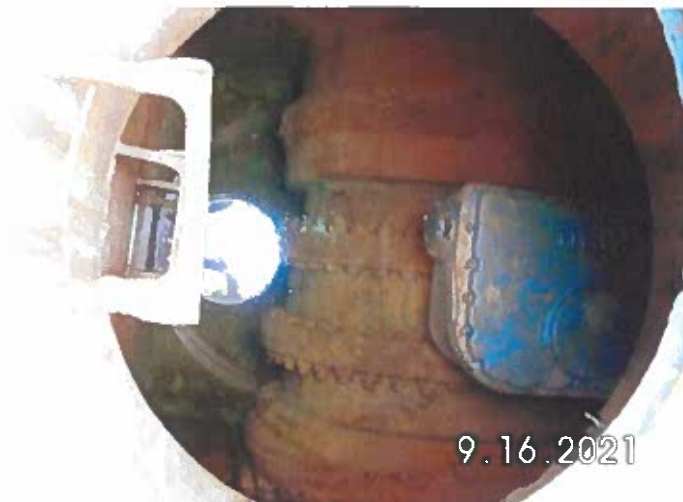
Photograph CC – Interior of Manhole with 48" Check Valve at "The Bluffs"

As previously noted, a valve manhole exists along the access road to "The Bluffs" development that is adjacent to the roadway. It is recommended that bollards be placed at this location to protect the manhole from a vehicular accident that could damage the manhole and/or the raw water transmission main.

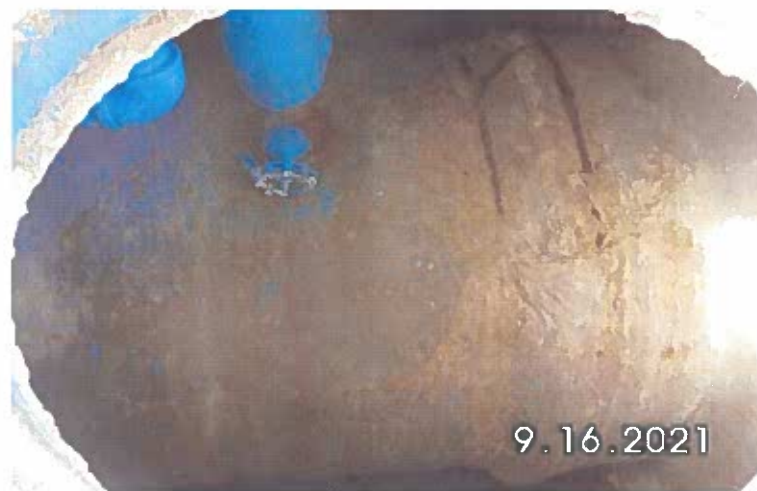
Photograph DD – Exposed Steel at ARV at Phelps Truck Sales (US 421)
