TECHNICAL MEMORANDUM

RE: Lower Cape Fear Water & Sewer Authority, Leland, North Carolina
Kings Bluff 48-Inch Raw Water Transmission Main
Aerial Crossing Structural Assessment

**Kings Bluff 48-Inch Raw Water Transmission Main
Aerial Crossing Structural Assessment**

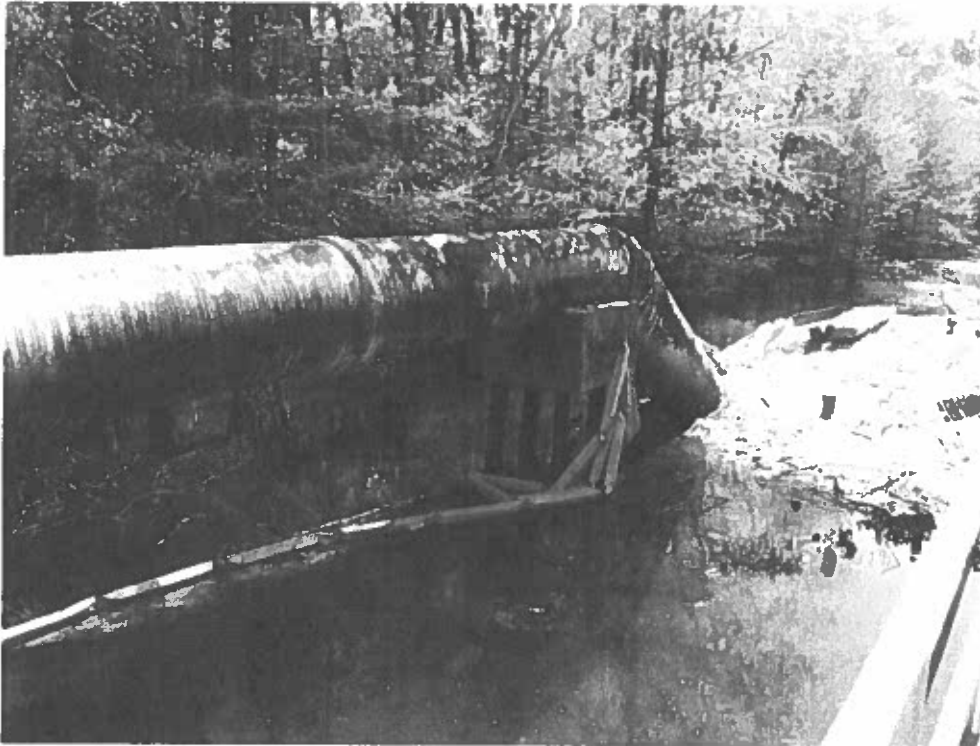
1. View Looking East at Pipe Support #1 & where Access Road Intersects w/ South/East Bank of Livingston Creek.

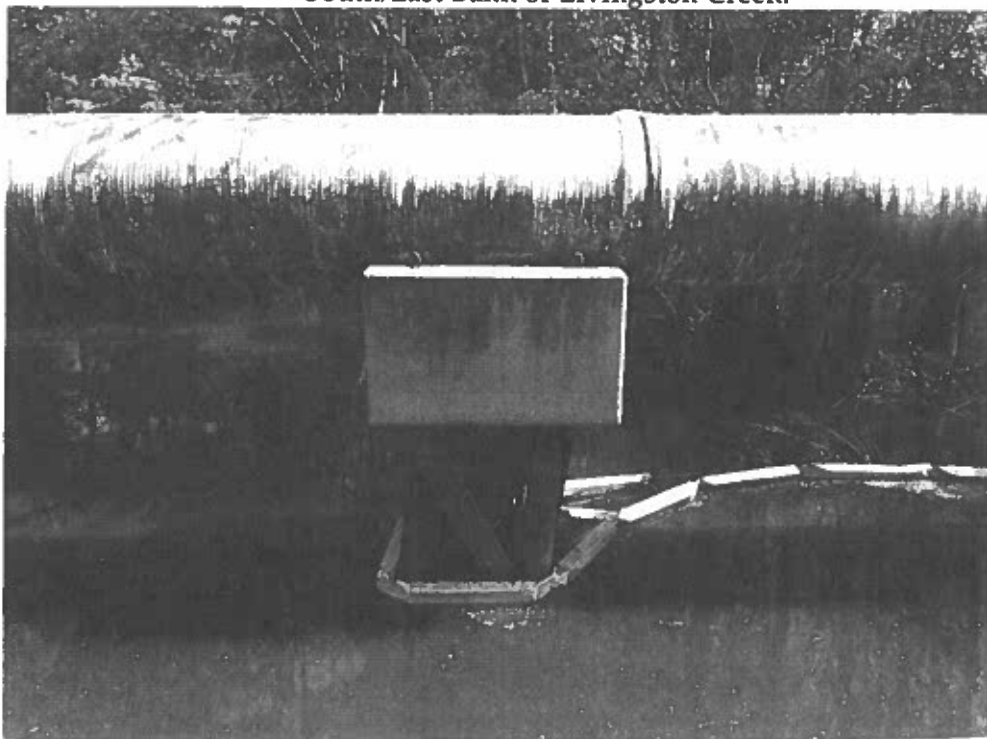
2. View Looking Northeast at Pipe Support #2 Assembly.

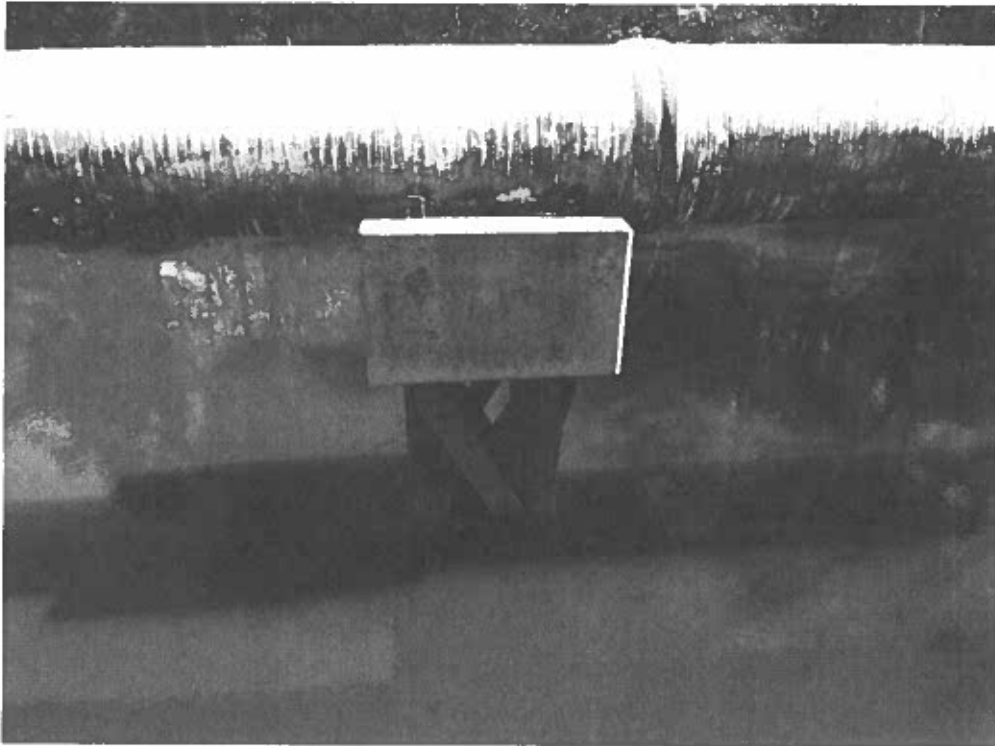
3. View Looking Northeast at Pipe Support #3 Assembly.

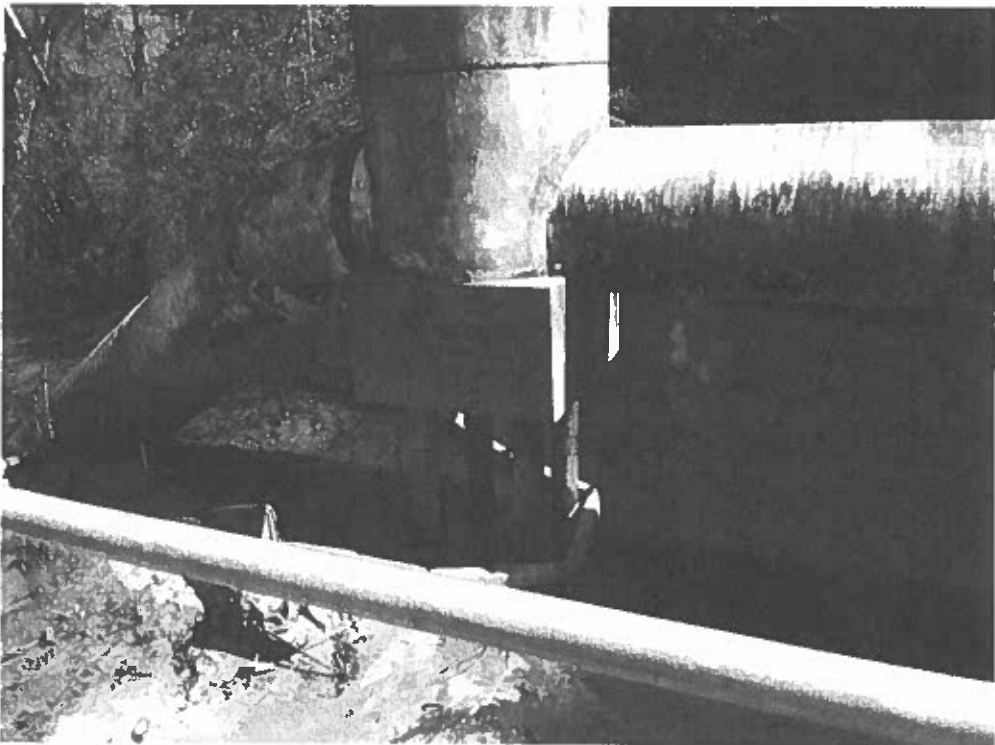
4. View Looking North at Pipe Support #4 Assembly & the North / West Bank of Livingston Creek.

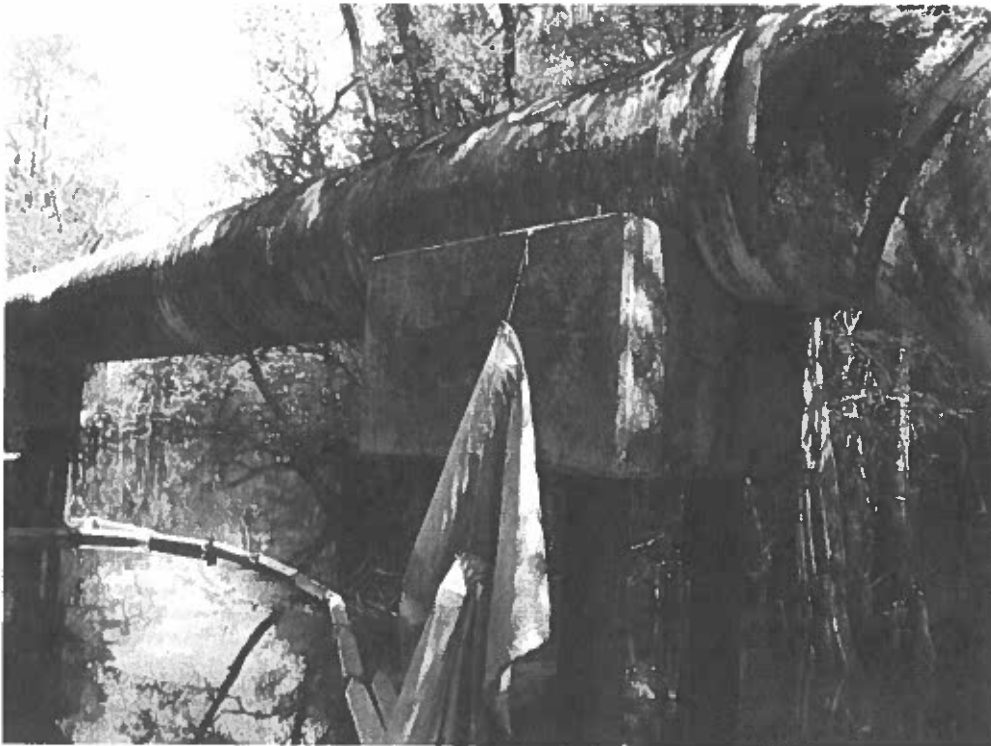
- Split lines were observed on the south face of the P4 pile at PS #1 approximately 1'-6" below the top of the pile (ref. photo no. 5).
- Peeling was observed on the south face of the P3 pile at PS #2 approximately 1'-6" below the top of the pile (ref. photo no. 6).
- Probe tests above the water line were negligible to extremely minor with measurements ranging from 0" to 1/16" penetration.
- Probe tests below the water line were negligible to minor, although measurements yielded a wider range of variability: Below waterline probe results are indicated in Attachment No. 1 but note the following:

5. View Looking at the Southwest Pile (P4) of Pipe Support #1 where Minor Split Lines in the Pile were Observed on the South Face of the Pile.

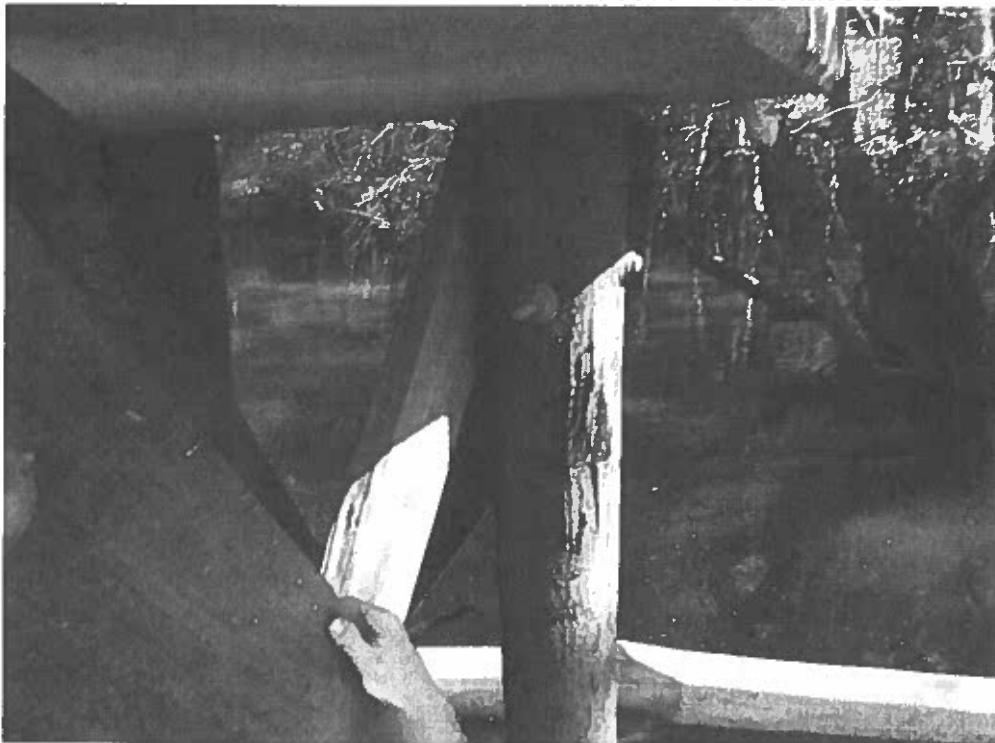
6. Close-Up View of South Face of the Southeast Pile (P3) of Pipe Support #2 where Surface Peeling was Observed.

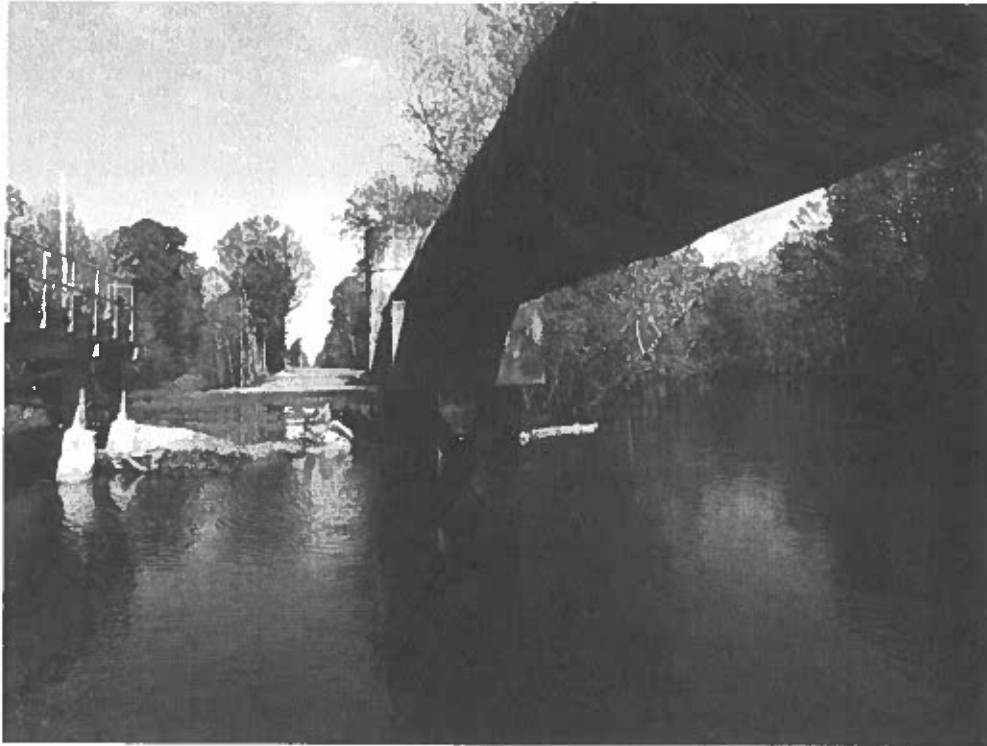
- PS #4: P1, P3 and P4 piles 0" penetration and the P2 pile measured approximately 1/4" penetration.
- In general, all piles for PS #1 and PS #4 and the P2 and P3 piles for PS #2 and PS #3 appeared to be plumb and did not appear to be exhibiting signs of excessive deflection. The P1 and P4 piles for PS #2 and PS #3 appeared out of plumb and leaning upstream in the west direction (ref. photo no. 7).

7. View Looking at the Southwest Pile (P3) of Pipe Support #3 that was Observed to be Out of Plumb in the Upstream Direction.

- M&C recommends setting benchmarks on the top surfaces of the existing concrete pile caps to tie to vertical datum and horizontal alignments. This data should help determine if the out of plumb piles observed, for the (2) interior pipe support structures require reclassification if they are in a continuous deflecting condition that could eventually impair the transmission line.

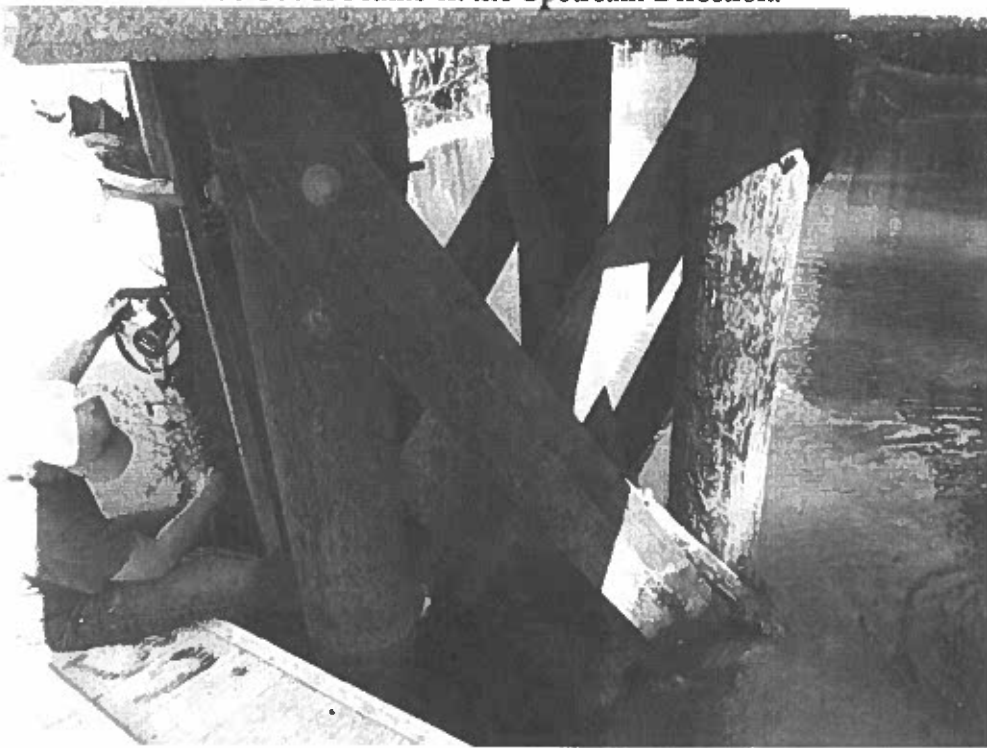
8. View Looking at Pipe Support #3 Cross Bracing with Minor Split Lines in the Timber Section.

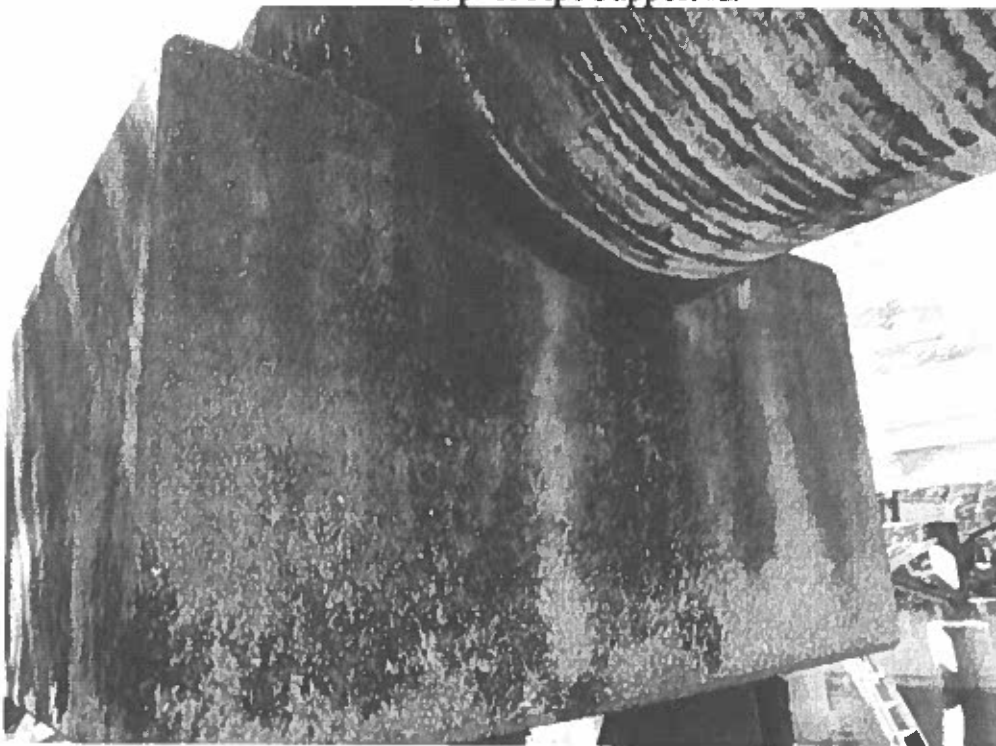
10. View Looking at the Small Area of Existing Honeycombing at the Northeast Corner of the Pile Cap for Pipe Support #3 and Concrete Staining Observed.

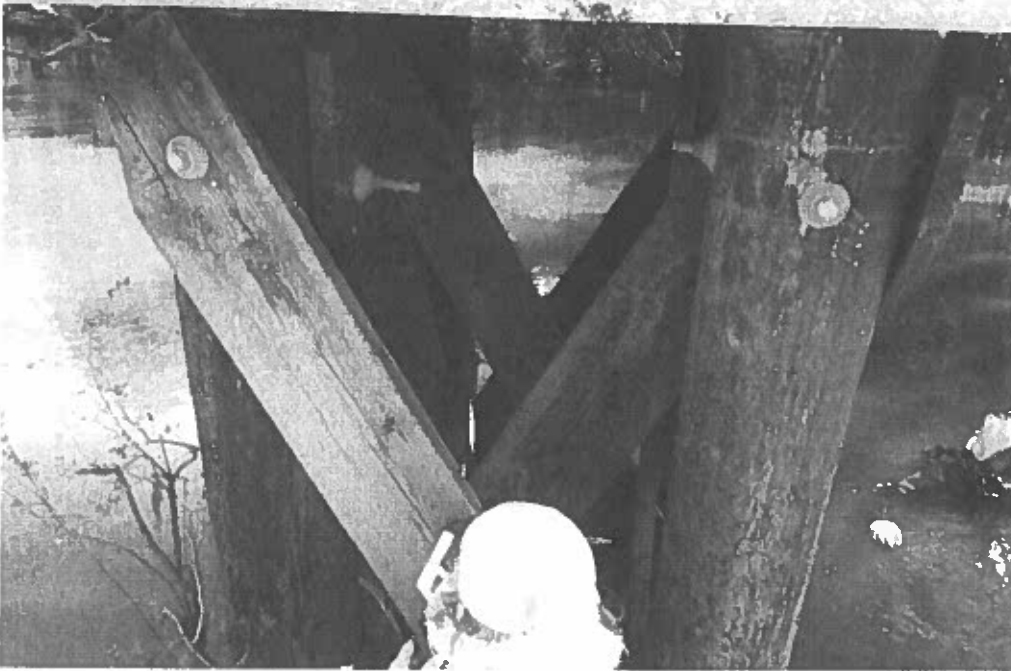
Miscellaneous metals observed included bracing / pile connection rods and hardware. In general, the timber connections included approximate 3/4" diameter galvanized single threaded rods, nuts and ogee washers. The condition of the fasteners was slight to moderate surface rusting (ref. photo no. 10).

11. Close-Up View of Timber Pile / Bracing Fastener Connection Assemblies & the Surface Rusting Observed.

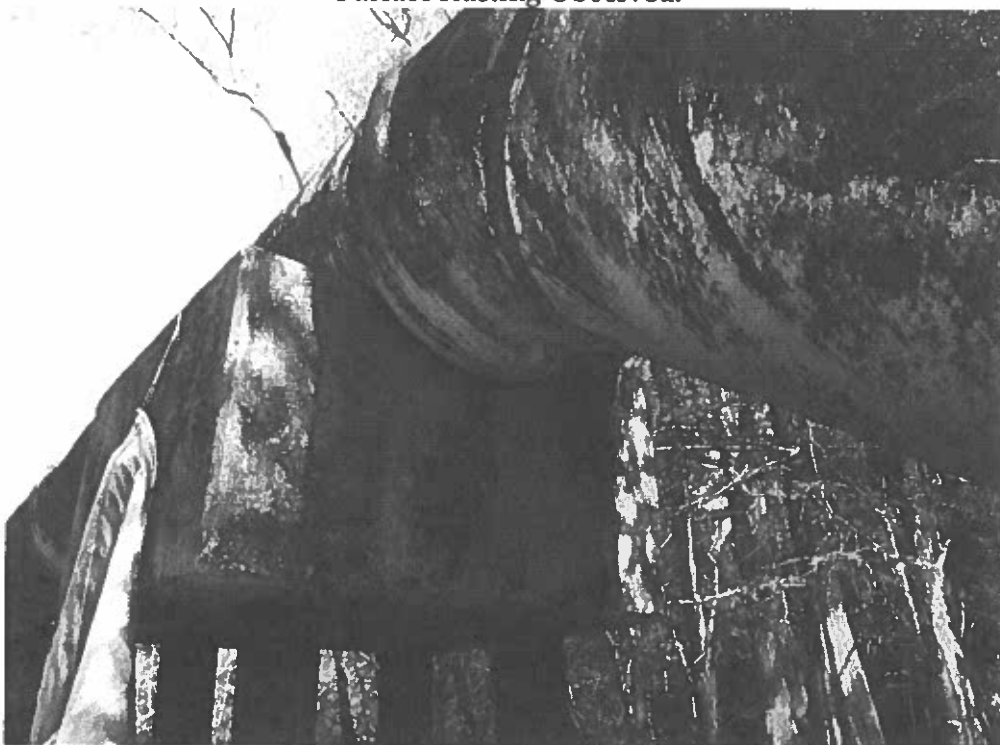
12. View Looking at the Underside of the Pipe Joint South of Pipe Support #1 & the Exposed and Cracked Grout.

- M&C recommends reviewing the existing pipe joints and consider replacing existing grout and installing new grout diaphragms for worn joints prior to existing pipe steel rings becoming exposed (ref. photo no. 12).
