**AGENDA**  
**Lower Cape Fear Water & Sewer Authority**  
**1107 New Pointe Boulevard, Suite # 17, Leland, North Carolina**  
**9:00 a.m. – Regular Monthly Board Meeting**  
**October 14, 2024**

- NB1** – Resolution Accepting the Lower Cape Fear Water and Sewer Authority Kings Bluff Regional Raw Water Supply Facilities FY 2024-2025 Annual Inspections Report (Tony Boahn, P.E., McKim and Creed)
- NB2** – Resolution Accepting the Lower Cape Fear Water and Sewer Authority Bladen Bluffs Regional Raw Water Supply Facilities FY 2024-2025 Annual Inspections Report (Tony Boahn, P.E., McKim and Creed)
- NB3** – Resolution of the Lower Cape Fear Water and Sewer Authority Board of Directors Establishing Criteria for a Design-Build Delivery Method and Authorizing Use of the Design-Build Delivery Method for the Kings Bluff Raw Water Pump Station Air Backwash Building and Access Walkway Replacement

## Kings Bluff Pumping Station Annual Inspection

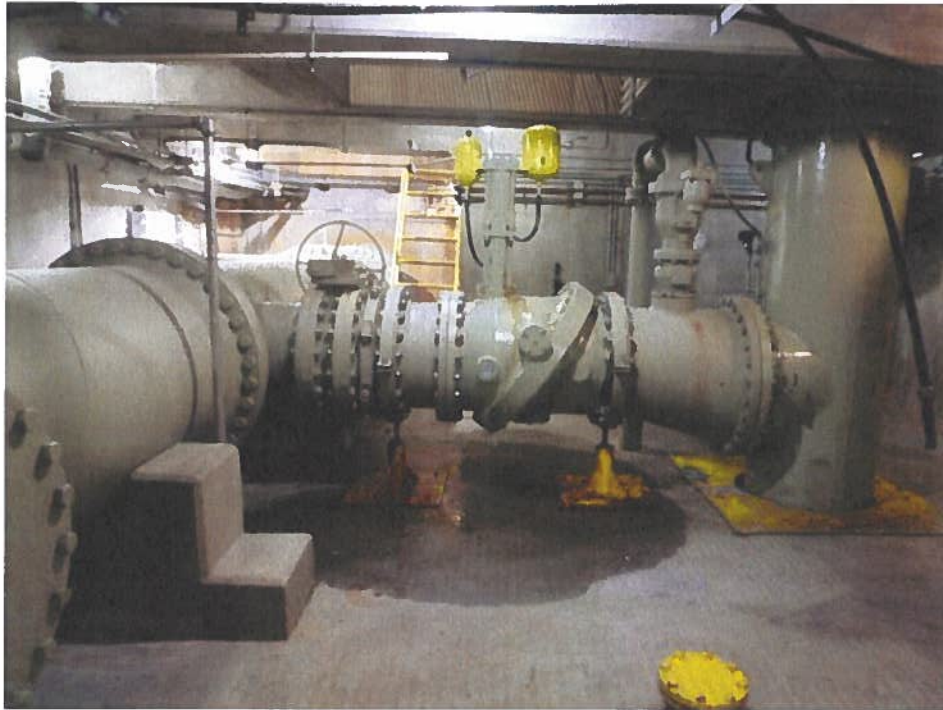
During this visit, it was noted that the check valve on Pump 1 was significantly leaking. Staff indicated that Underwood recently installed a rebuilt unit that did not initially leak; however, over time, the valve began to leak. Staff indicated Underwood would be reviewing the installation next week in hopes of addressing the issue (See *Appendix F - Photographs B*).

**Photograph B – Check Valve on Pump #1 Leaking**

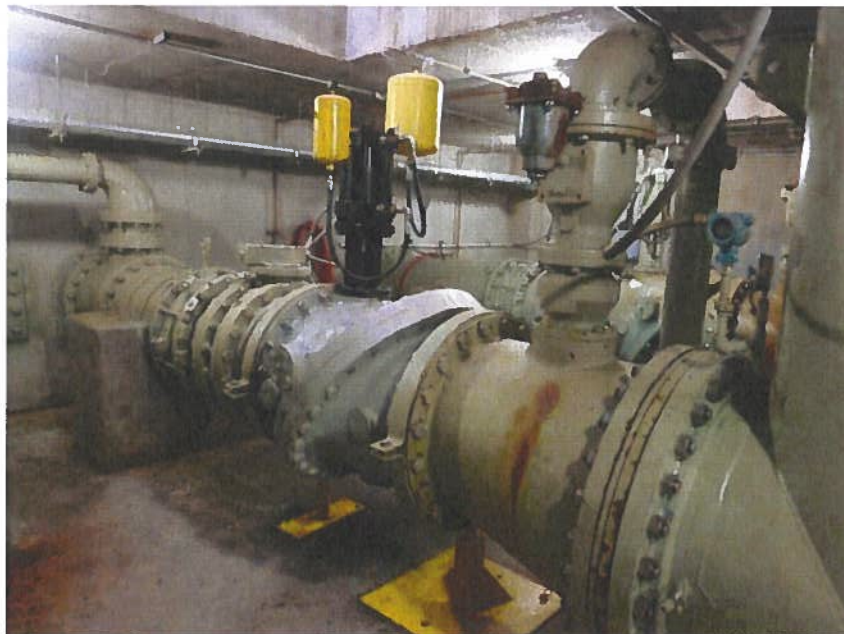
**Photograph C – Failed Check Valve on Pump 5**

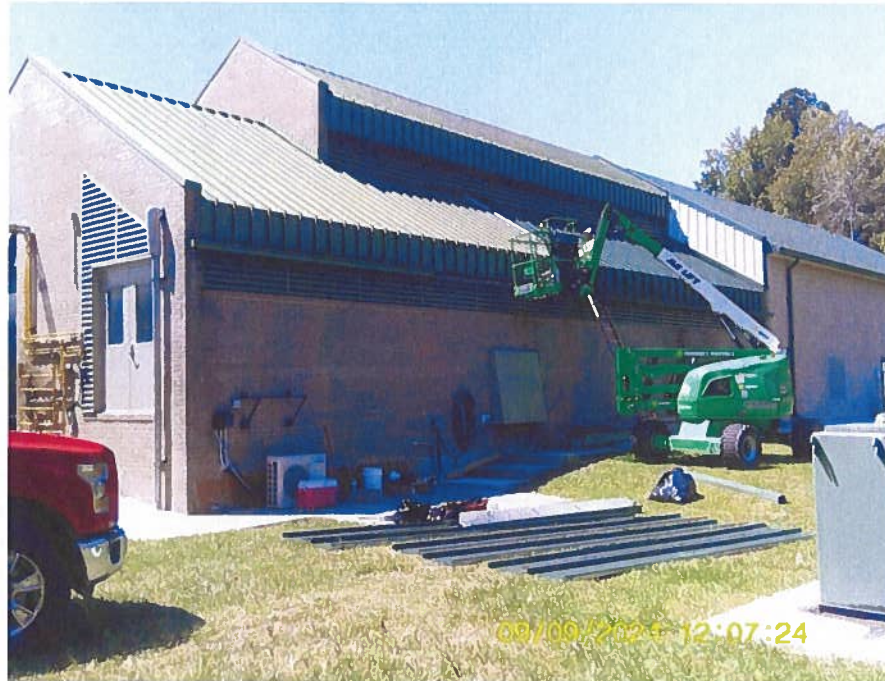
Additionally, staff indicated the lighting in the old station was scheduled to be replaced with LED lighting and the existing was outdated florescent type. The roof replacement project at the old pump station (previously funded and awarded) was underway and approximately 25% complete (See *Appendix F - Photographs D*).

**Photograph D –Old Pump Station Roof Replacement**

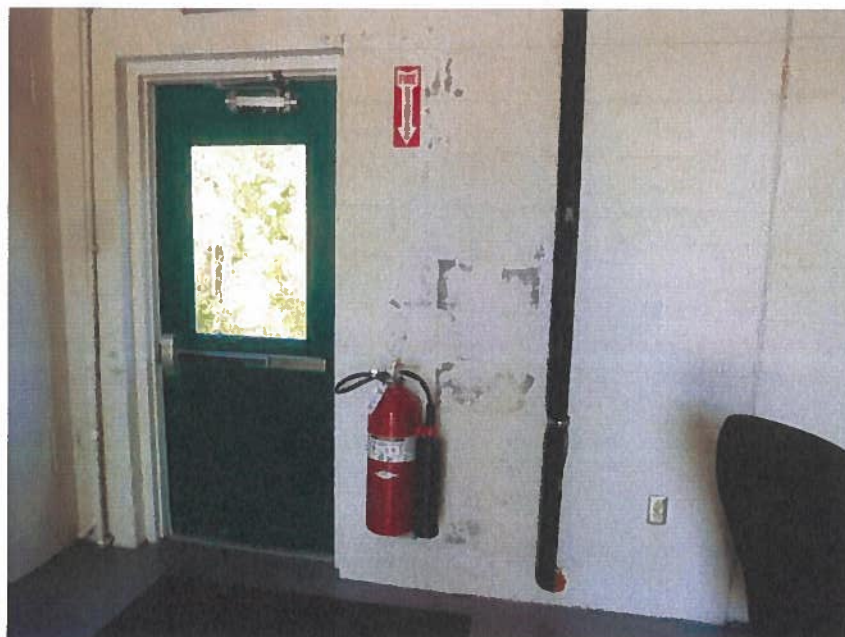
During this inspection, failing paint on the interior wall adjacent to the personnel door leading to the pier from the new pump station was observed (See *Appendix F - Photographs E*). After further inspection, failing paint was observed on the exterior of the same wall along with a failing mortar joint located 1 block course above the base slab. Minor block spalling was also observed (See *Appendix F- Photograph F*). It is recommended this area be investigated and addressed.

**Photograph E –New Pump Station Paint Failure**

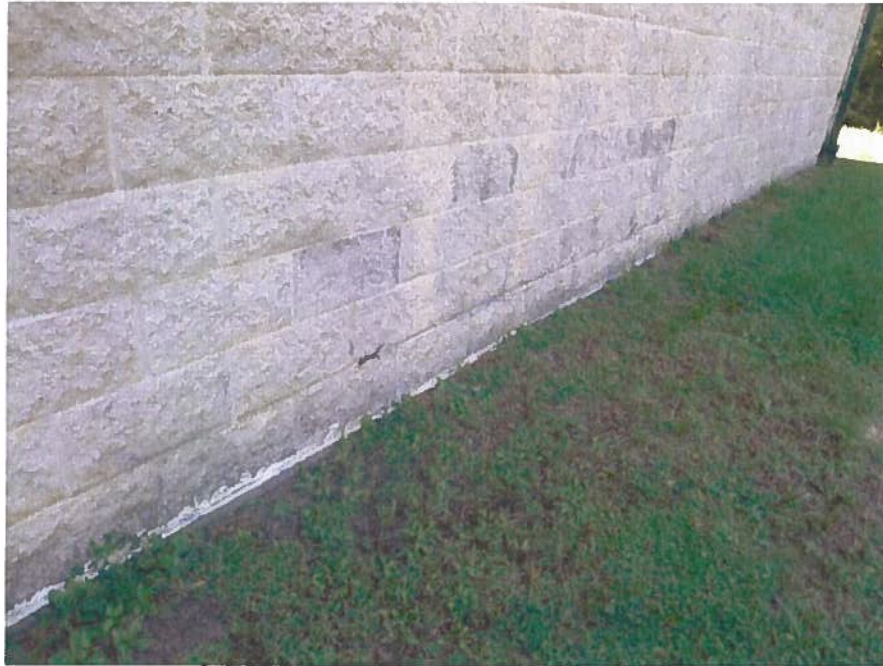
**Photograph F – New Pump Station Masonry Failure**

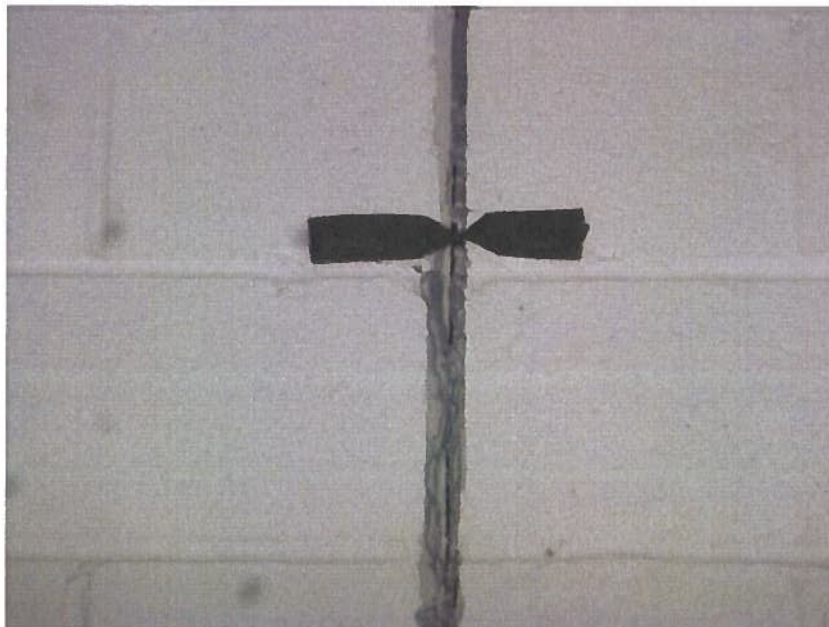
The 1,600 HP pumps are controlled by a separate electrical control room housing variable frequency drives and motor starters. During the 2016 inspection, it appeared that the masonry wall to wall joints located inside the new pump station electrical building had shifted producing cracked paint at the intersection of the walls. The most noticeable crack is located on the

masonry wall joint located west of the western most roll up door. Since the 2016 inspection, Engineer reviewed the joints and found that the issue was not structurally detrimental; however, it was recommended that staff should continue to monitor the issue. During this inspection, visual observation indicated that the size of the separation did not appear to have increased (See *Appendix F - Photographs G*). It is recommended that the wall separation continue to be monitored.

**Photograph G – New Electrical Room Existing Wall Crack**

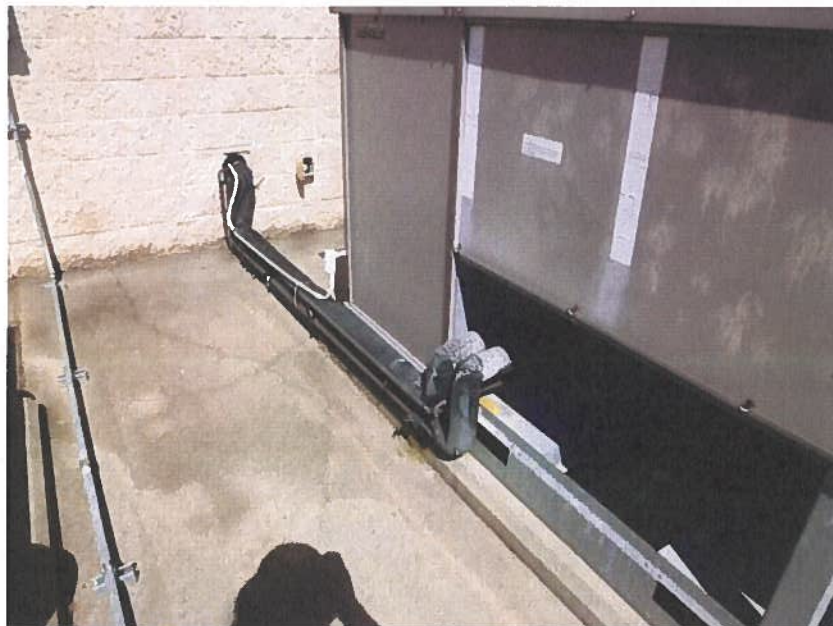
Adjacent to the new electrical control room is an HVAC room housing the HVAC equipment (See *Appendix F - Photographs H*). As noted during the 2023 inspection, a new HVAC unit had been installed outside with an associated air handler inside. All exterior HVAC units were reviewed and were clear of any debris blocking the condenser coils; however, it was noted that the insulation on the exterior HVAC piping had failed in several areas. It is recommended that the failing insulation be addressed (See *Appendix F - Photographs I*).

**Photograph I – HVAC Insulation**

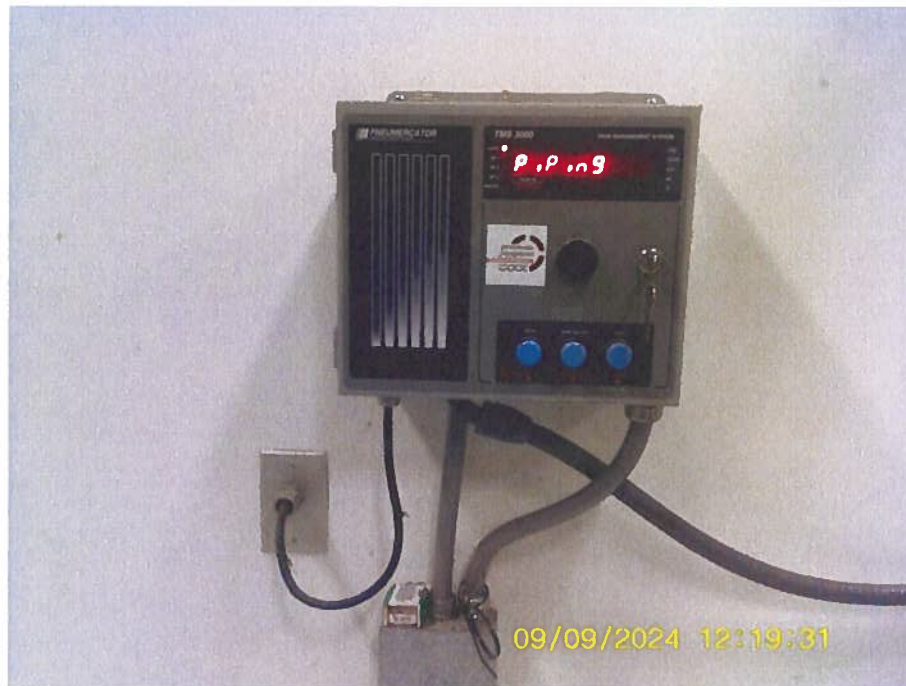
The two 3.0 Mega Watt standby generators are supplied by (2) 12,000-gallon concrete fuel tanks, which are located adjacent to the generator building. The tanks were installed with a 110% secondary containment wall to capture overflow, ruptures, or spills of diesel fuel. During previous inspections, significant efflorescence was noted to exist on the tanks, suggesting coatings failure. During this inspection, the external fuel tanks were found to be repaired. Staff indicated a contractor had started repairing the coating; however, the work is suspended until weather conditions become favorable to complete the work (See *Appendix F – Photograph K*). Also noted during the inspection, a diesel leak alarm was present on the interior leak detection display located inside the generator building. A local leak test alarm was also found inoperable at the diesel storage area (See *Appendix F - Photographs L*).

**Photograph L- Generator Building Diesel Leak Detection Alarm**

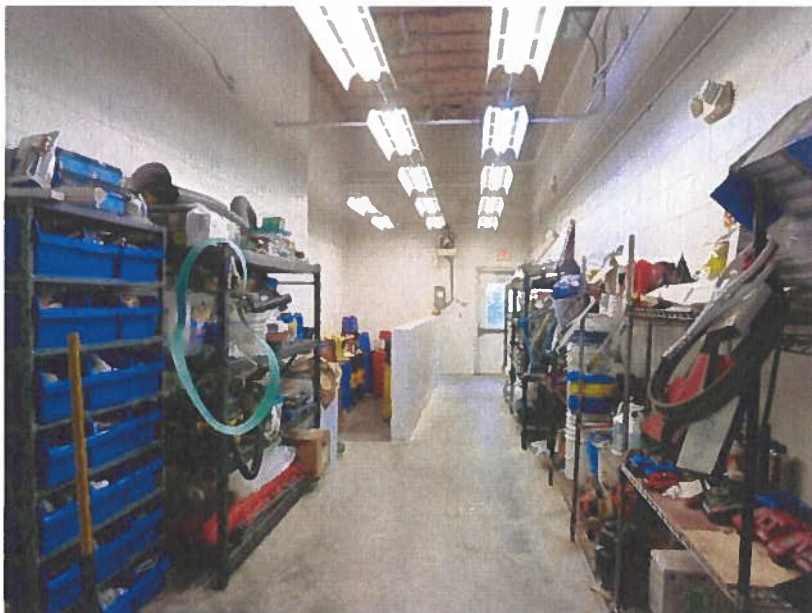
- During this year's inspection, it was noted that both pump station piping rooms need to be cleaned out due to bugs and debris. With respect to the new pump station storage room, this room was found to be sustainably filled with stored items during the last inspection. Since then, items have been relocated/stored to not impede access to the exit door (See *Appendix F – Photograph M*).

**Photograph M- Lubricant Storage Room**

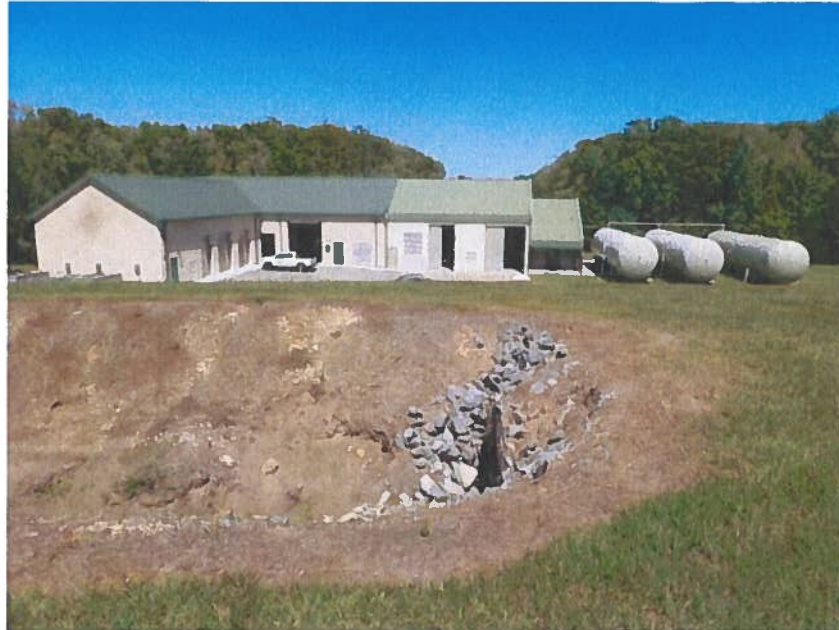
As of this inspection, the walkway that crosses the elevated ditch near the generator facility is in very poor condition (See *Appendix F - Photographs N*). It is recommended that the walkway be

**Photograph N- Ditch Access Walkway**

removed from service and replaced. In its current condition, it is not recommended that the walkway be utilized to cross the elevated ditch near the generator facility.

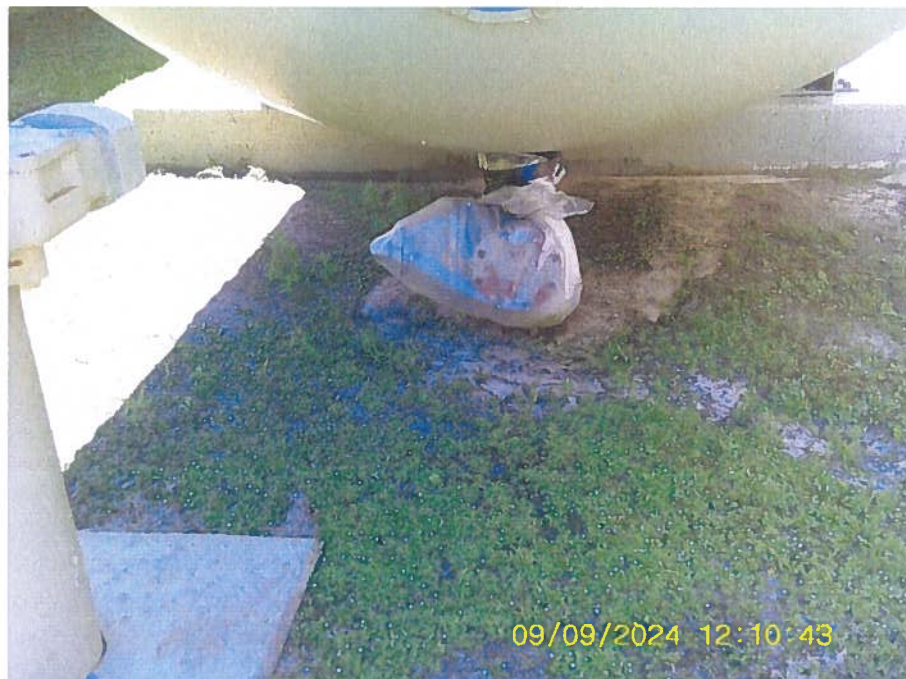
During this inspection (2024), it was noted that the paint was failing in several areas especially on the tank drain valves and tank #3 (See *Appendix F – Photograph O and P*). Staff are in the process of addressing the situation.

**Photograph O - Surge Tank Drain Piping**

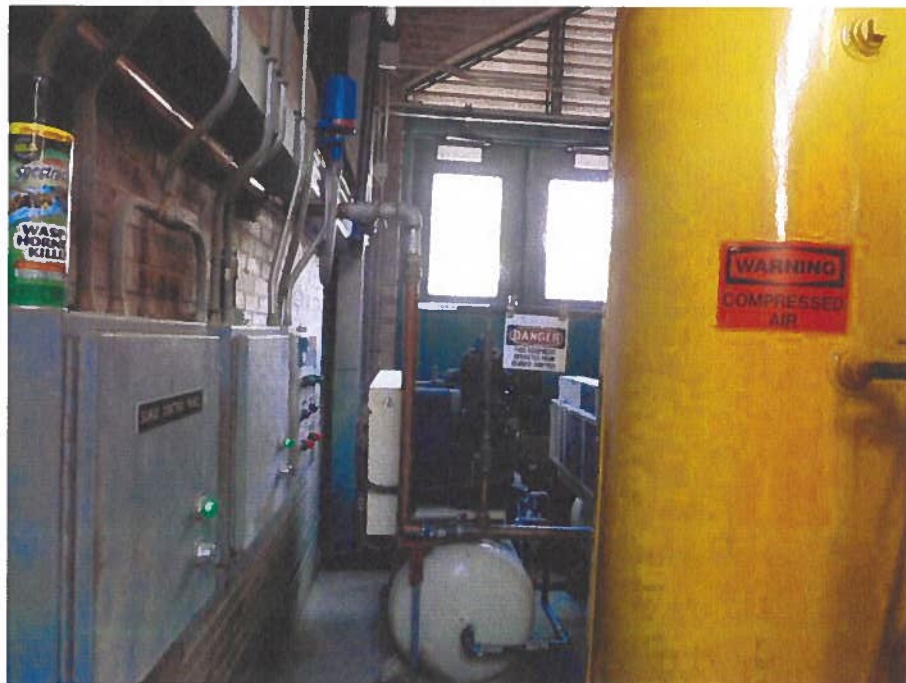
During the 2023 inspection, the surge tank control panels located inside of the pump station were observed to have several indicator lights that required replacement. Lights have since been replaced as of this inspection. Also, during this inspection, all surge tanks had their respective controls turned on (See *Appendix F – Photograph Q*).

**Photograph Q –Surge Tank Control Stations**

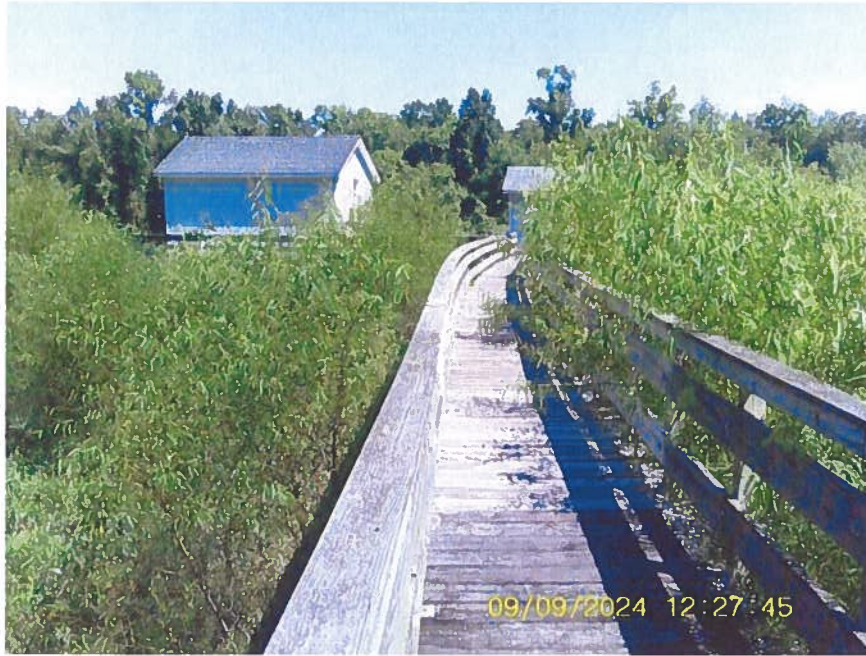
The pipe corridor of the 60-inch intake pipeline is located parallel and adjacent to the existing pier. An inspection of this area indicated that vegetative cover is established, and that the area is slightly flooded (See *Appendix F - Photograph R*). Additionally, overgrown vegetation was in the process of being cleared but the work was not yet complete, as significant growth was observed near the building (See *Appendix F – Photograph S*). Staff indicated clearing was delayed but would resume shortly.

**Photograph S – Area near Backwash Building Overgrown**

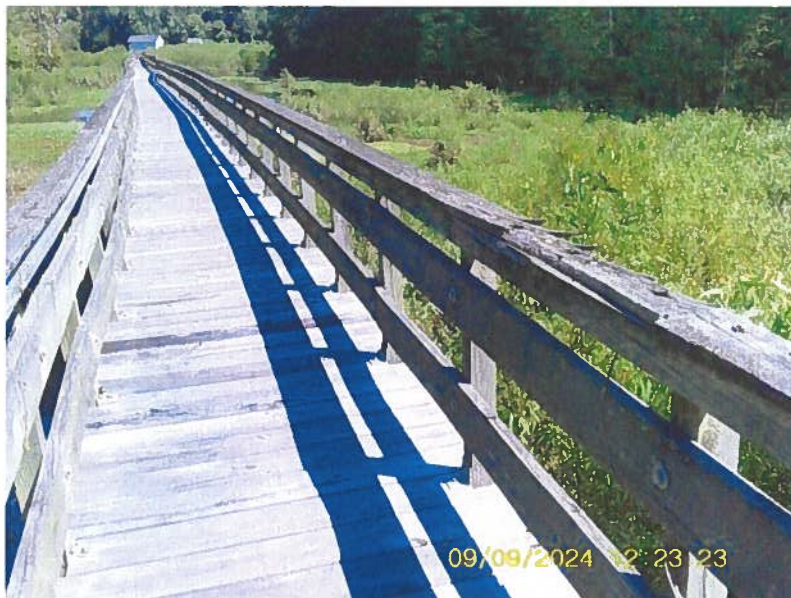
During the 2018 inspection, it was observed that the pier and walkways to the air-backwash control buildings needed repair. Several deck boards and handrails were in poor shape. During the 2019 inspection, it was noted that some repairs had been made (stair and plank replacement); however, more are still required. Also noted in previous reports, several areas on the older building’s wall panels are still showing signs of rot. As of this inspection, the dock remains in poor condition (See *Appendix F - Photographs T*). The old backwash building remains in need of repair as wall boards are rotted. It is noted that the LCFWSA is currently under contract with McKim & Creed to evaluate options for replacement of the pier and air

**Photograph T – Pier Rotten Boards**

backwash buildings; however, it is recommended that the pier and buildings be maintained until the project is completed.

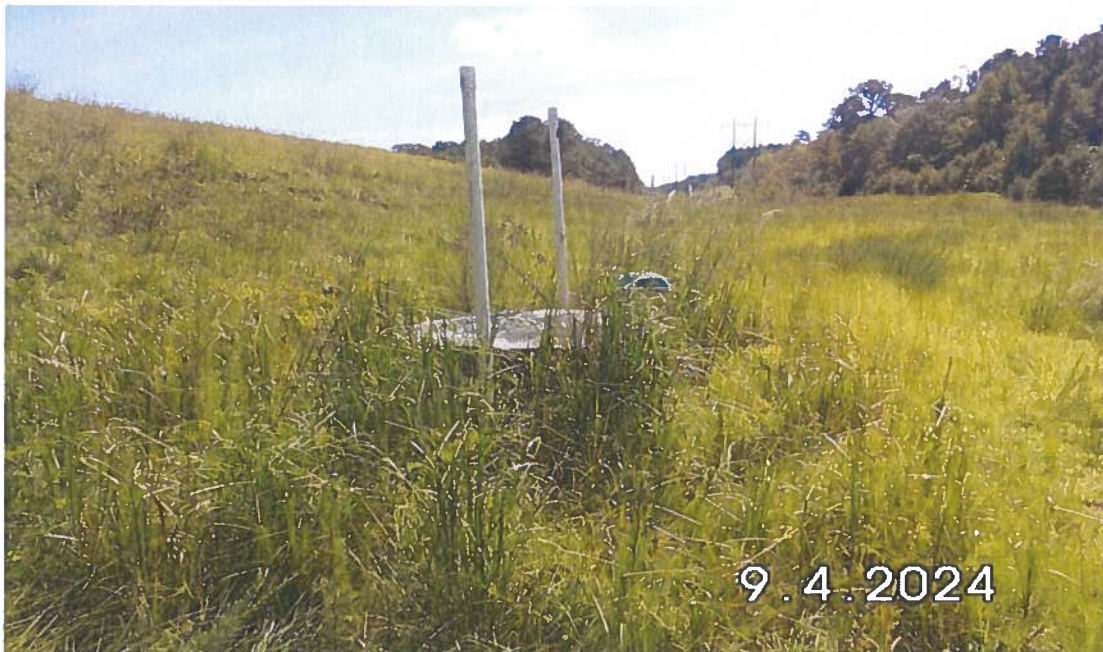
**Photograph AA – Overgrown Area along Right-of-Way**

1. Mow/Clear overgrown areas along pipeline route.
2. Continue to monitor and evaluate need to paint manhole ring and covers and concrete flat-tops for manholes, valves, blow-offs where required.
3. (New) Replace or provide "Blue makers" as installed during 54" RWM project along 48" RWM R/W.
4. Exercise all valves and blow-offs annually.
5. Add bollards to protect manhole within "The Bluffs" development access drive.
6. Monitor and evaluate for repair the eroded pipe joint in the ARV manhole near Phelps Truck Sales on US-421.
7. Periodically operate the emergency connection at the Dak Industries (former) site.
8. Ensure that valves and ARV's can be properly operated with current valve box configuration. Noted that some valve boxes appeared to be out of plumb and could create issues with operations.

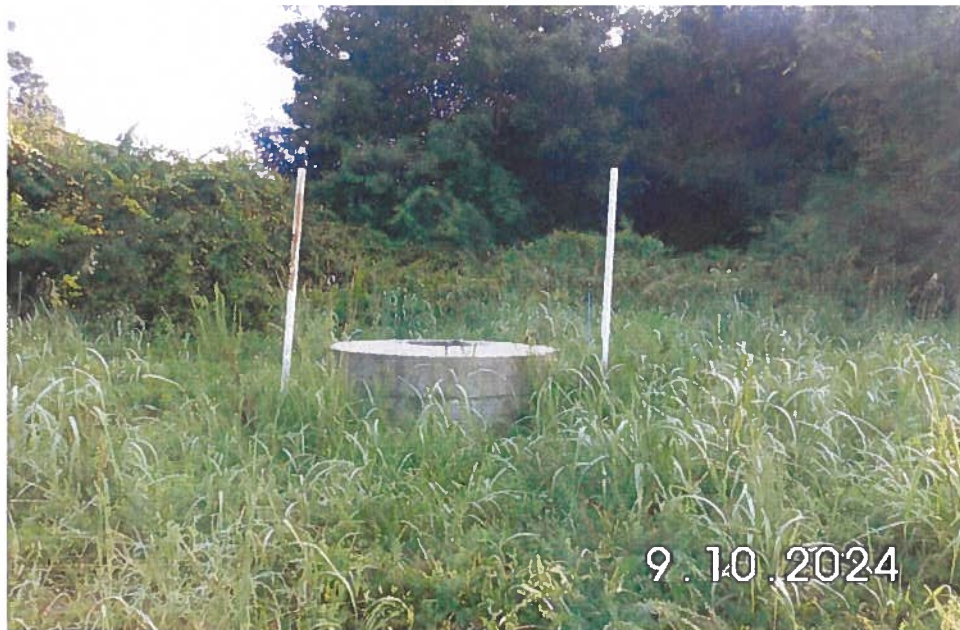
**Photograph BB – Orange Painted Structure Marker Deterioration**

1. Recommend painted 2" PVC poles painted "orange" to mark each valve structure.
2. Recommend all valve structures to be re-painted "blue".
3. Additional "blue" marker posts are needed to mark valve locations.

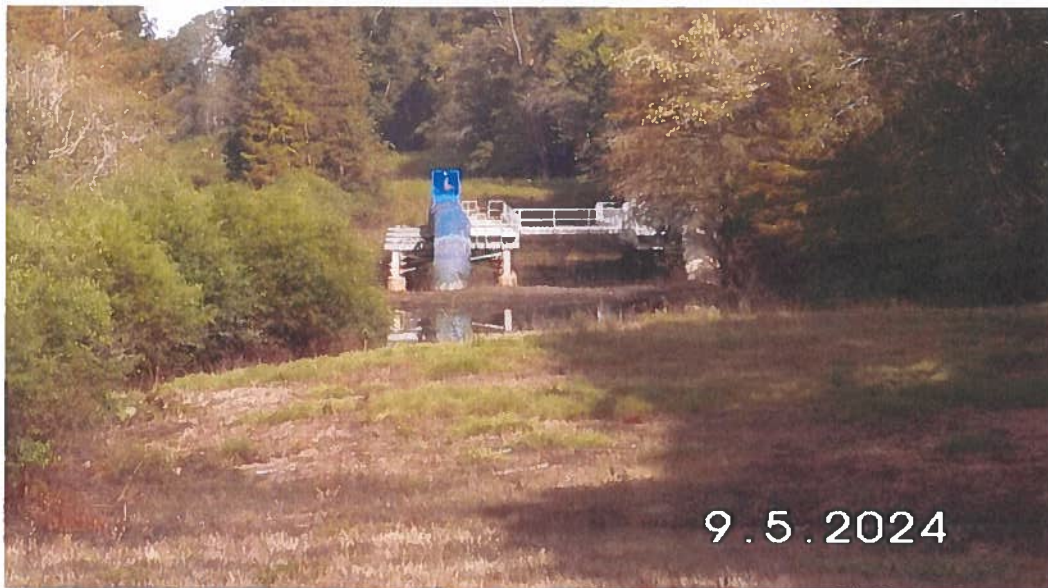
Also completed by Intracoastal Marine during the same time was a joint repair on the existing 48" PCCP elevated pipe where degradation of one of the existing joints had occurred. The contractor repaired the joint in accordance with specifications provided by the pipe manufacturer and at the direction of McKim & Creed's structural engineer. (See Photograph II)

**Photograph II- Walkway Access across Livingston Creek on Existing 48" PCCP pipe**

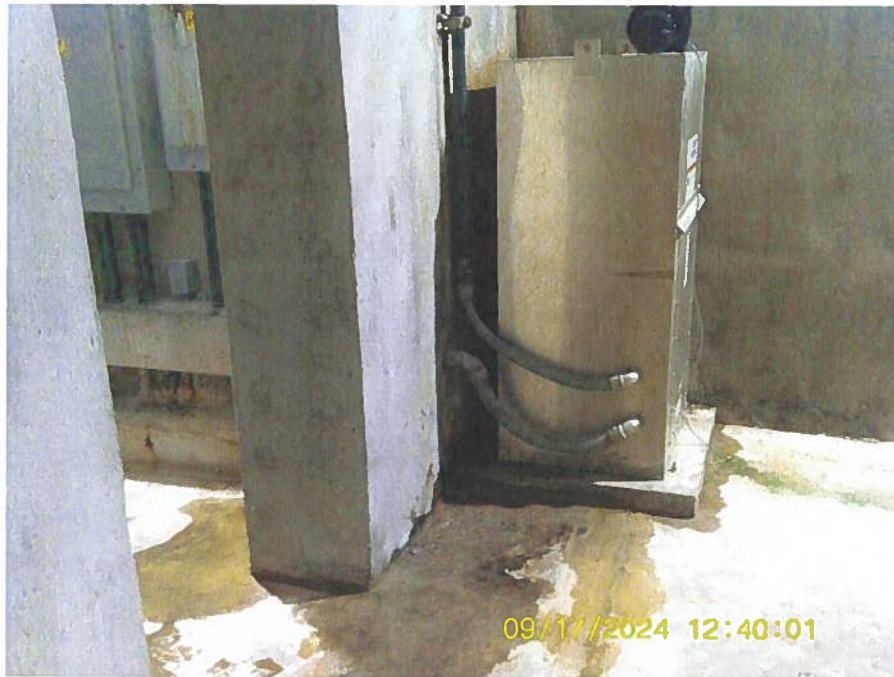
**Photograph Q – Filter Gallery Wall Leaks**

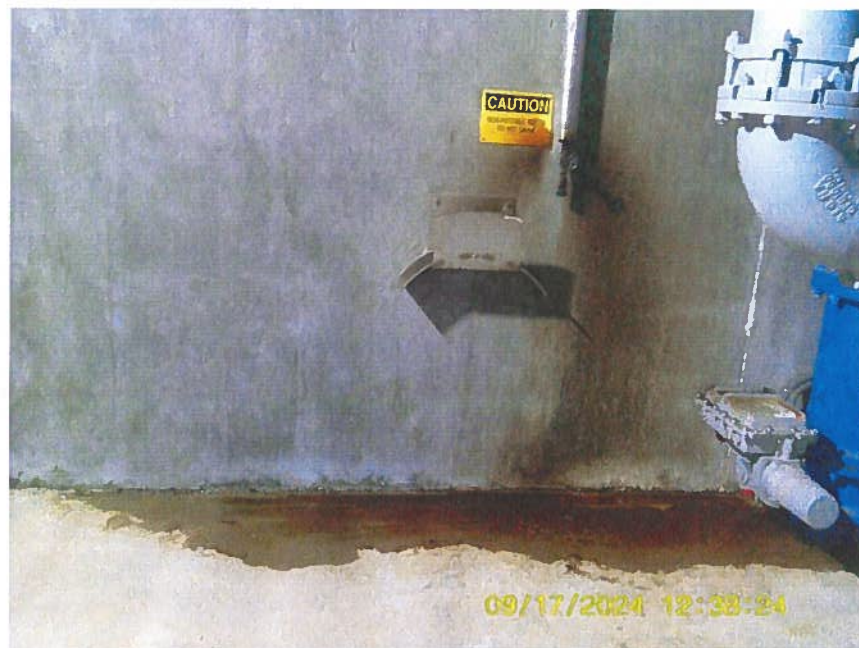
**Photograph R – Filter Gallery Piping Leaks**

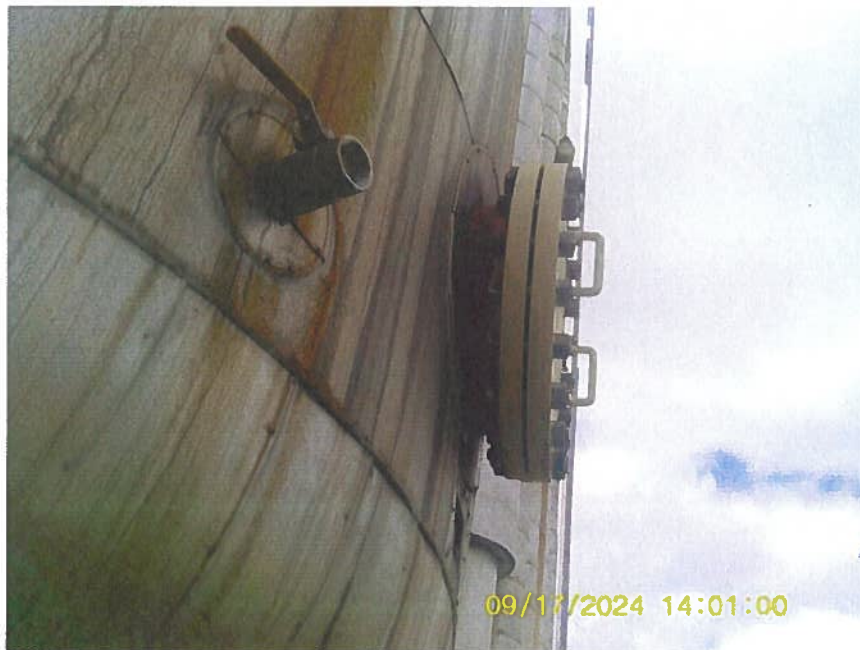
**Photograph X- GAC Filter Manway Corrosion**

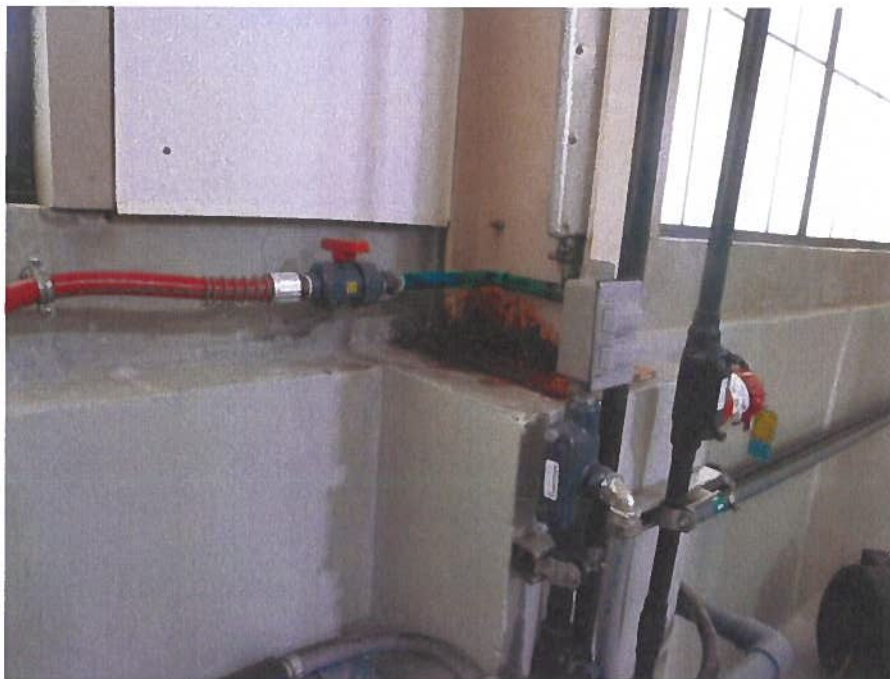
| Couple leaks on copper lines for water hose | Planning repair |

**Photograph Y- Chemical Building Interior Piping Leak**

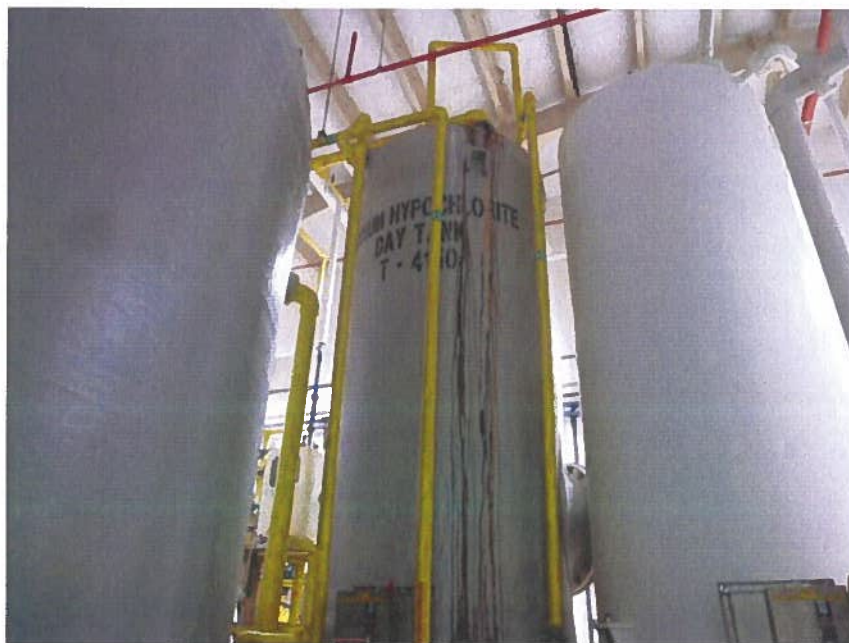
| Leak on top of chlorine day tank at flange fitting | Planning repair |

**Photograph Z- Chemical Building Chlorine Tank Leak**
