Lower Cape Fear Water & Sewer Authority
Regular Board Meeting Minutes
October 14th, 2024

Lower Cape Fear Water & Sewer Authority Kings Bluff Regional Raw Water Supply Facilities FY 2024-2025 Annual Inspection Report

FY 2024-2025 Annual Inspection Report

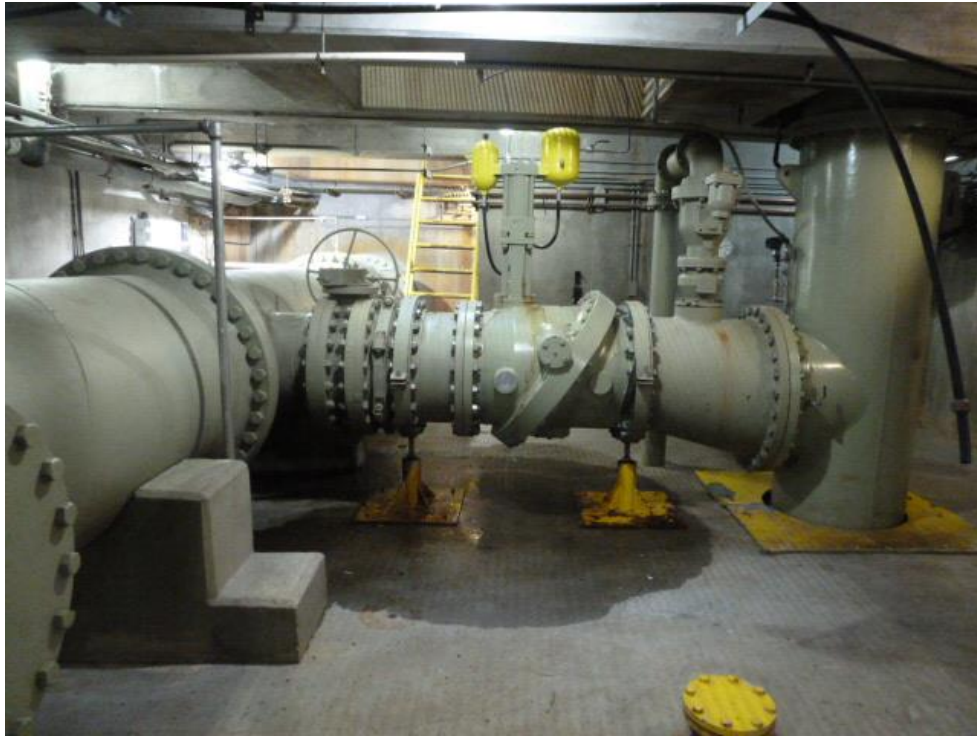
During this visit, it was noted that the check valve on Pump 1 was significantly leaking. Staff indicated that Underwood recently installed a rebuilt unit that did not initially leak; however, over time, the valve began to leak. Staff indicated Underwood would be reviewing the installation next week in hopes of addressing the issue (See *Appendix F - Photographs B*).

Photograph B – Check Valve on Pump #1 Leaking

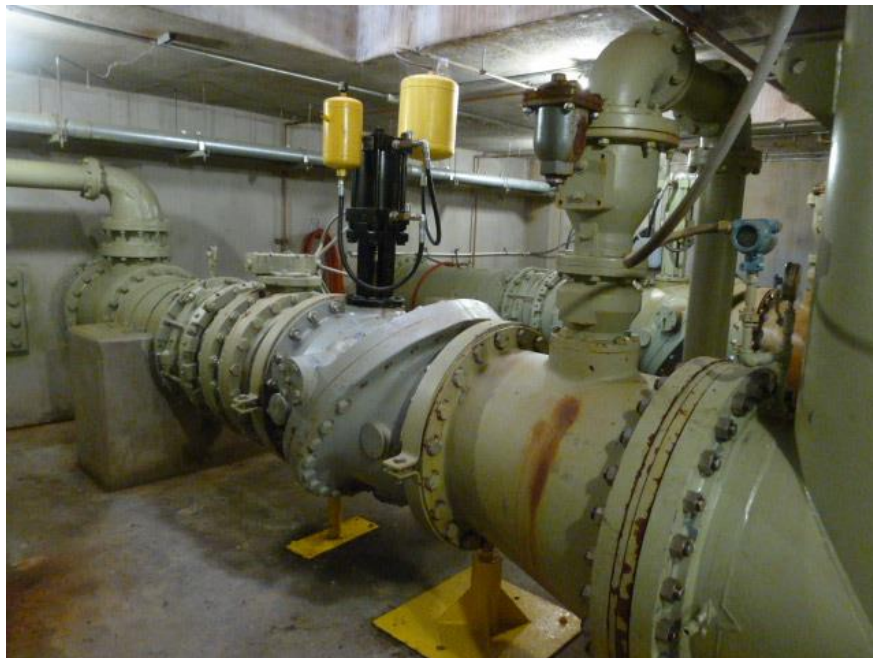
Photograph C – Failed Check Valve on Pump 5

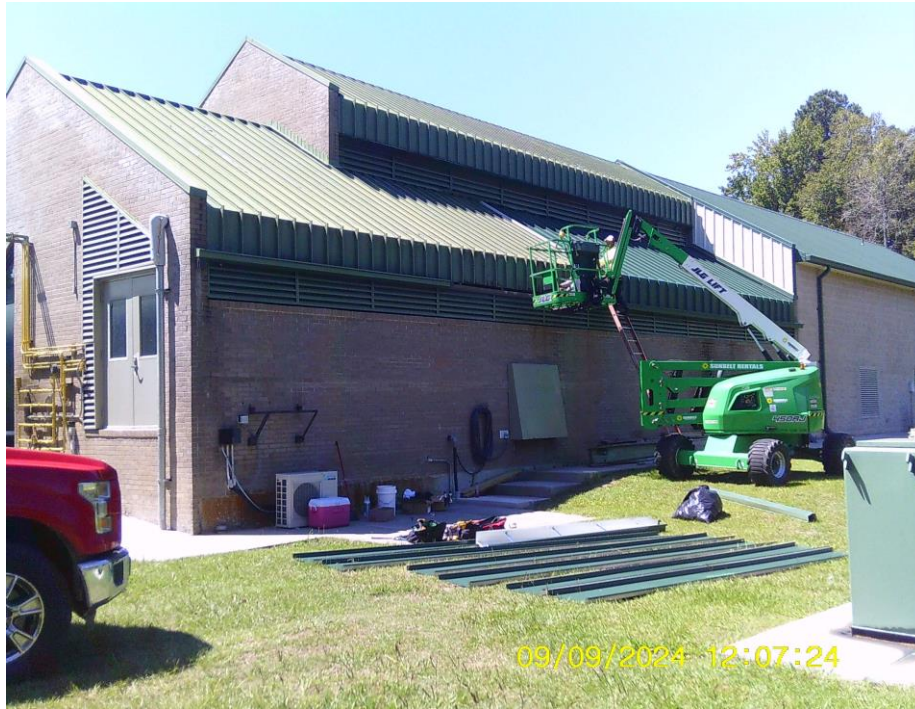
Additionally, staff indicated the lighting in the old station was scheduled to be replaced with LED lighting and the existing was outdated florescent type. The roof replacement project at the old pump station (previously funded and awarded) was underway and approximately 25% complete (See *Appendix F - Photographs D*).

Photograph D –Old Pump Station Roof Replacement

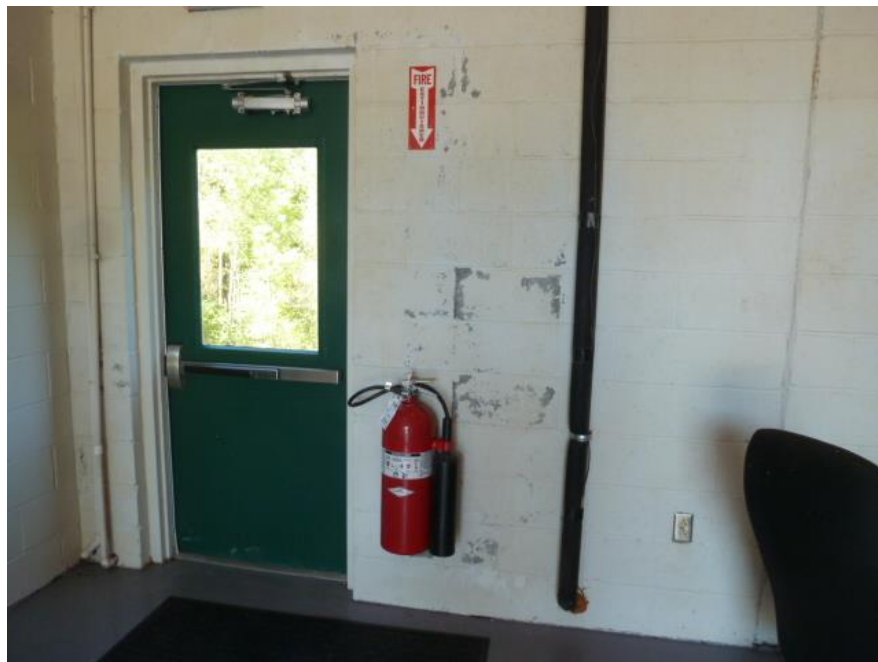
During this inspection, failing paint on the interior wall adjacent to the personnel door leading to the pier from the new pump station was observed (See *Appendix F - Photographs E*). After further inspection, failing paint was observed on the exterior of the same wall along with a failing mortar joint located 1 block course above the base slab. Minor block spalling was also observed (See *Appendix F - Photograph F*). It is recommended this area be investigated and addressed.

Photograph E –New Pump Station Paint Failure

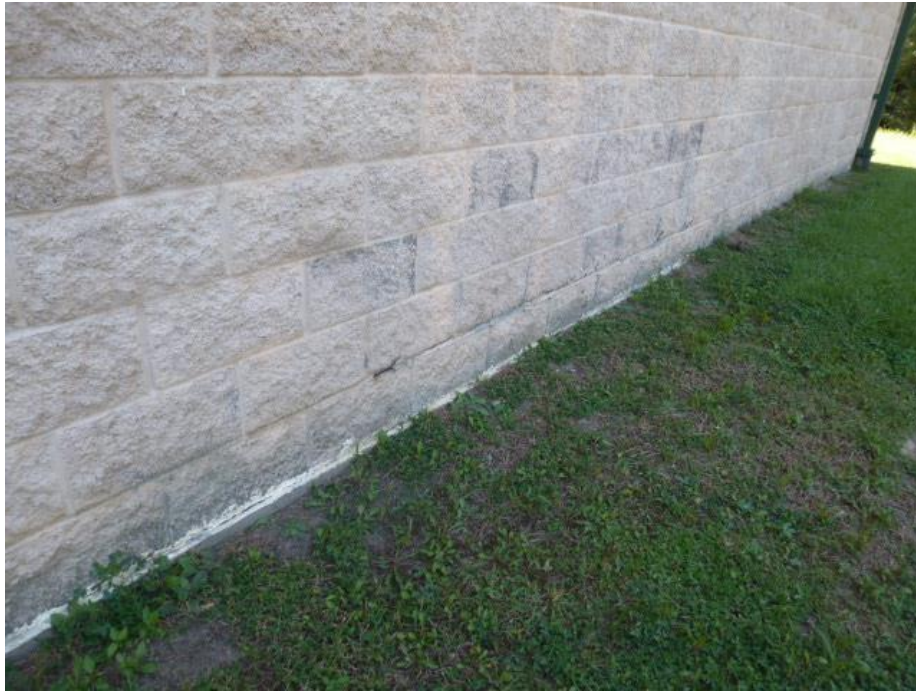
Photograph F – New Pump Station Masonry Failure

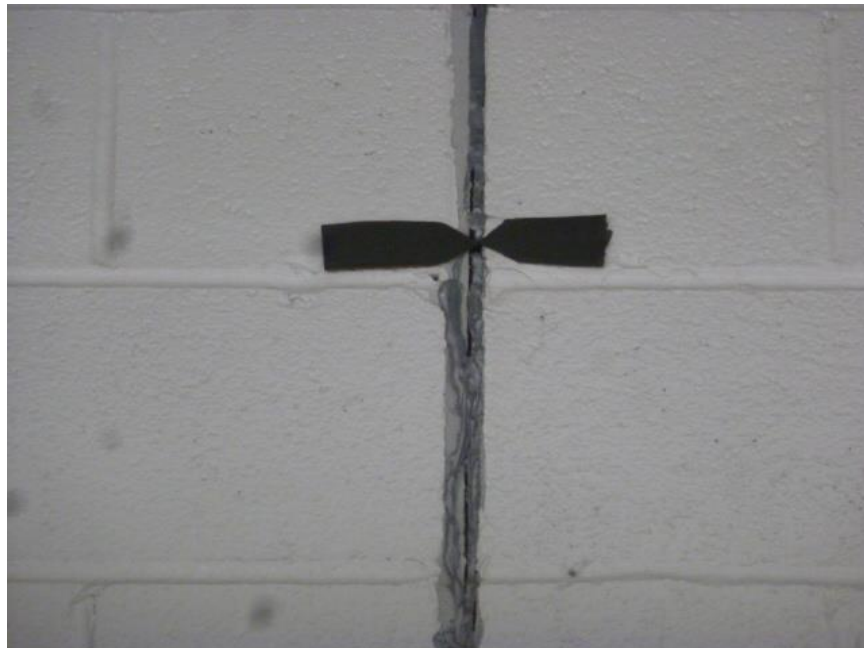
The 1,600 HP pumps are controlled by a separate electrical control room housing variable frequency drives and motor starters. During the 2016 inspection, it appeared that the masonry wall to wall joints located inside the new pump station electrical building had shifted producing cracked paint at the intersection of the walls. The most noticeable crack is located on the

masonry wall joint located west of the western most roll up door. Since the 2016 inspection, Engineer reviewed the joints and found that the issue was not structurally detrimental; however, it was recommended that staff should continue to monitor the issue. During this inspection, visual observation indicated that the size of the separation did not appear to have increased (See *Appendix F - Photographs G*). It is recommended that the wall separation continue to be monitored.

Photograph G – New Electrical Room Existing Wall Crack

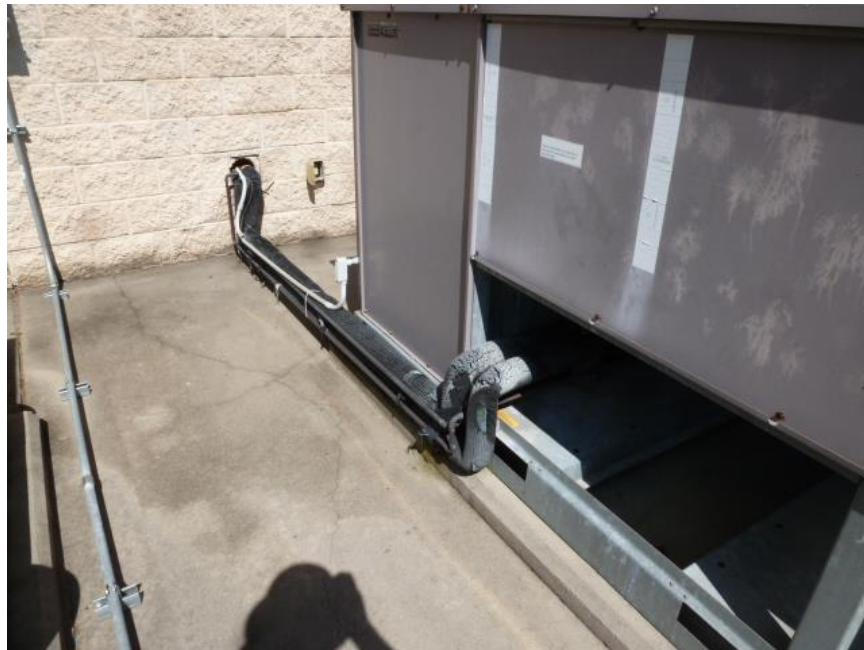
Adjacent to the new electrical control room is an HVAC room housing the HVAC equipment (See *Appendix F - Photographs H*). As noted during the 2023 inspection, a new HVAC unit had been installed outside with an associated air handler inside. All exterior HVAC units were reviewed and were clear of any debris blocking the condenser coils; however, it was noted that the insulation on the exterior HVAC piping had failed in several areas. It is recommended that the failing insulation be addressed (See *Appendix F - Photographs I*).

Photograph I - HVAC Insulation

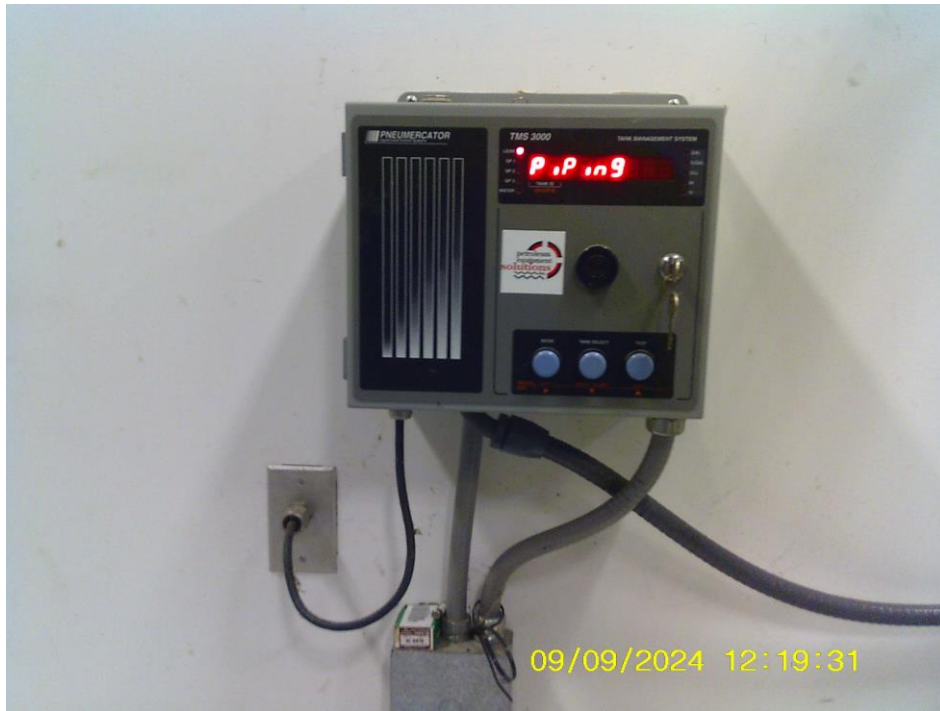
The two 3.0 Mega Watt standby generators are supplied by (2) 12,000-gallon concrete fuel tanks, which are located adjacent to the generator building. The tanks were installed with a 110% secondary containment wall to capture overflow, ruptures, or spills of diesel fuel. During previous inspections, significant efflorescence was noted to exist on the tanks, suggesting coatings failure. During this inspection, the external fuel tanks were found to be repaired. Staff indicated a contractor had started repairing the coating; however, the work is suspended until weather conditions become favorable to complete the work (See *Appendix F - Photograph K*). Also noted during the inspection, a diesel leak alarm was present on the interior leak detection display located inside the generator building. A local leak test alarm was also found inoperable at the diesel storage area (See *Appendix F - Photographs L*).

Photograph L- Generator Building Diesel Leak Detection Alarm

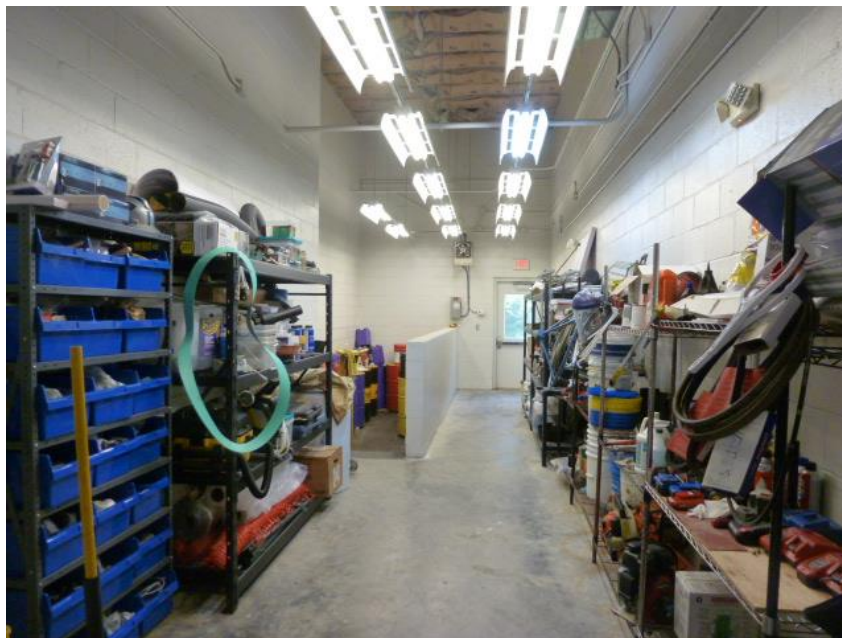
- During this year's inspection, it was noted that both pump station piping rooms need to be cleaned out due to bugs and debris. With respect to the new pump station storage room, this room was found to be sustainably filled with stored items during the last inspection. Since then, items have been relocated/stored to not impede access to the exit door (See *Appendix F – Photograph M*).

Photograph M- Lubricant Storage Room

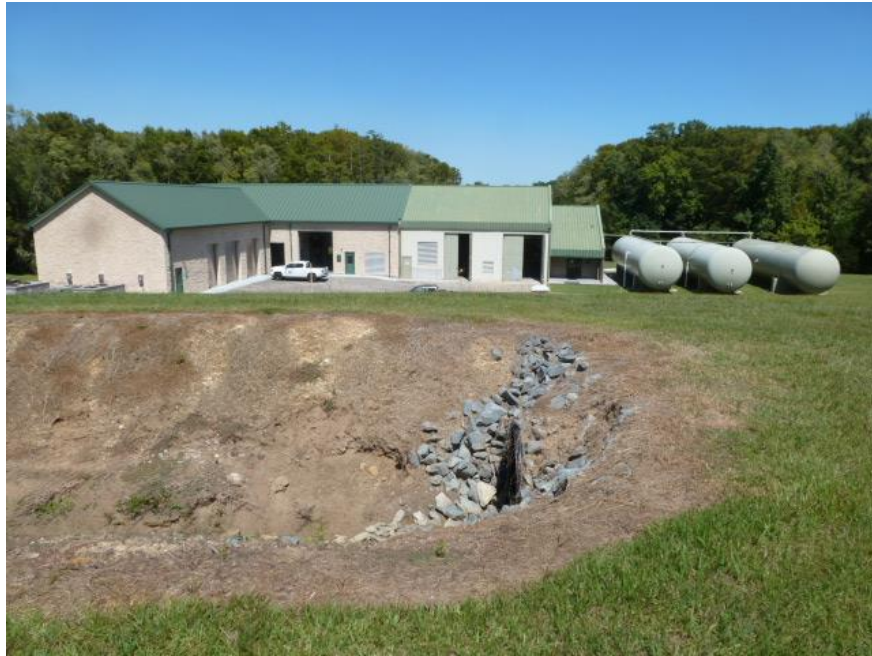
As of this inspection, the walkway that crosses the elevated ditch near the generator facility is in very poor condition (See *Appendix F - Photographs N*). It is recommended that the walkway be

Photograph N- Ditch Access Walkway

removed from service and replaced. In its current condition, it is not recommended that the walkway be utilized to cross the elevated ditch near the generator facility.

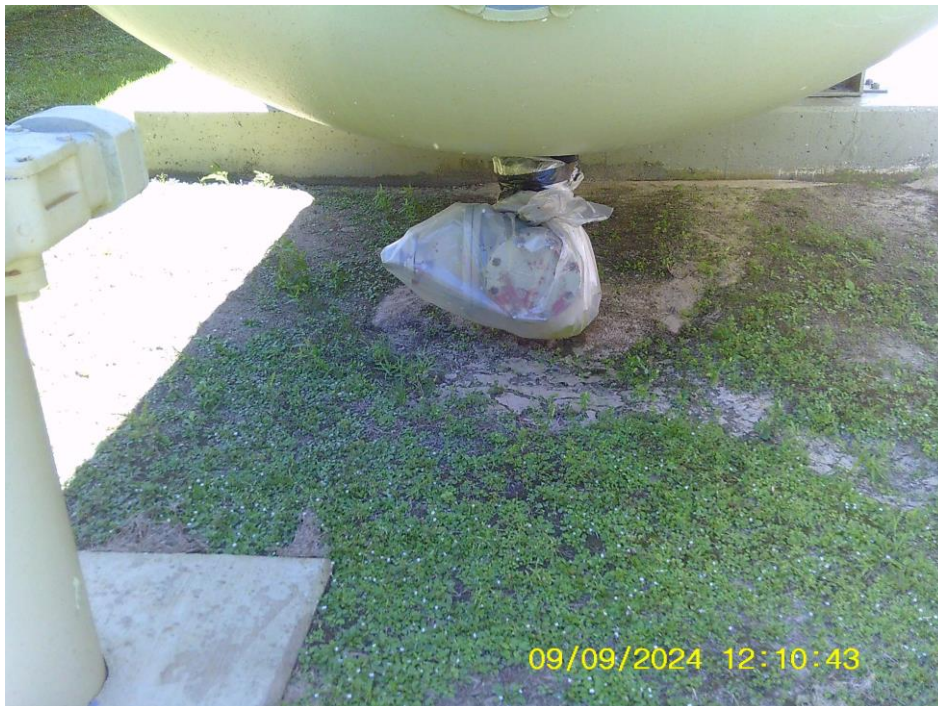
During this inspection (2024), it was noted that the paint was failing in several areas especially on the tank drain valves and tank #3 (See *Appendix F – Photograph O and P*). Staff are in the process of addressing the situation.

Photograph O - Surge Tank Drain Piping

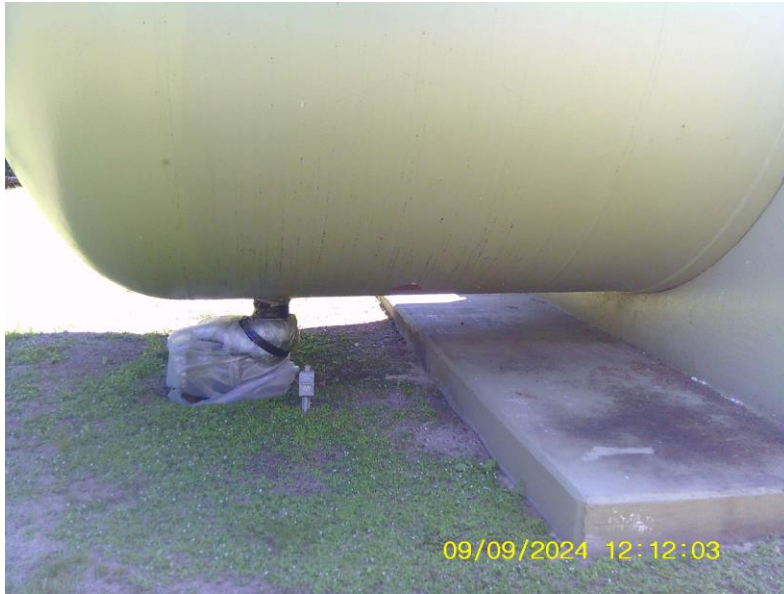
Photograph P – Surge Tank Drain Piping

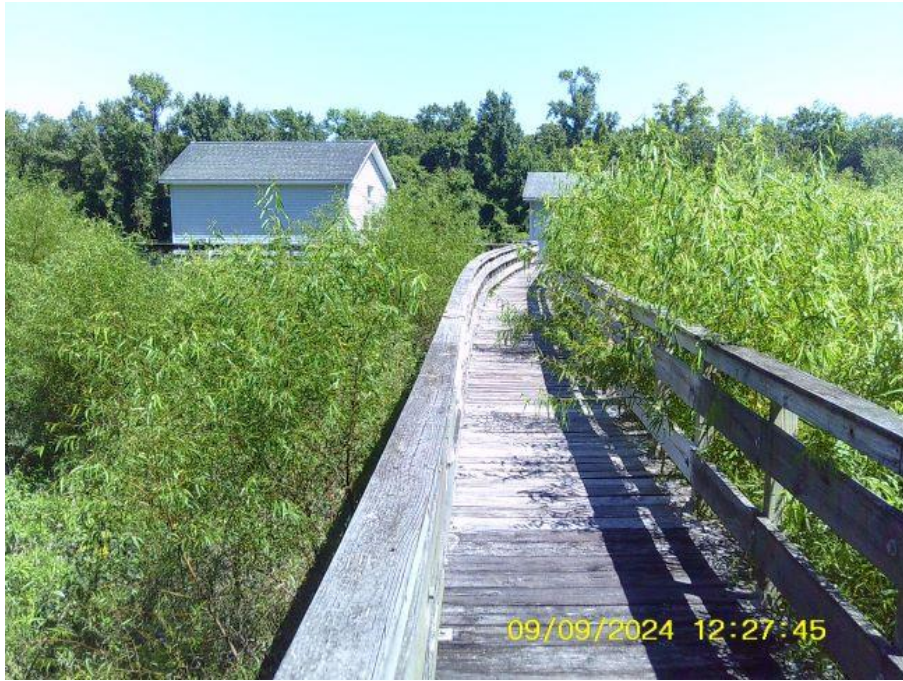
The pipe corridor of the 60-inch intake pipeline is located parallel and adjacent to the existing pier. An inspection of this area indicated that vegetative cover is established, and that the area is slightly flooded (See *Appendix F - Photograph R*). Additionally, overgrown vegetation was in the process of being cleared but the work was not yet complete, as significant growth was observed near the building (See *Appendix F – Photograph S*). Staff indicated clearing was delayed but would resume shortly.

Photograph S – Area near Backwash Building Overgrown

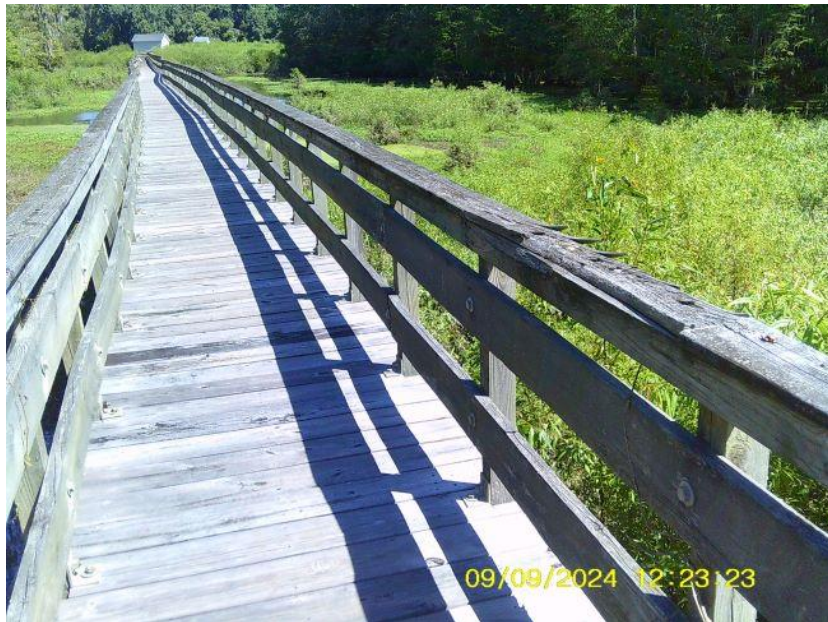
During the 2018 inspection, it was observed that the pier and walkways to the air-backwash control buildings needed repair. Several deck boards and handrails were in poor shape. During the 2019 inspection, it was noted that some repairs had been made (stair and plank replacement); however, more are still required. Also noted in previous reports, several areas on the older building's wall panels are still showing signs of rot. As of this inspection, the dock remains in poor condition (See *Appendix F - Photographs T*). The old backwash building remains in need of repair as wall boards are rotted. It is noted that the LCFWSA is currently under contract with McKim & Creed to evaluate options for replacement of the pier and air

Photograph T – Pier Rotten Boards

backwash buildings; however, it is recommended that the pier and buildings be maintained until the project is completed.

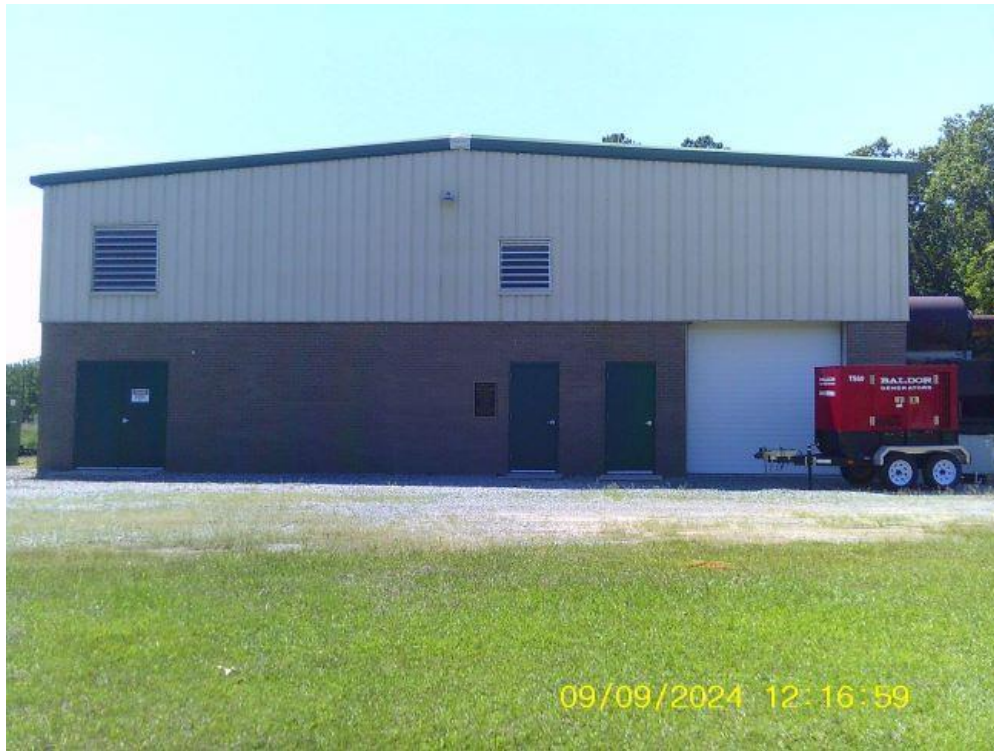
Noted during previous inspections, exterior personnel doors were rusted to such an extent that holes appeared. The doors were replaced at the time of this inspection. (**See Appendix F – Photograph U**).

Photograph U – Generator Building Doors Replaced

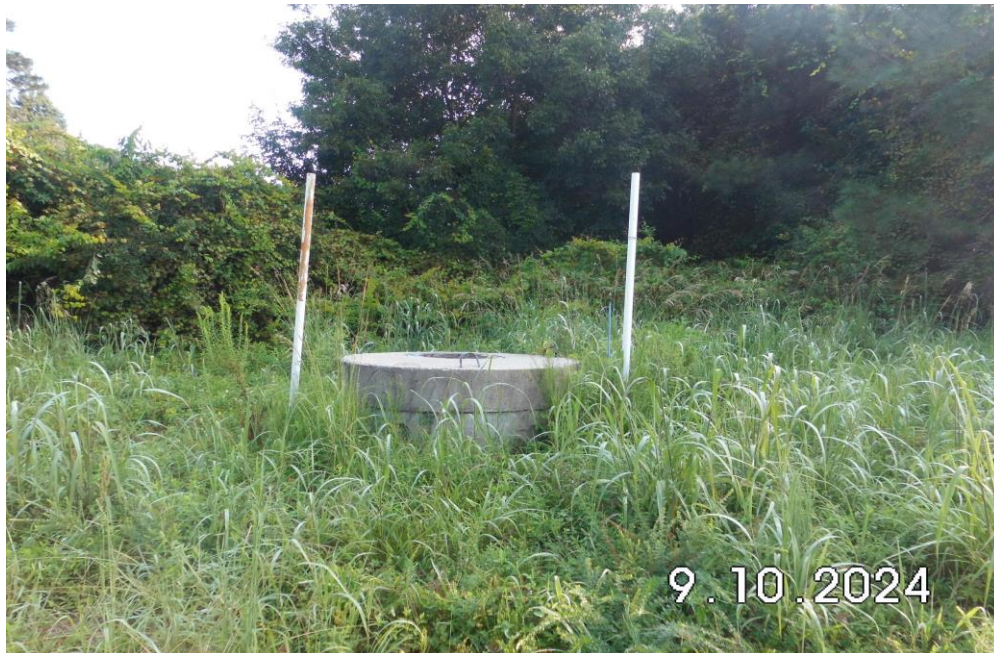
Photograph BB – Orange Painted Structure Marker Deterioration

1. Recommend painted 2" PVC poles painted "orange" to mark each valve structure.
2. Recommend all valve structures to be re-painted "blue".
3. Additional "blue" marker posts are needed to mark valve locations.

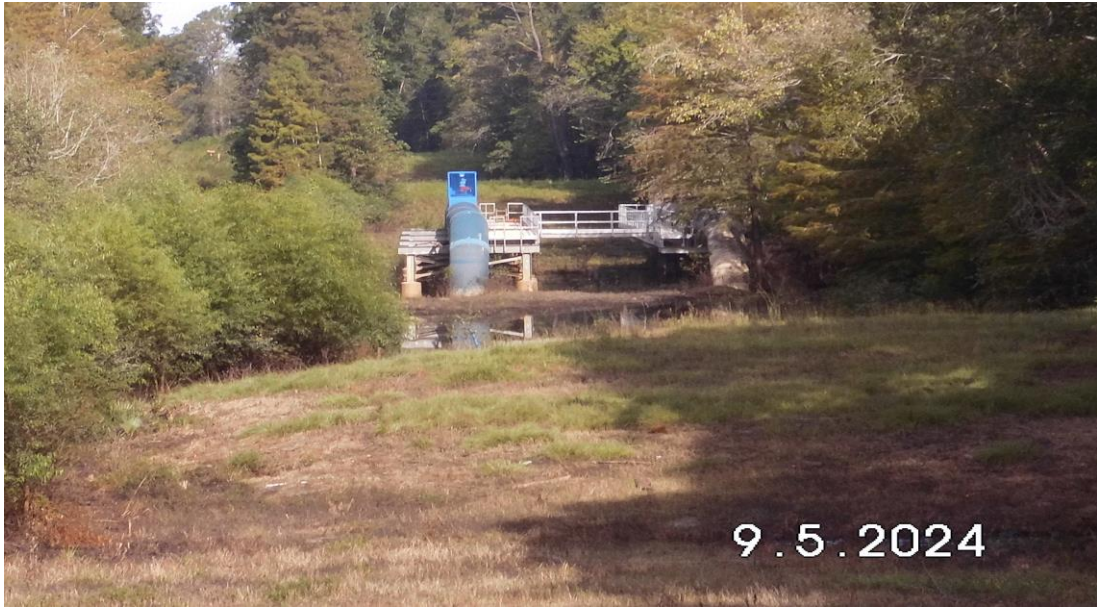
Also completed by Intracoastal Marine during the same time was a joint repair on the existing 48" PCCP elevated pipe where degradation of one of the existing joints had occurred. The contractor repaired the joint in accordance with specifications provided by the pipe manufacturer and at the direction of McKim & Creed's structural engineer. (See **Photograph II**)

Photograph II- Walkway Access across Livingston Creek on Existing 48" PCCP pipe

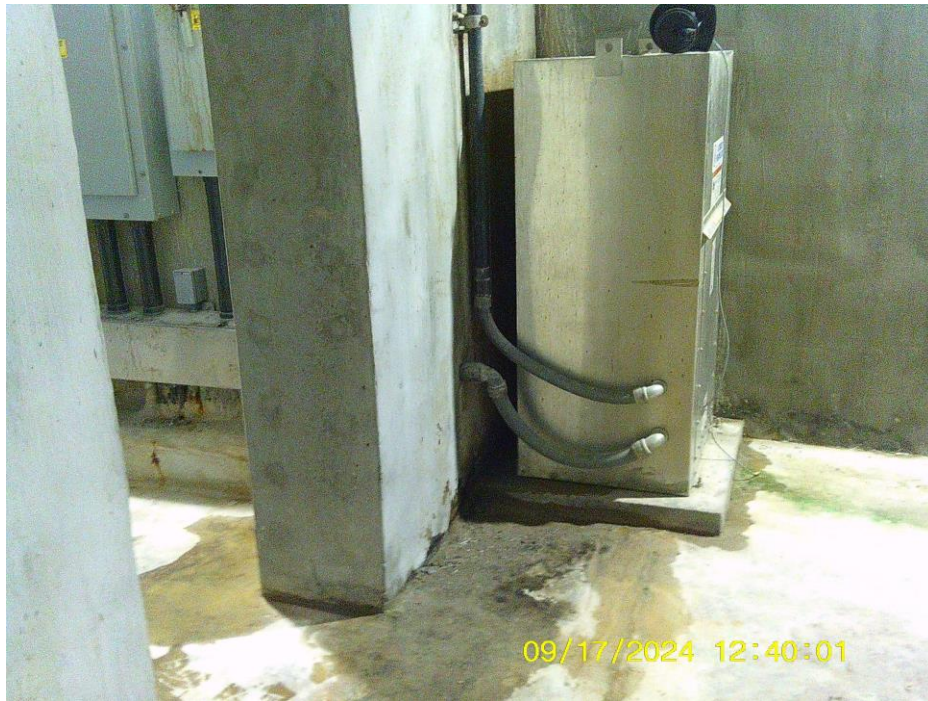
Photograph Q – Filter Gallery Wall Leaks

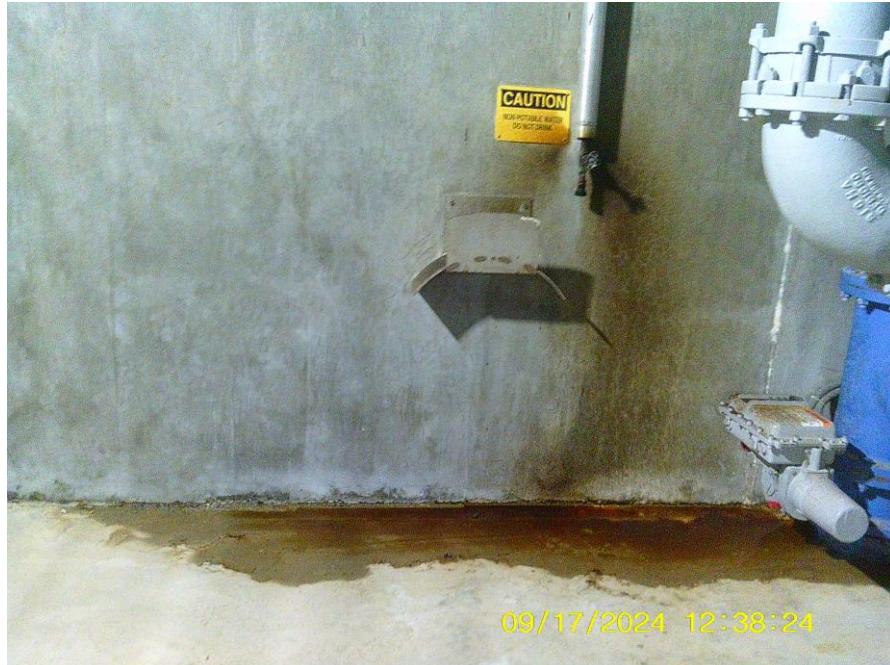
Photograph R – Filter Gallery Piping Leaks

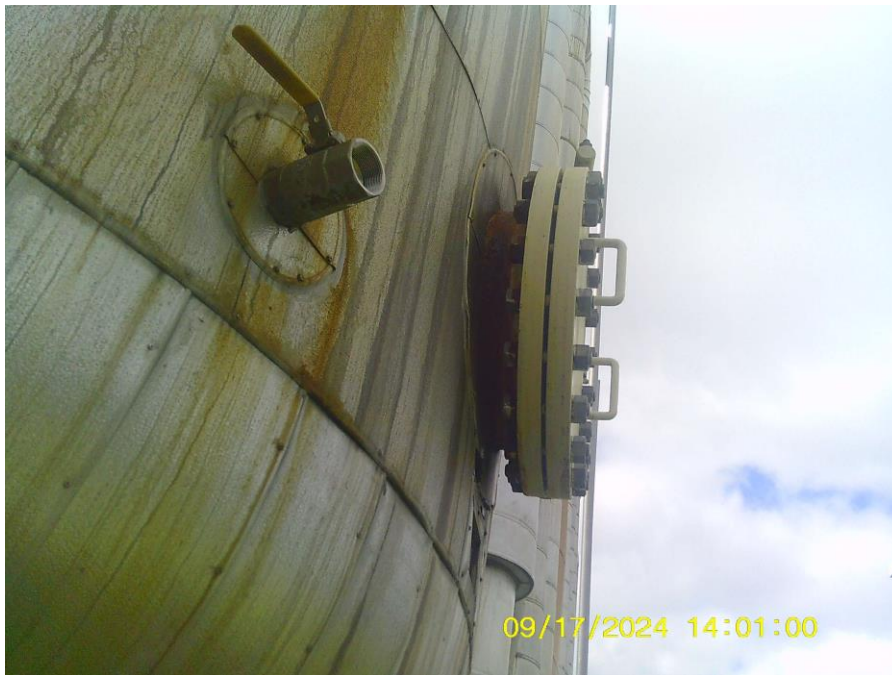
Photograph X- GAC Filter Manway Corrosion

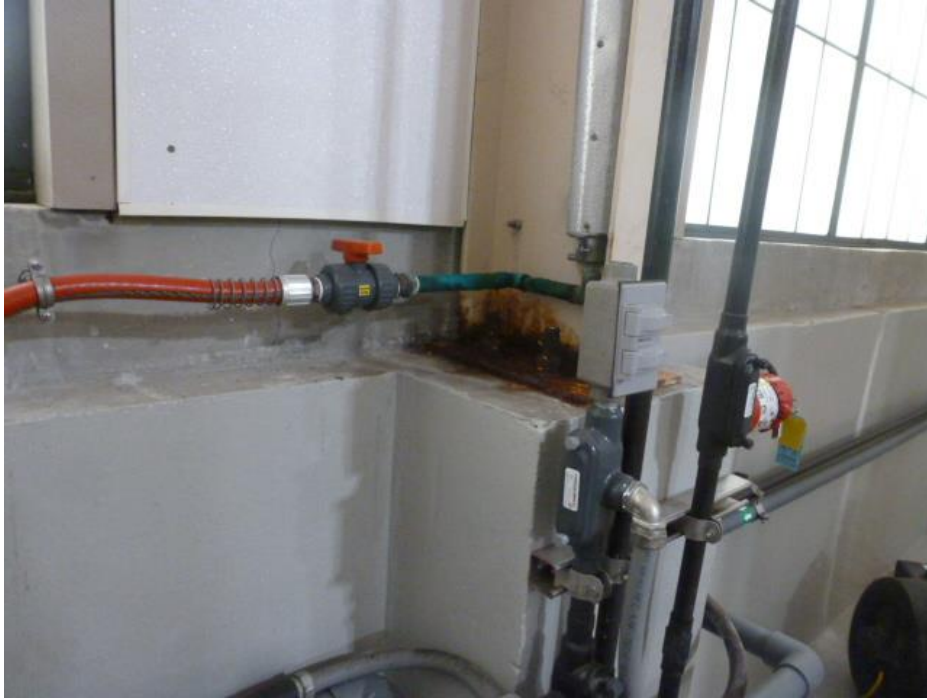
Photograph Y- Chemical Building Interior Piping Leak

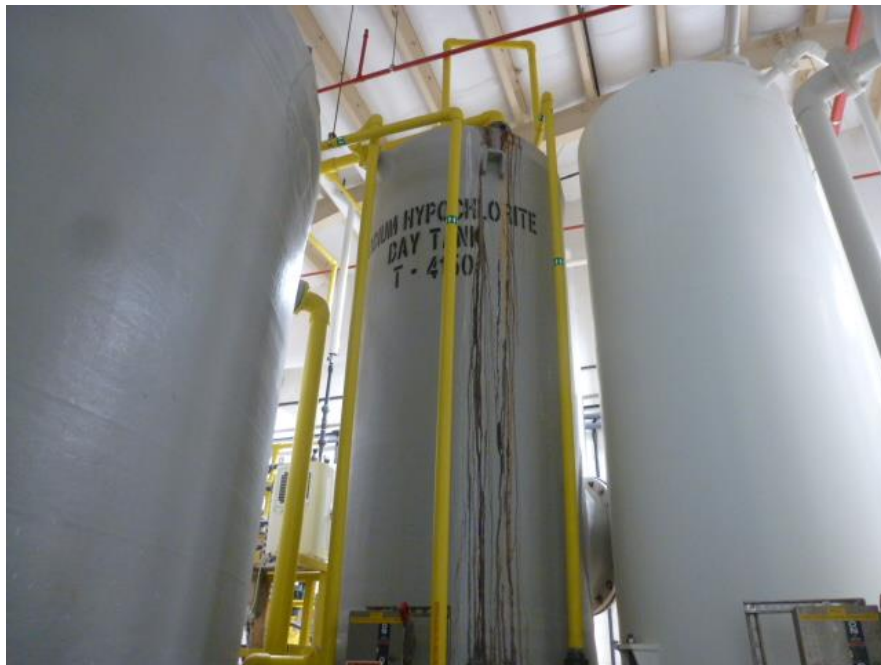
systems, and administrative facilities. Mr. Powell concluded that the items identified in the report are minor maintenance items, and the facility is well maintained. Jess advised there is a new item, which is the Chemical Building chlorine tank leak and corroding column, and that will be addressed by staff. Chairman Knight is concerned that both inspection reports show routine maintenance items listed for multiple years. Director Williams requested a quarterly update for the board on outstanding items on the annual inspection if the item is from the previous year, the urgency for the repair, and the consequences of not completing the repair. A copy of the report is hereby incorporated as part of these minutes.

Photograph Z- Chemical Building Chlorine Tank Leak
