AGENDA
Lower Cape Fear Water & Sewer Authority
1107 New Pointe Boulevard, Suite # 17, Leland, North Carolina
9:00 a.m. – Regular Monthly Board Meeting
October 13, 2025

**Lower Cape Fear Water & Sewer Authority
Kings Bluff Regional Raw Water Supply Facilities
FY 2025-2026 Annual Inspection Report**

FY 2025-2026 Annual Inspection Report

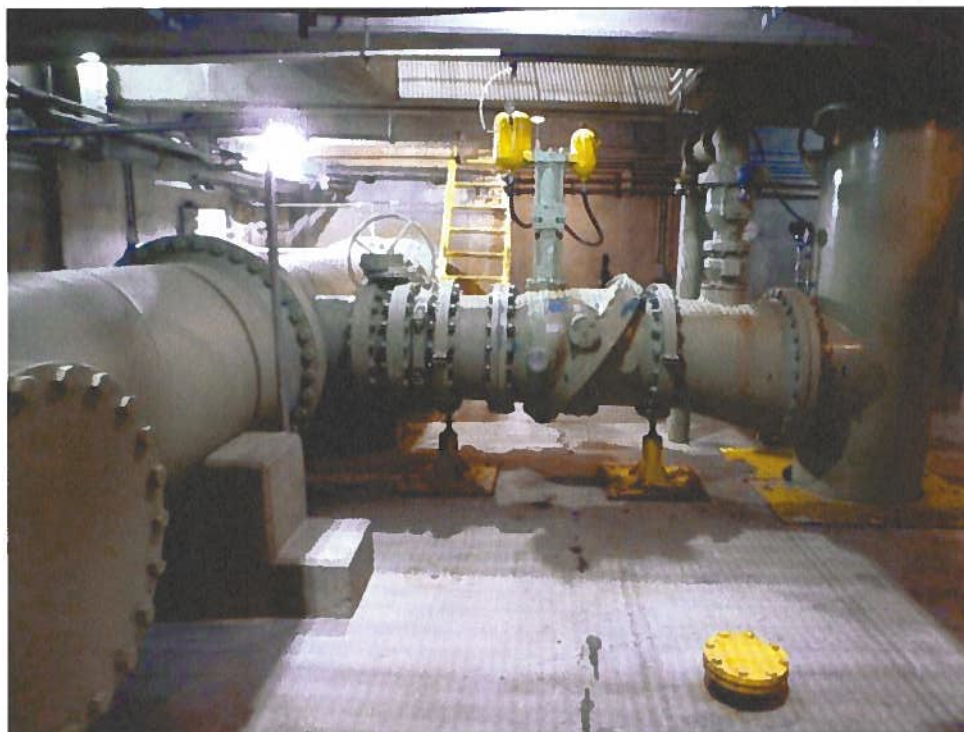
Photograph B – Check Valve on Pump #1 No Longer Leaking

During this visit, it was noted the check valve on Pump 1 that was leaking significantly during the last inspection had been addressed and no evidence of a leak was noted. (See *Appendix F - Photographs B*).

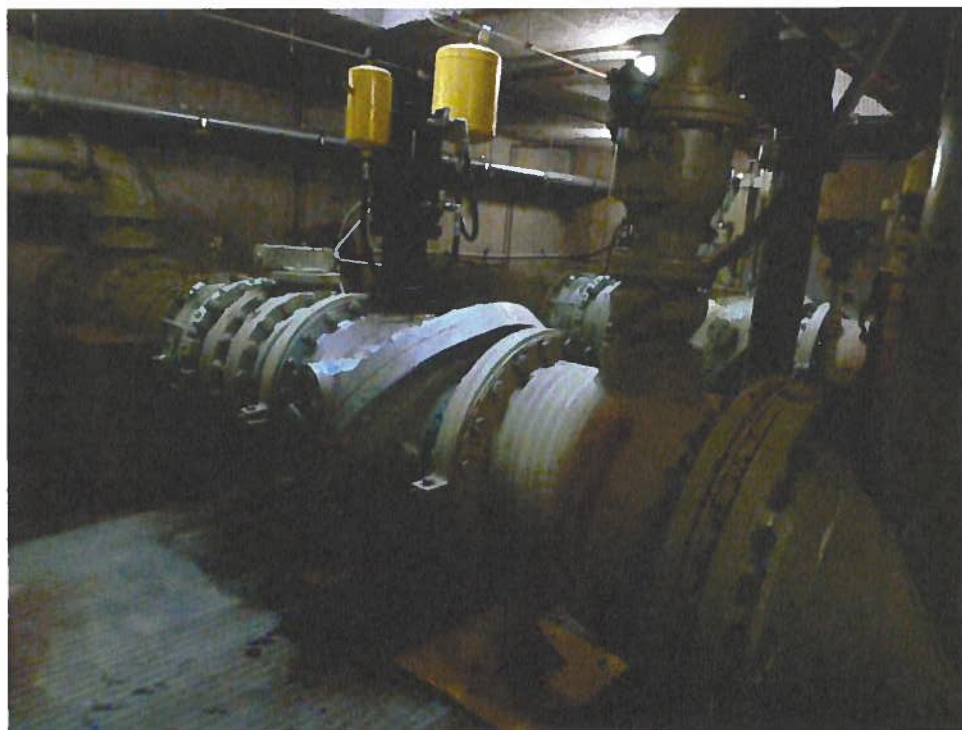
Photograph C – Serviced Check Valve on Pump 5

Also, during our last inspection, it was noted that the pump 5 check valve was making significant noise clearly suggesting that there was an issue internally with the valve. The noise was concerning enough for staff to modify the operation of the station to reduce the number of stops and starts on pump 5, thus reducing the "slamming" of the valve. It was observed during this inspection that the check valve had been serviced, and the stations operation was returned to normal with all three pumps being driven from their respective VFDs. Also noted during this inspection, there was slight bubbling noise at the top of the check valve which suggests that there could be air trapped in the top of the valve. Staff were aware of the issue, were monitoring it, and indicated they would be reaching out to Underwood for assistance (See *Appendix F - Photographs C*).

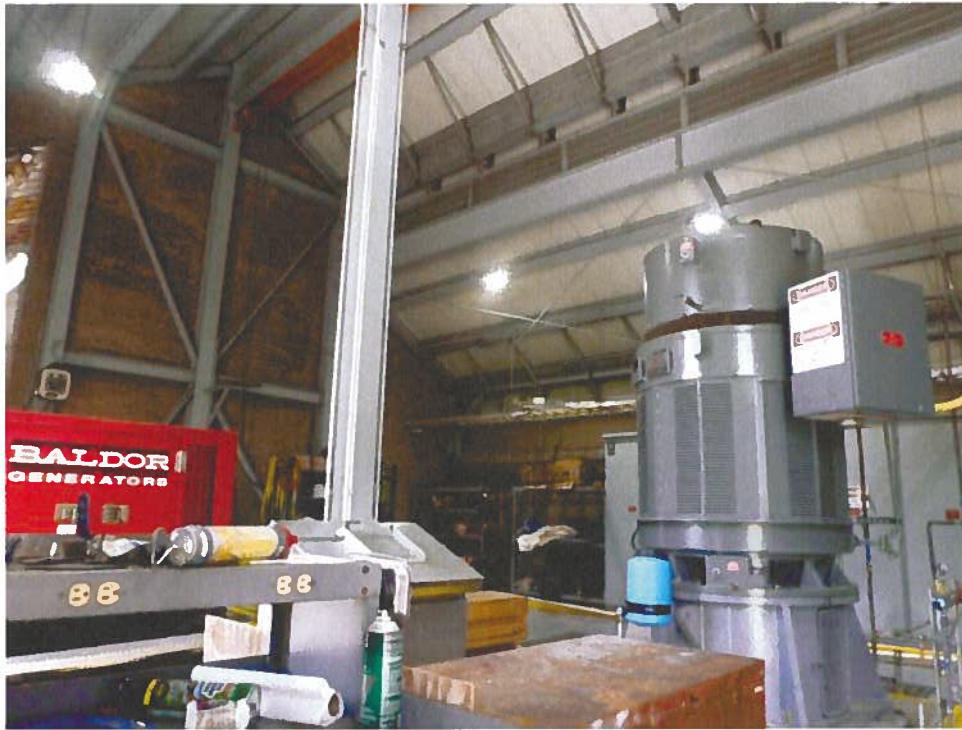
Photograph D –LED Lighting

During the previous inspection, staff indicated the lighting in the old station was scheduled to be replaced with LED lighting as the existing was outdated florescent type. As for this inspection, the lighting has been replaced and is a marked improvement. In addition, since the last inspection, the old pump station roof replacement work has been completed. (See *Appendix F - Photographs D*).

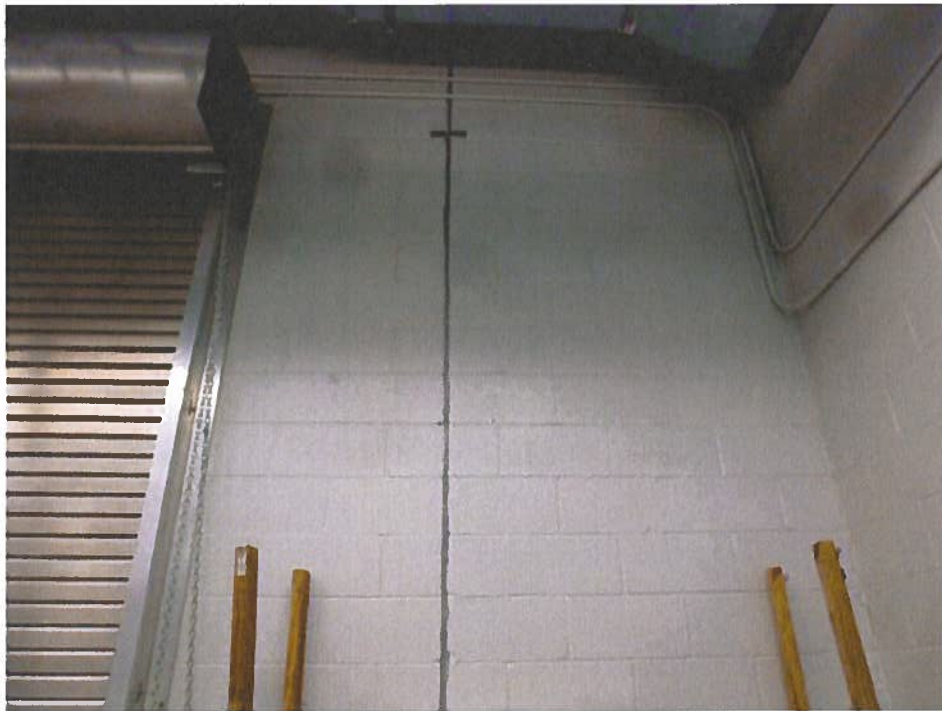
Photograph F – Masonry Control Joint in Electrical Room

The 1,600 HP pumps are controlled by a separate electrical control room housing variable frequency drives and motor starters. During the 2016 inspection, it appeared that the masonry wall to wall joints located inside the new pump station electrical building had shifted producing cracked paint at the intersection of the walls. The most noticeable crack is located on the masonry wall joint located west of the westernmost roll up door. Since the 2016 inspection,

Engineer reviewed the joints and found that the issue was not structurally detrimental; however, it was recommended that staff should continue to monitor the issue. During this inspection, visual observation indicated that the size of the separation did not appear to have increased (See *Appendix F - Photograph F*). It is recommended that the wall separation continue to be monitored.

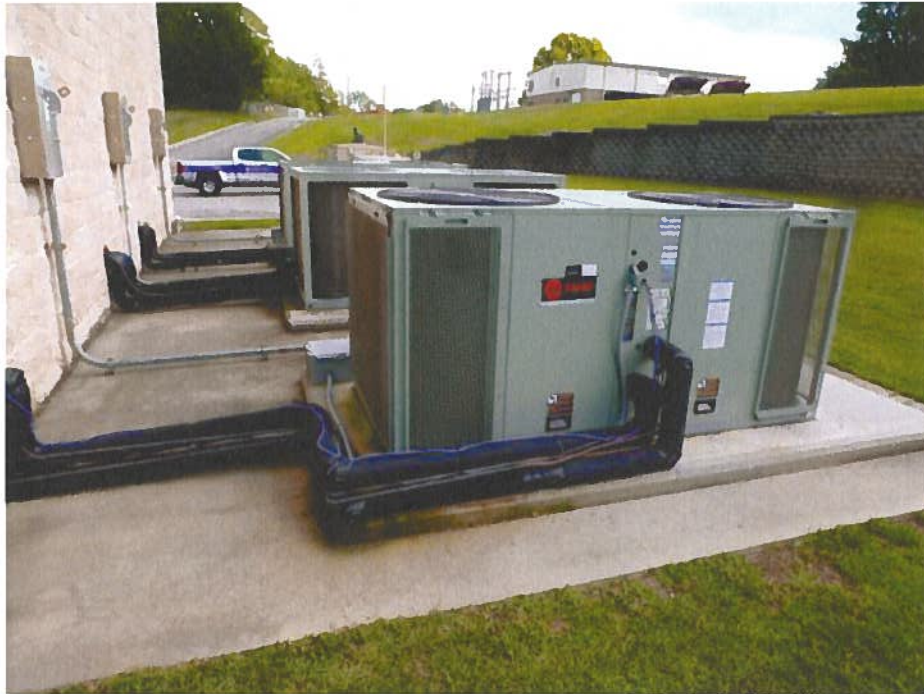
Photograph G – New Electrical Room HVAC Units

Adjacent to the new electrical control room is an HVAC room housing the HVAC equipment. As for this inspection, no issues were observed in the room. As noted during the 2023 inspection, a new HVAC unit had been installed outside with an associated air handler inside. As for this inspection, two other condensing units have been replaced with new HVAC units as the existing ones were failing over the past year. (See *Appendix F - Photograph G*).

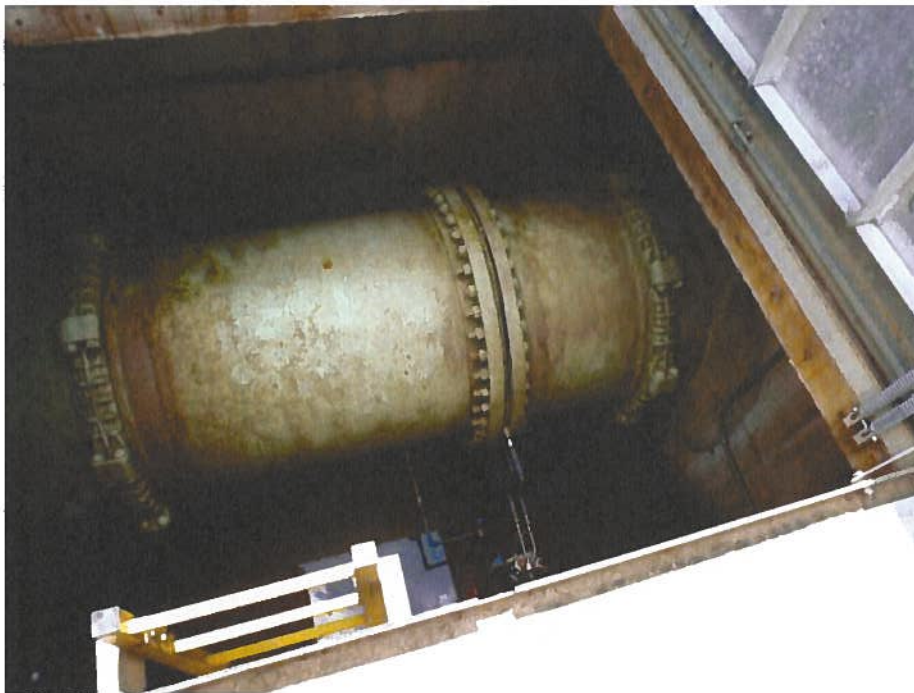
Photograph H –Effluent Pump Station Flow Meter

The raw water pump station is provided with two flow meters that measure flow leaving the station. In the past, the flow meter readings at the station have been significantly different than the sum of the customer flow meters. Historically, the summation of the customer meters has been generally within 1-2% of the station meter totals. Per our understanding, County staff has conducted field testing and determined that the customer flow meters appear to be within acceptable ranges; therefore, customer billing appears to be normal and generally accurate. It is recommended that the County and Authority continue to monitor the metering conditions for accuracy at the Kings Bluff Pump Station. No issues were reported as a result of this year's inspection. The flow meter vault was inspected and found to be in good condition *Appendix F - Photographs H*).

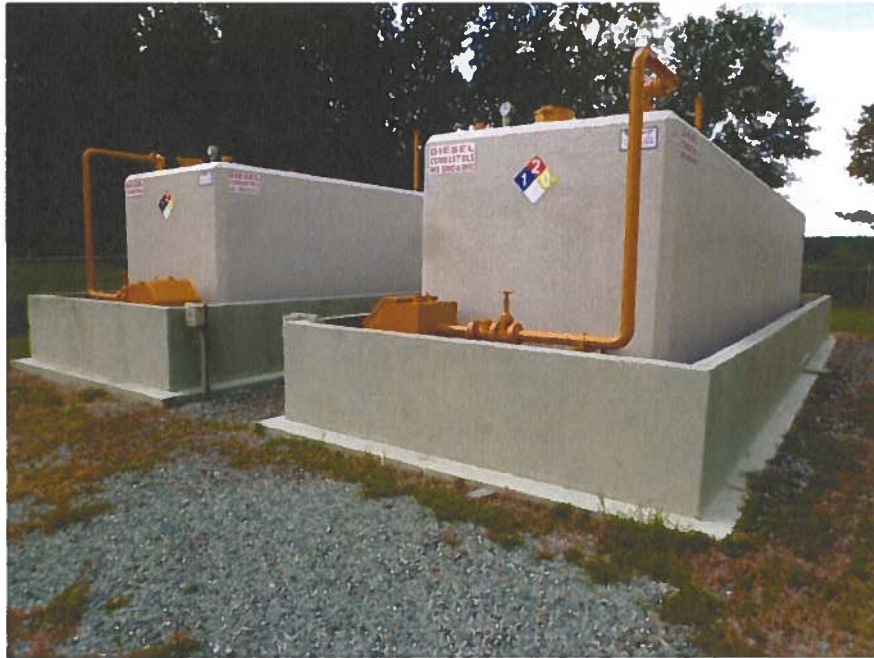
Photograph I – Generator Fuel Storage Tanks

The two 3.0 Mega Watt standby generators are supplied by (2) 12,000-gallon concrete fuel tanks, which are located adjacent to the generator building. The tanks were installed with a 110% secondary containment wall to capture overflow, ruptures, or spills of diesel fuel. During previous inspections, significant efflorescence was noted to exist on the tanks, suggesting coatings failure. During this inspection, the external fuel tanks were found to have been repaired completely with a new coat of paint and new signage (See *Appendix F - Photograph I*).

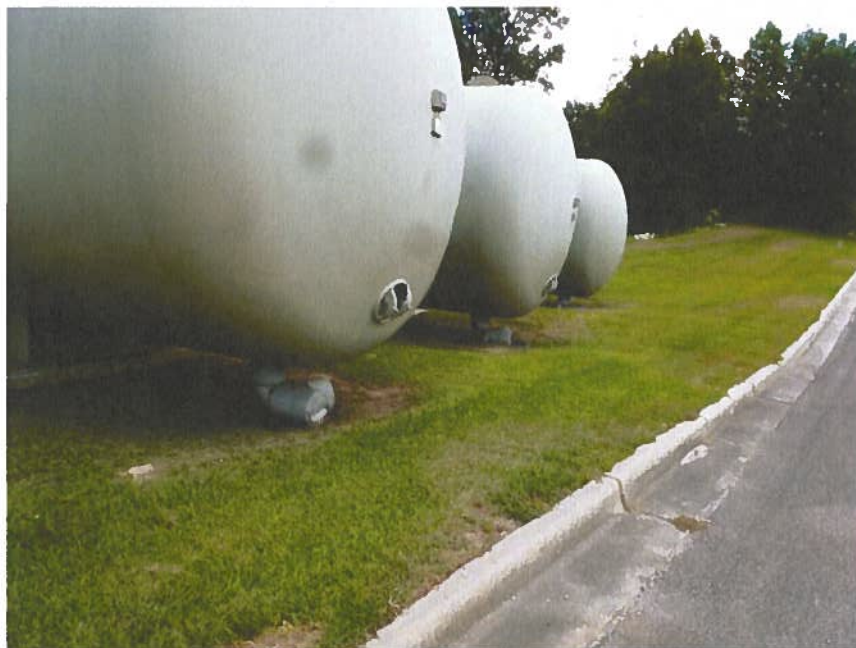
Photograph J – Surge Tanks

During the 2024 inspection, it was noted that the paint was failing in several areas especially on the tank drain valves and tank #3 and that all exterior small diameter piping needed insulation replaced or installed. Since that inspection, tanks have been painted and all drain lines insulated (See *Appendix F – Photograph K and J*).

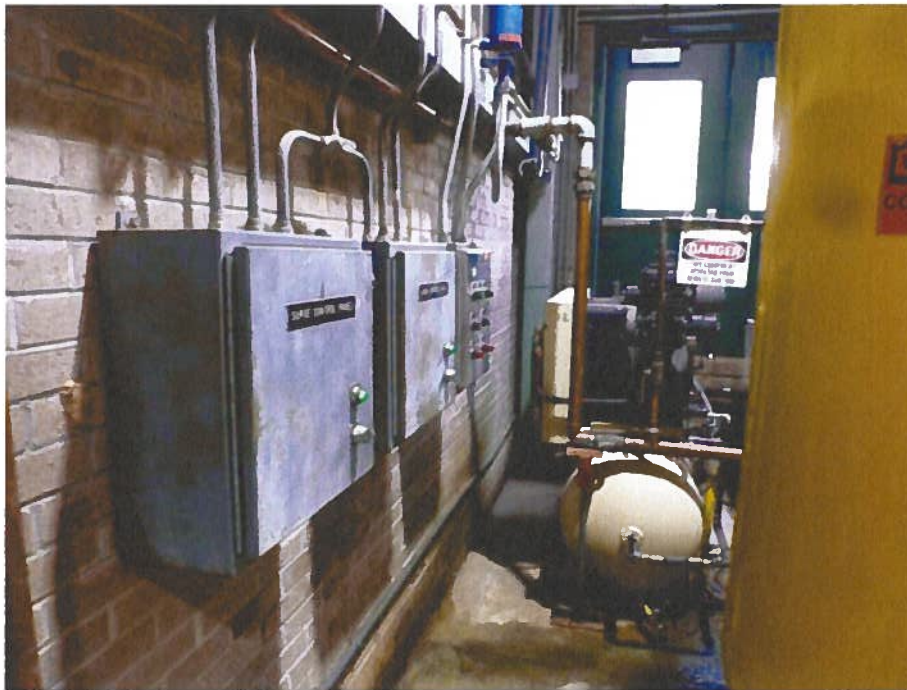
Photograph L- Surge Tank Controls

With regards to the surge tank controls, during this year's inspection, two older tank surge control systems were found to be in operation but the third was not. Staff indicated that they had no issues with the operation of the system, however they had noted that the controls would lose tank pressure over time and that the automatic fill system did not appear to keep up with the loss. As a result, staff has been manually adding air periodic to maintain the desired level (See *Appendix F – Photograph L*). It is recommended that all three control systems be serviced to address the air loss and adjust control settings to the dual pipeline and three-tank scenario.

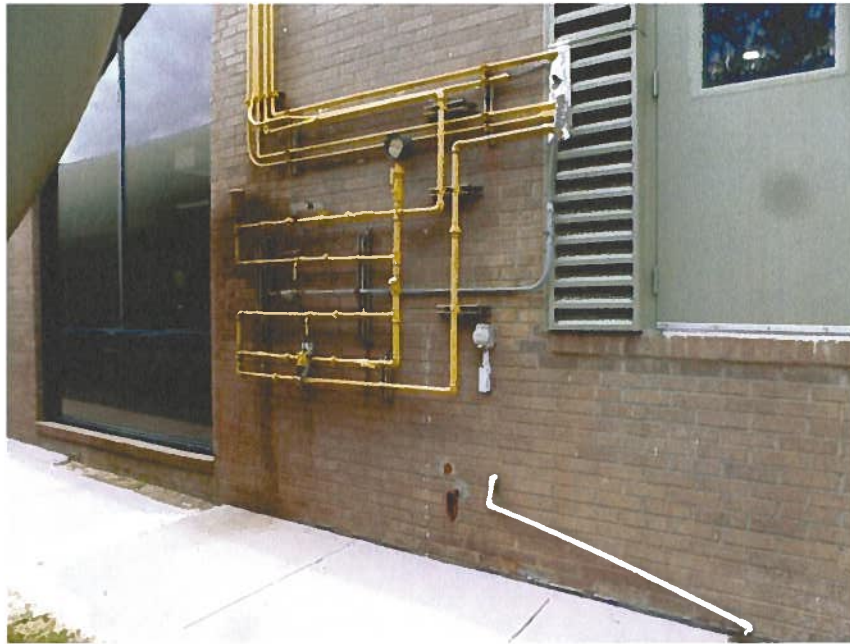
Photograph M- Surge Tank 3 Exterior Controls

Previously with regards to tank 3 exterior level controls, it was recommended that the control and level piping mounted to the tank be heat traced insulated. All piping is small in diameter

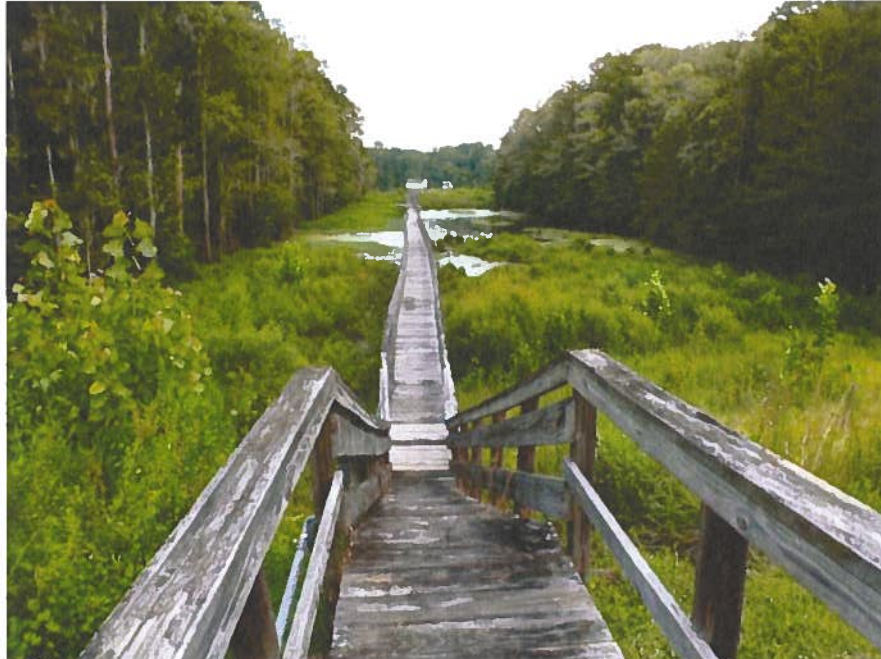
Photograph N- Pier Access

The pipe corridor of the 60-inch intake pipeline is located parallel and adjacent to the existing pier. An inspection of this area indicated that vegetative cover is established, and that the area is slightly flooded (See *Appendix F - Photograph N*). Additionally, overgrown vegetation was in the process of being cleared but the work was not yet complete, as significant growth was observed near the building (See *Appendix F – Photograph O*). Staff indicated clearing work was delayed.

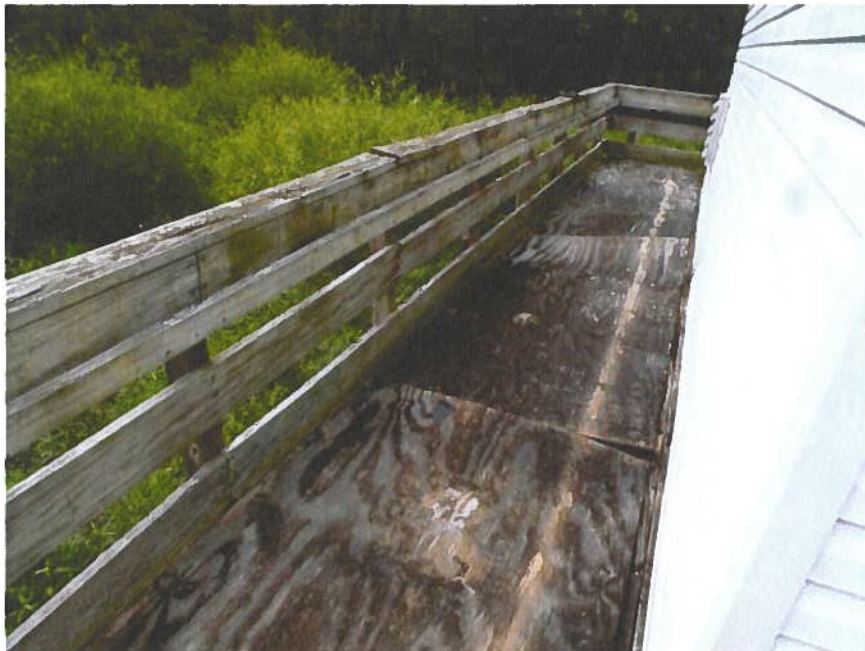
Photograph P – Pier/Dock Failing Boards

During the 2018 inspection, it was observed that the pier and walkways to the air-backwash control buildings needed repair. Several deck boards and handrails were in poor shape. During the 2019 inspection, it was noted that some repairs had been made (stair and plank replacement); however, more are still required. Also noted in previous reports, several areas on the older building's wall panels are still showing signs of rot.

As for this inspection, the dock remains in poor condition (See *Appendix F - Photograph P*). Design of a replacement pier structure and air backwash building are currently underway and anticipated to be completed in 2025. Construction is slated to begin in 2026.

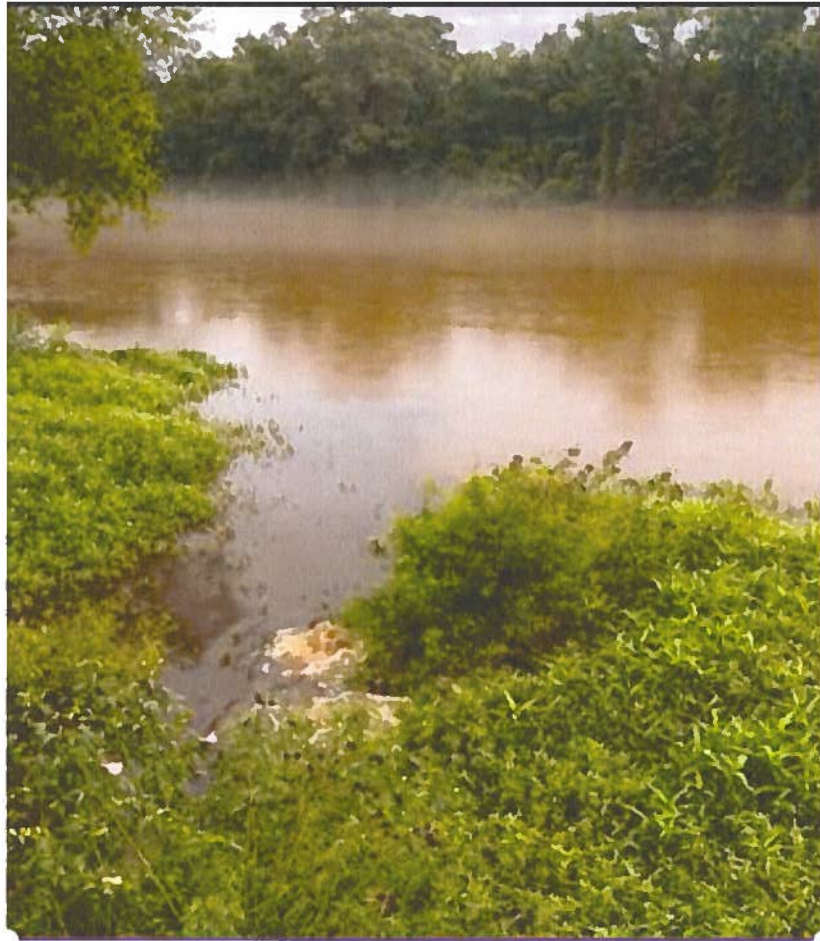
Photograph S – Leaking Air Lines to 60 inch Intakes

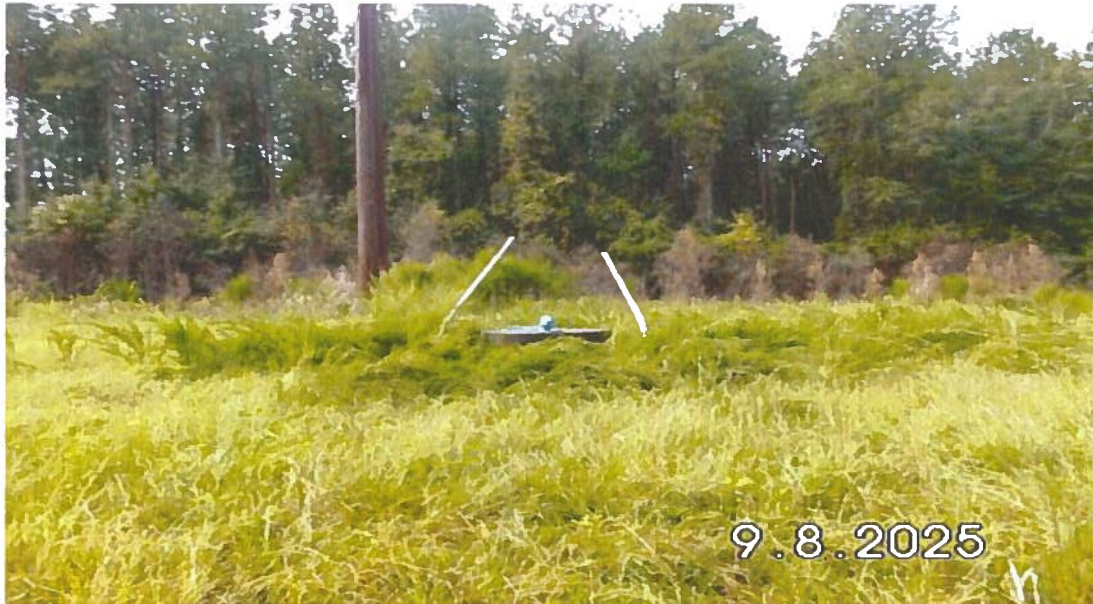
Photograph BB – Orange Painted Structure Marker Deterioration

1. Recommend operation of blow-offs on an annual basis.
2. Recommend all blow-off structures on 48" RWM to be re-painted "blue" as paint has faded and deteriorated.
3. Mowing contract shall include cutting all grass away from all structures within Right-of-Way.

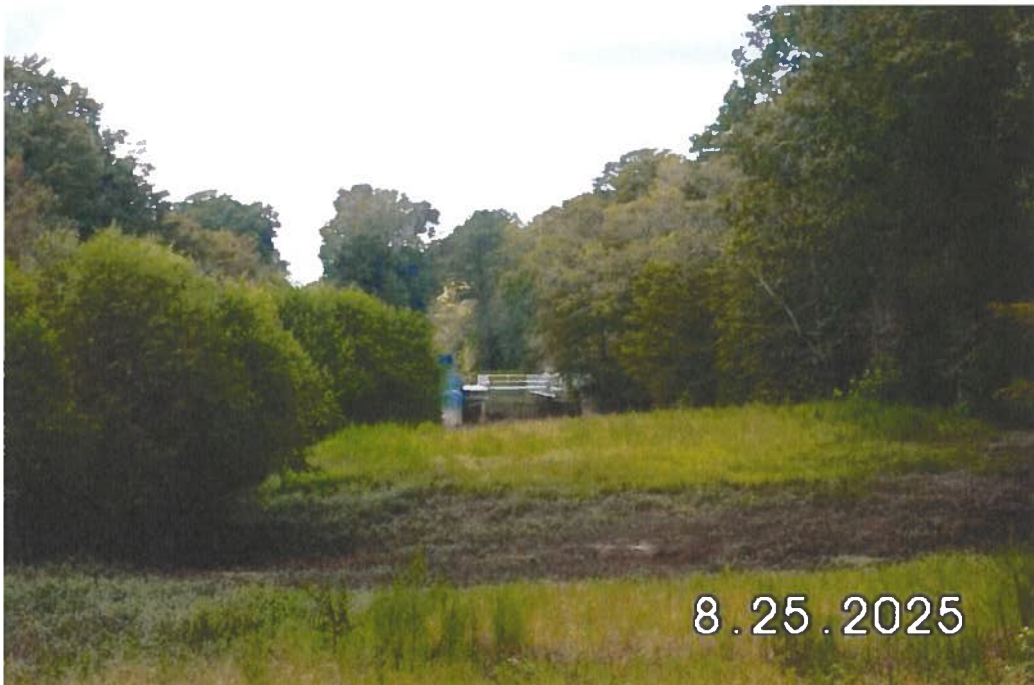
Photograph II- Walkway Access across Livingston Creek on Existing 48" PCCP pipe

Also completed by Intracoastal Marine during the same time was a joint repair on the existing 48" PCCP elevated pipe where degradation of one of the existing joints had occurred. The contractor repaired the joint in accordance with specifications provided by the pipe manufacturer and at the direction of McKim & Creed's structural engineer. (See Photograph II)
