**AGENDA**  
**Lower Cape Fear Water & Sewer Authority**  
**1107 New Pointe Boulevard, Suite # 17, Leland, North Carolina**  
**9:00 a.m. – Regular Monthly Board Meeting**  
**October 12, 2026**

- NB1** – Resolution Accepting the Lower Cape Fear Water and Sewer Authority Kings Bluff Regional Raw Water Supply Facilities FY 2026-2027 Annual Inspections Report (Jess Powell, P.E., McKim and Creed)
- NB2** – Resolution Accepting the Lower Cape Fear Water and Sewer Authority Bladen Bluffs Regional Raw Water Supply Facilities FY 2026-2027 Annual Inspections Report (Jess Powell, P.E., McKim and Creed)
- NB3** – Resolution Approving Contract with HDR Engineering, Inc. of the Carolinas for Owner-Advisor Services (Phase 1 – Preconstruction) for 100 MG Reservoir Project

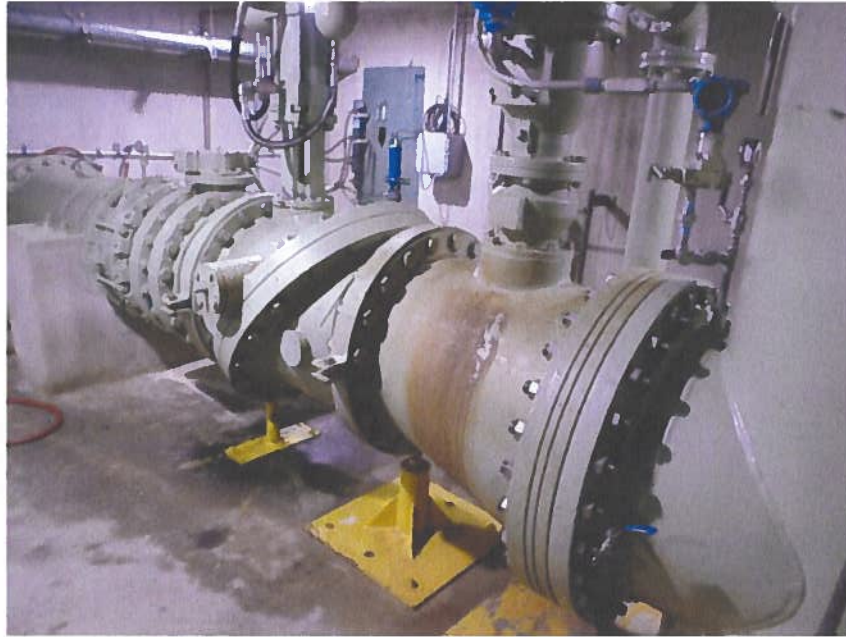
**Photograph B – Check Valve on Pump #4 Dash Pot Leaking**

During this year's inspection, the 1,600 HP vertical turbine pumps (installed as part of the 2009 expansion/upgrade of the Kings Bluff facility) were inspected and found to be in good condition and meet the needs of the Authority's customers (See *Appendix F - Photograph A*). During this year's inspection, it was observed that the pump #4 check valve dash pot was leaking and the hydraulic fluid line to the lower pump bearing had a small leak. Staff indicated they would address both shortly. (See *Appendix F- Photograph B*).

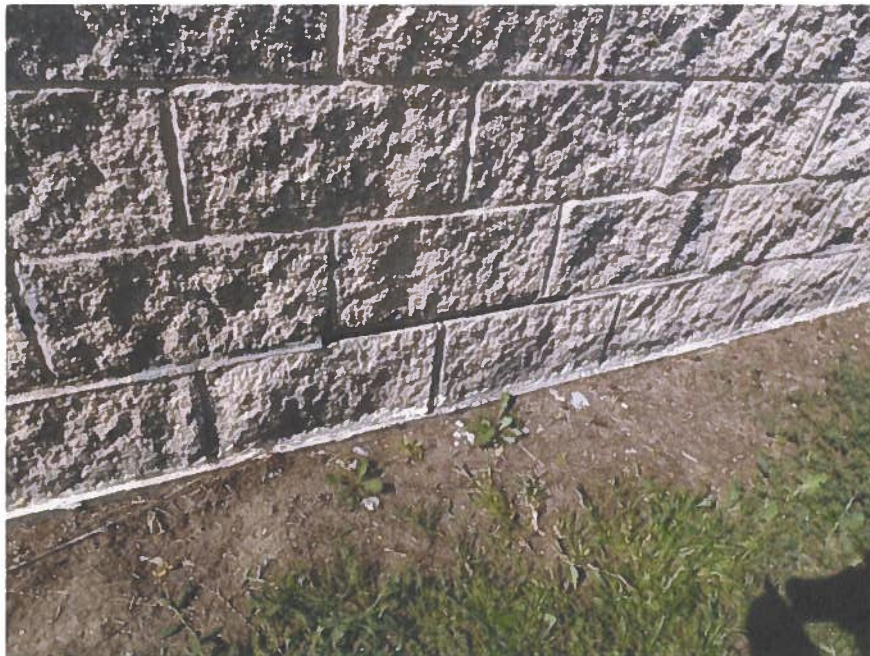
**Photograph C –Corroding Masonry Wall Joints**

During the last inspection, the building exterior masonry wall exhibited spalling at a few of the lower horizontal joints facing the river. This spalling is exposing the horizontal reinforcing which is turn is corroding. As of this inspection, the area remains unchanged. Area is being monitored by staff. (See *Appendix F- Photograph C*).

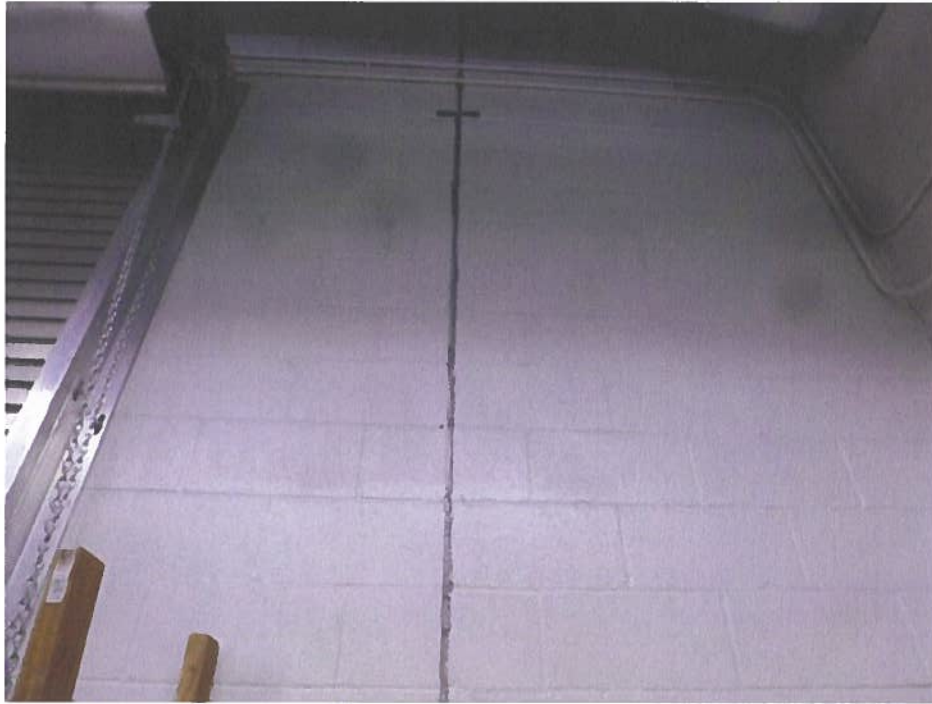
**Photograph D – Masonry Control Joint in Electrical Room**

The 1,600 HP pumps are controlled by a separate electrical control room housing variable frequency drives and motor starters. During the 2016 inspection, it appeared that the masonry wall to wall joints located inside the new pump station electrical building had shifted producing cracked paint at the intersection of the walls. The most noticeable crack is located on the masonry wall joint located west of the westernmost roll up door. Since the 2016 inspection, Engineer reviewed the joints and found that the issue was not structurally detrimental; however, it was recommended that staff should continue to monitor the issue. During this inspection, visual observation indicated that the size of the separation did not appear to have increased (See *Appendix F - Photograph D*). It is recommended that the wall separation continue to be monitored.

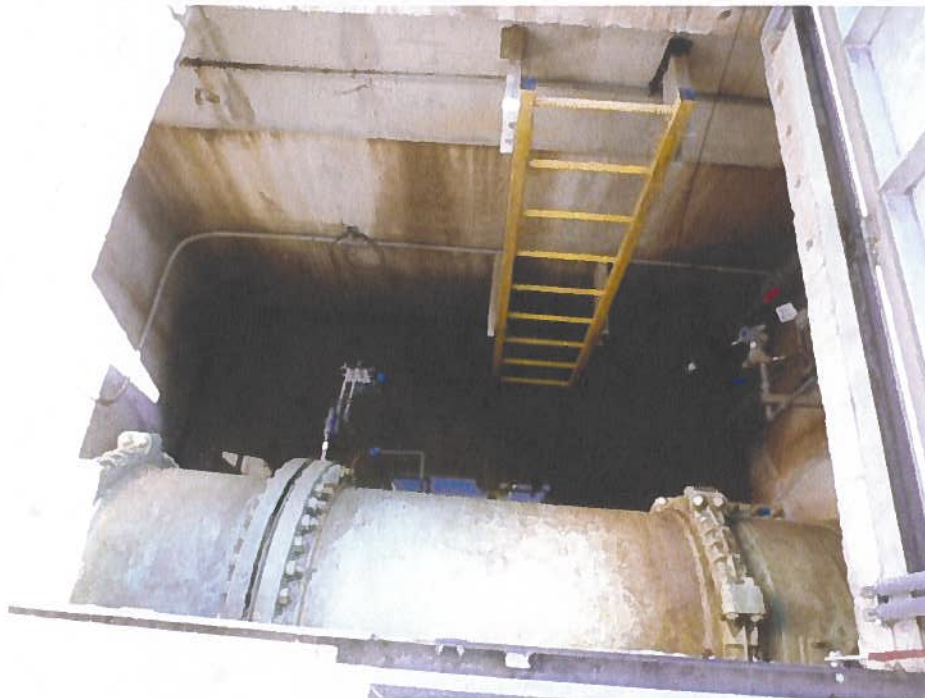
**Photograph E – Raw Water Flow Meter Vault**

The raw water pump station is provided with two flow meters that measure flow leaving the station. In the past, the flow meter readings at the station have been significantly different than the sum of the customer flow meters. Historically, the summation of the customer meters has been generally within 1-2% of the station meter totals. Per our understanding, County staff has conducted field testing and determined that the customer flow meters appear to be within acceptable ranges; therefore, customer billing appears to be normal and generally accurate. It is recommended that the County and Authority continue to monitor the metering conditions for accuracy at the Kings Bluff Pump Station. No issues were reported during this year's inspection. The flow meter vault was inspected and found to be in good condition *Appendix F - Photographs E*.

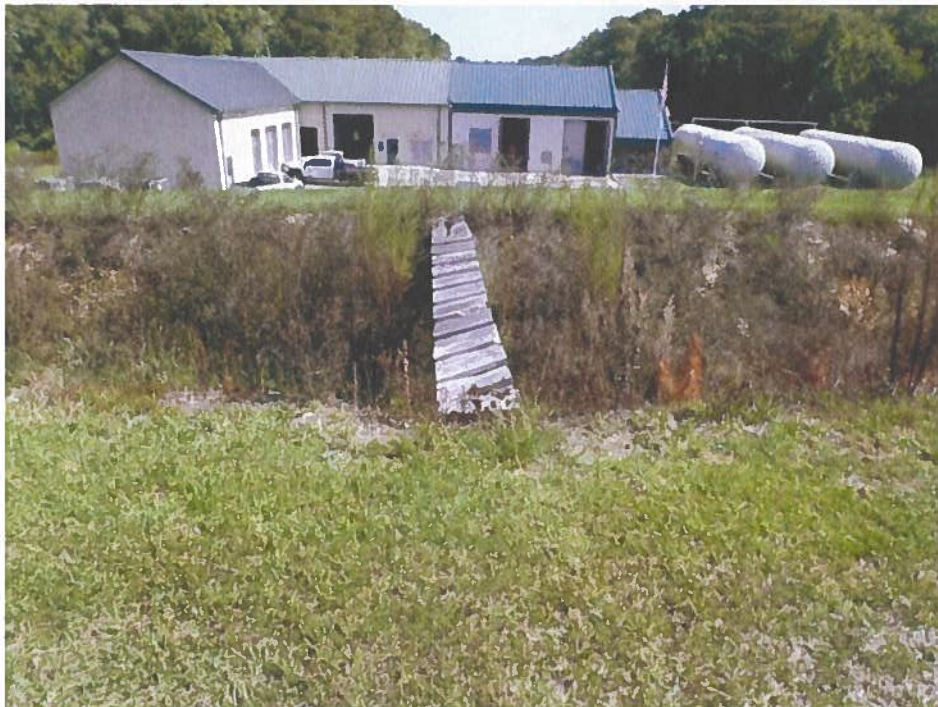
**Photograph I –Failing Protective Bridge**

During this inspection, significant erosion on the upper ditch side slopes was noted. (See *Appendix F – Photograph H*) It is recommended these slopes be restored and stabilized. In addition to the erosion, the protective bridge mounted over the fiber optic conduit crossing the ditch has worsened from previous inspections. It is recommended that the bridge be replaced or other actions taken to protect the exposed conduit exposed below it. (*Appendix F – Photograph I*)

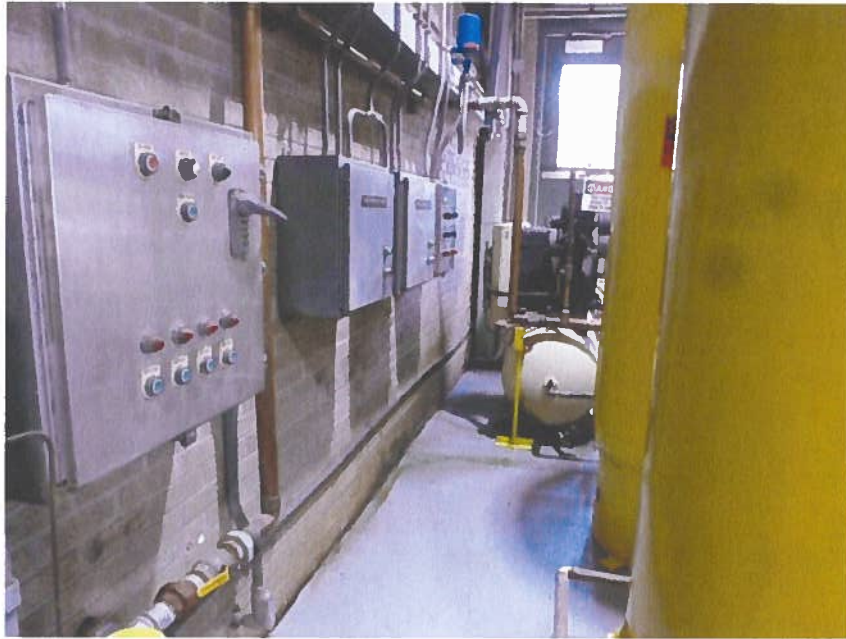
**Photograph J - Surge Tank Controls**

During last year's inspection and this year's, the two older tank surge control systems were found to be in operation but the third was not. Staff again indicated that they had no issues with the operation of the system, however they had noted that the controls would lose tank pressure over time and that the automatic filling system did not appear to keep up with the loss. As a result, staff has been manually adding air periodic to maintain the desired level (*See Appendix F – Photograph J*). As was previously noted, it is recommended that all three control systems be serviced to address the air loss and adjust control settings to the dual pipeline and three-tank scenario. It the understanding at this time that the panels will be replaced with a common panel when the 4<sup>th</sup> surge tank is installed during a future project.

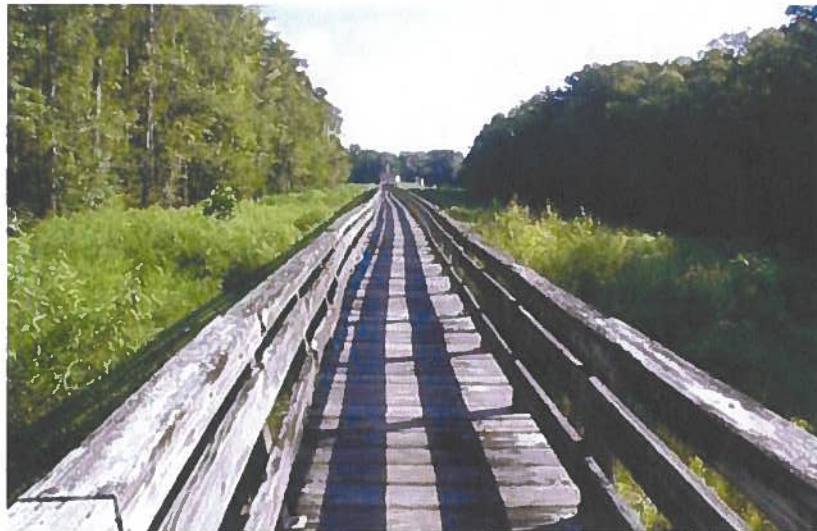
**Photograph L - Dock Condition**

As for this inspection, the dock remains in poor condition (See *Appendix F - Photograph L*). Design of a replacement pier structure and air backwash building are currently underway and anticipated to be completed in 2027.

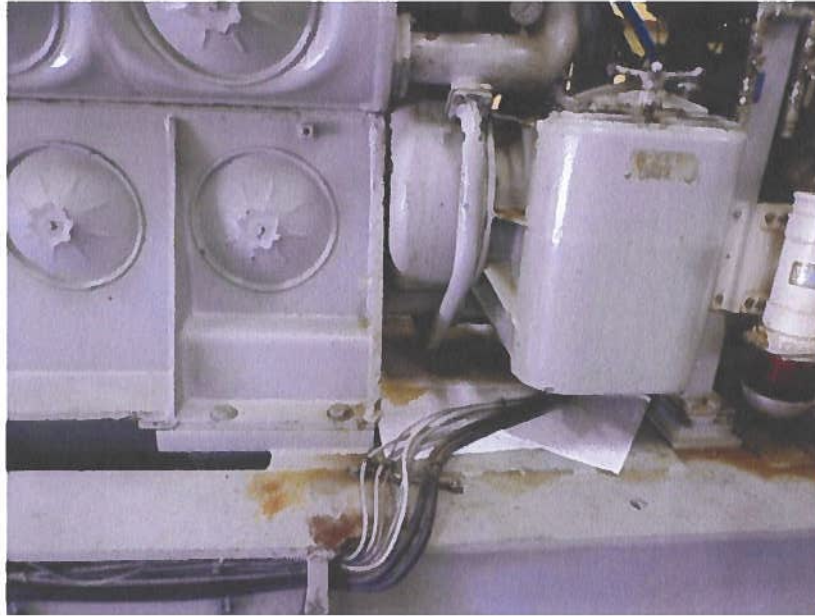
**Photograph M – Generator #2 Coolant Leak**

During this year's inspection (2026), the station's generators were not started, however one issue of importance was noted. Staff indicated that during a recent preventative maintenance visit, the technician noted there were signs that there was possibly a coolant and oil leak on generator no. 2. In fact, radiator fluid was present outside the generator in various areas surrounding the water pump as evidence of a leak. It is recommended this issue be investigated further and remedied. (See *Appendix F – Photograph M*).

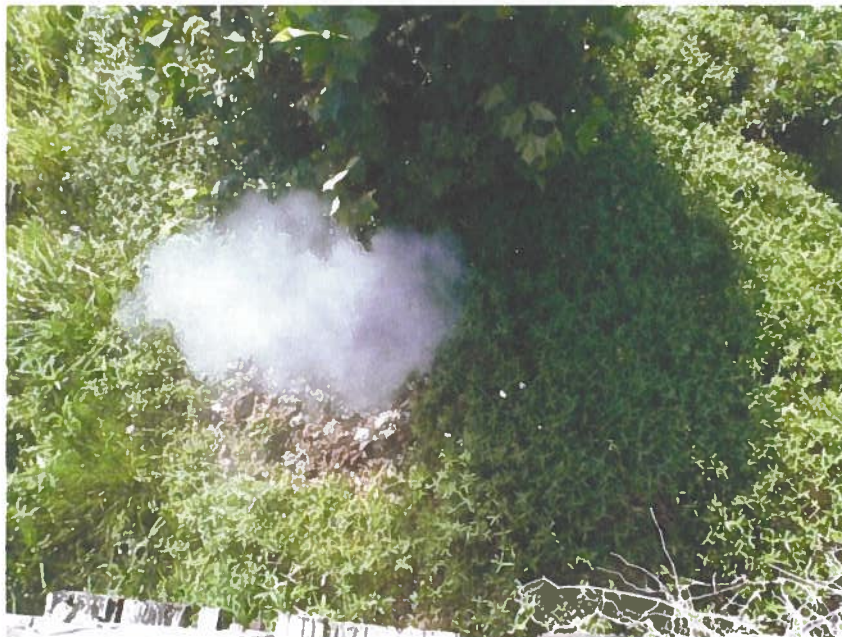
**Photograph O –Old Backwash System Leak**

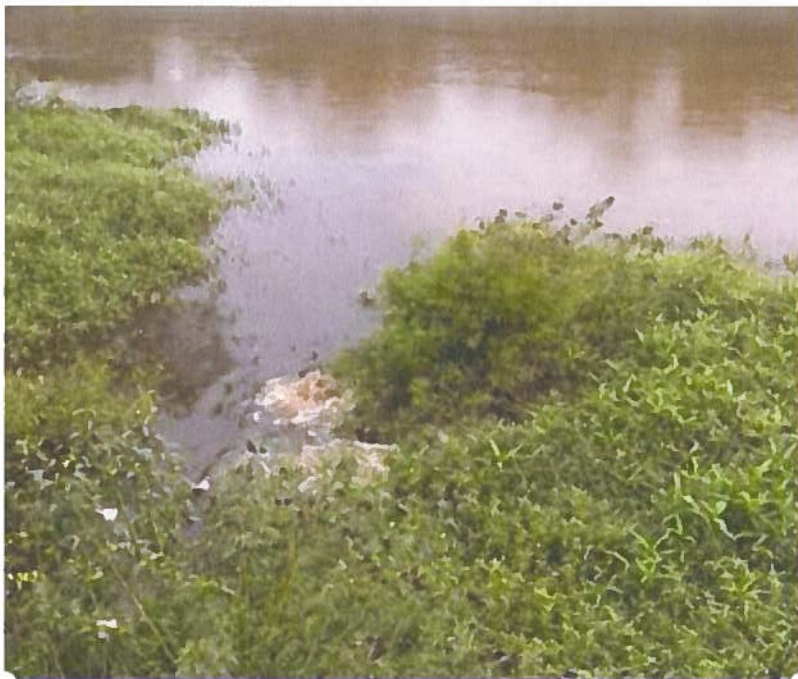
**Photograph S – Leaking Air Lines to 60 inch Intakes**

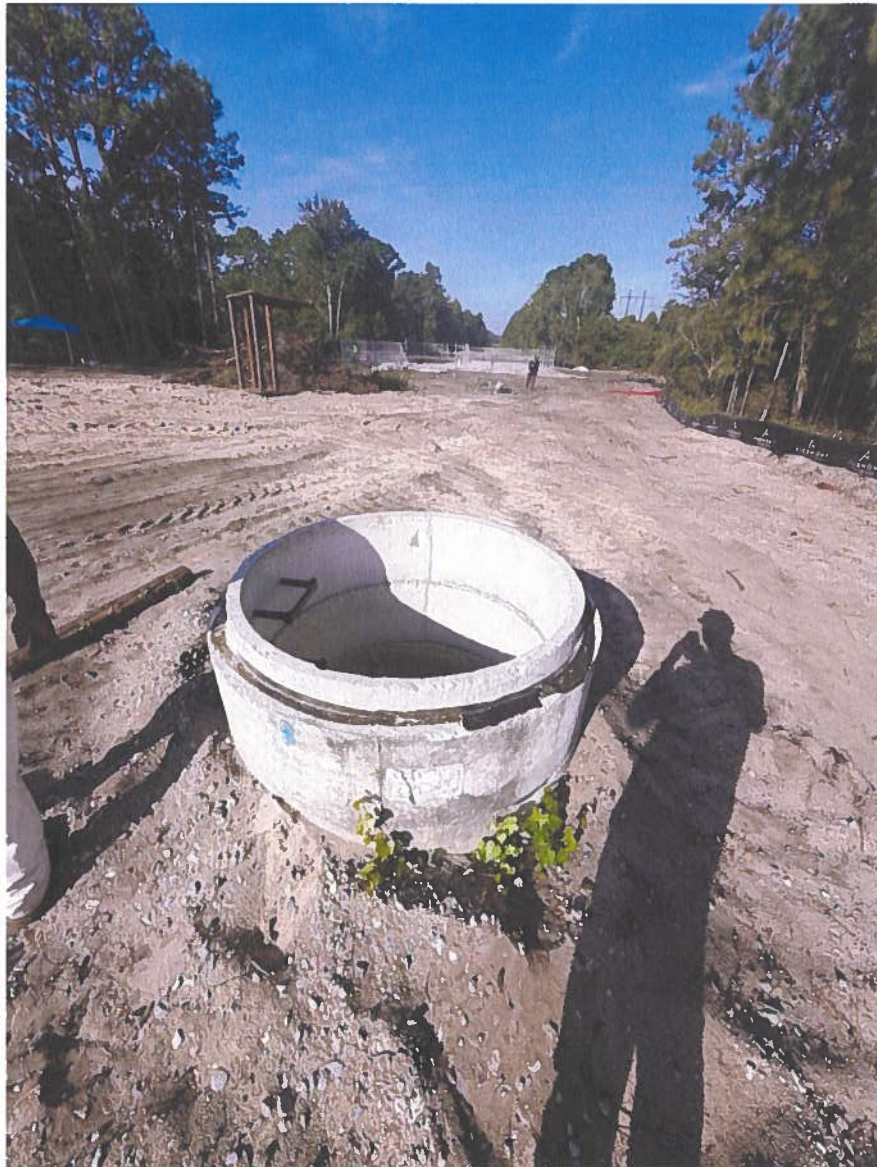
**Photograph AA – Structure Damage during construction of 54" RWM**

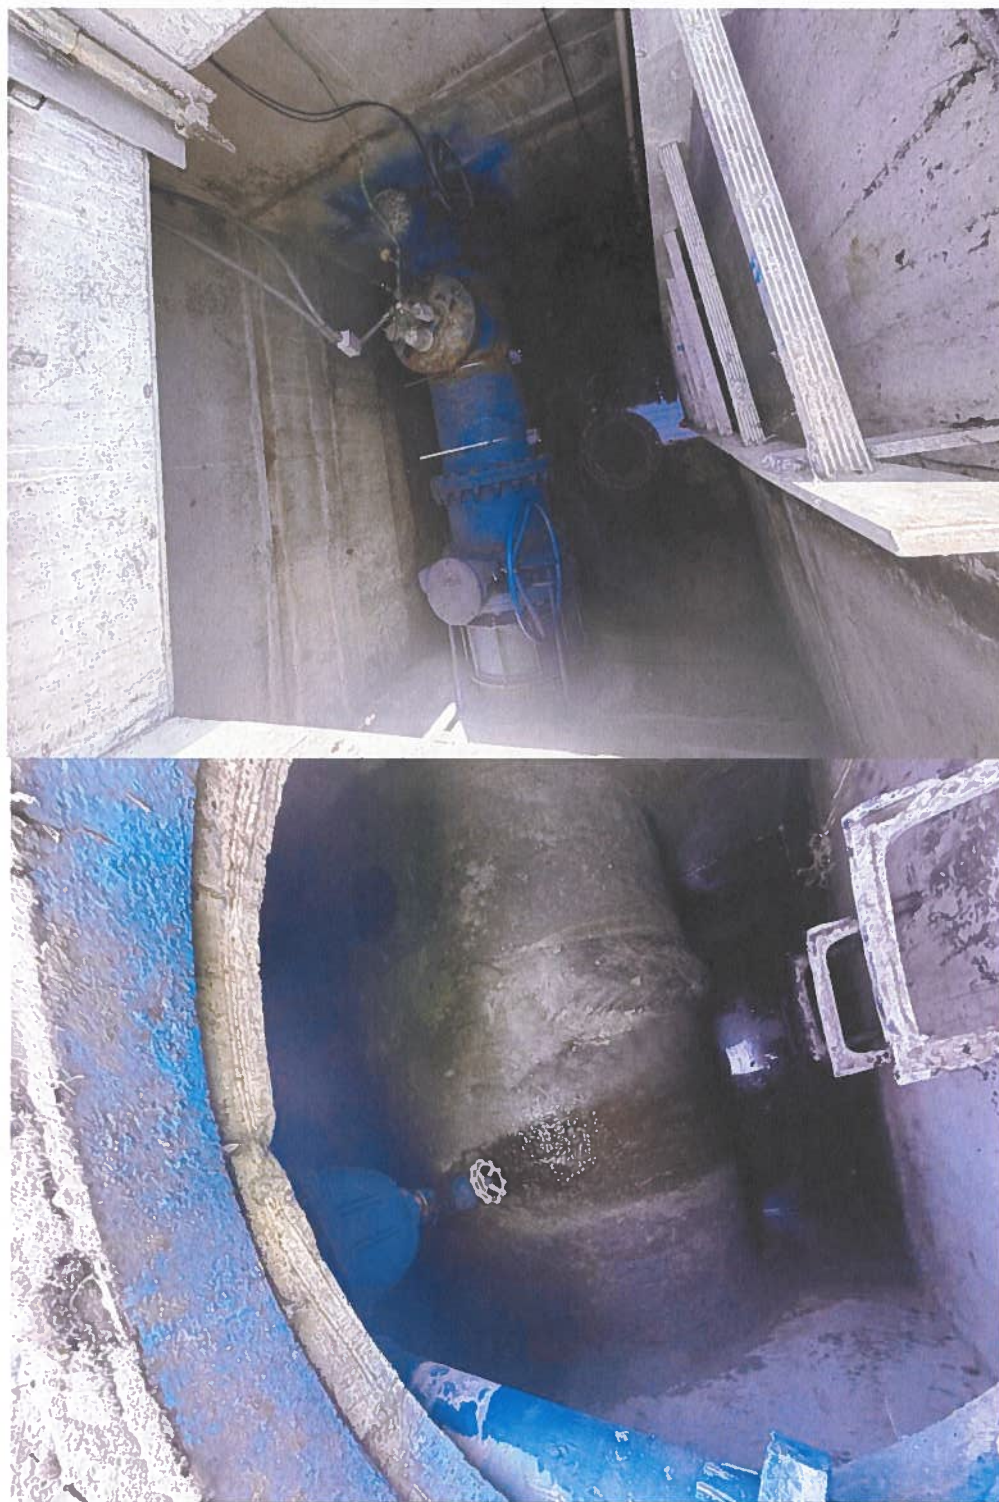
**Photograph CC – Leaking ARV at Praxair**

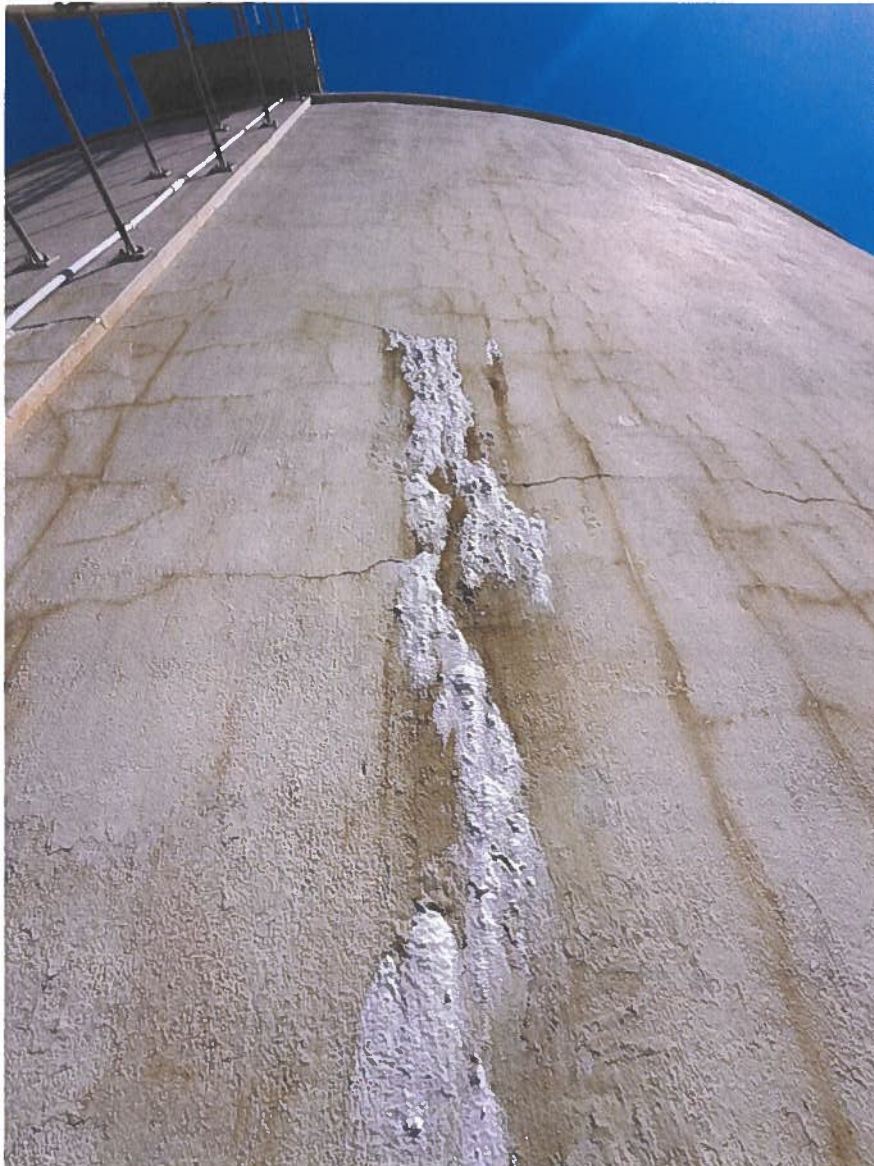
**Photograph JJ- 3 Million Gallon Ground Storage Tank Calcification**

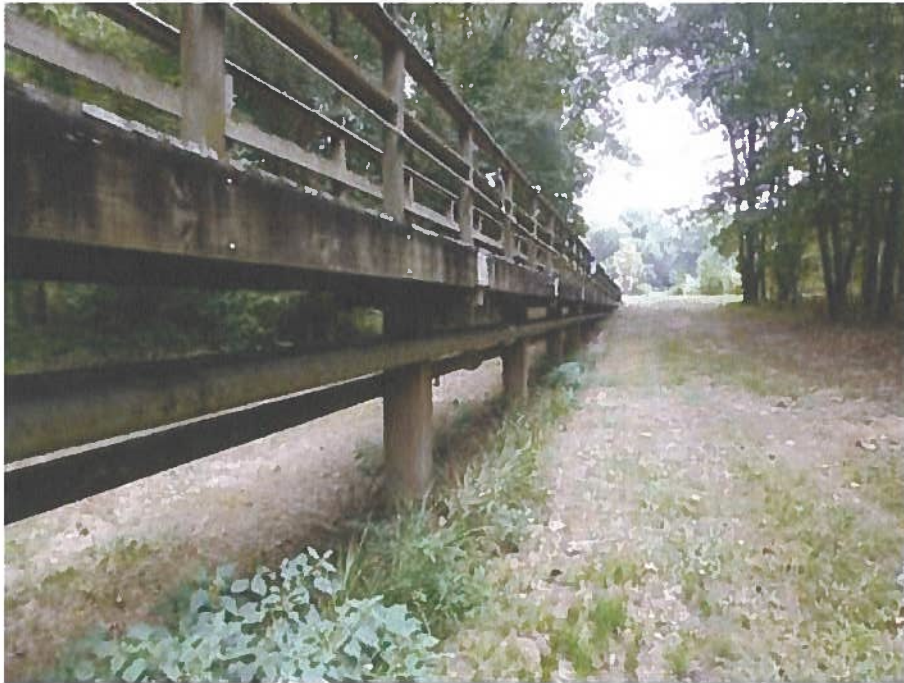
**Photograph D – River Access Walkway Underside**

| 2. Wooden walkway to river needs replacement | 2. Inspected with Stacey during inspection – planning repair |

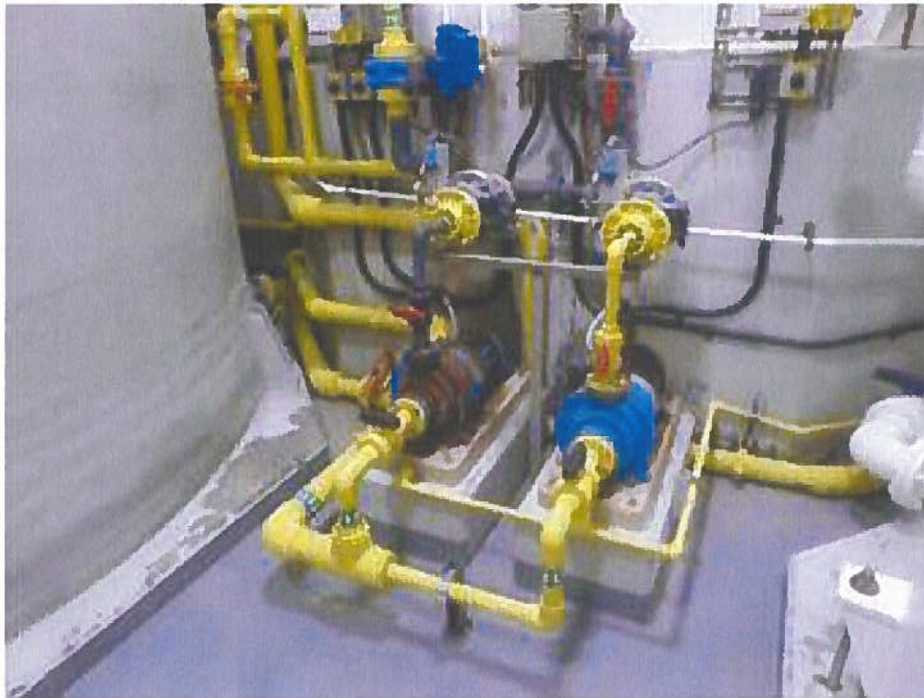
**Photograph T - Chlorine Transfer Pump**

| 7. Bleach transfer pump not working | 7. Pump is at OEC shop to see if repairs can be made |

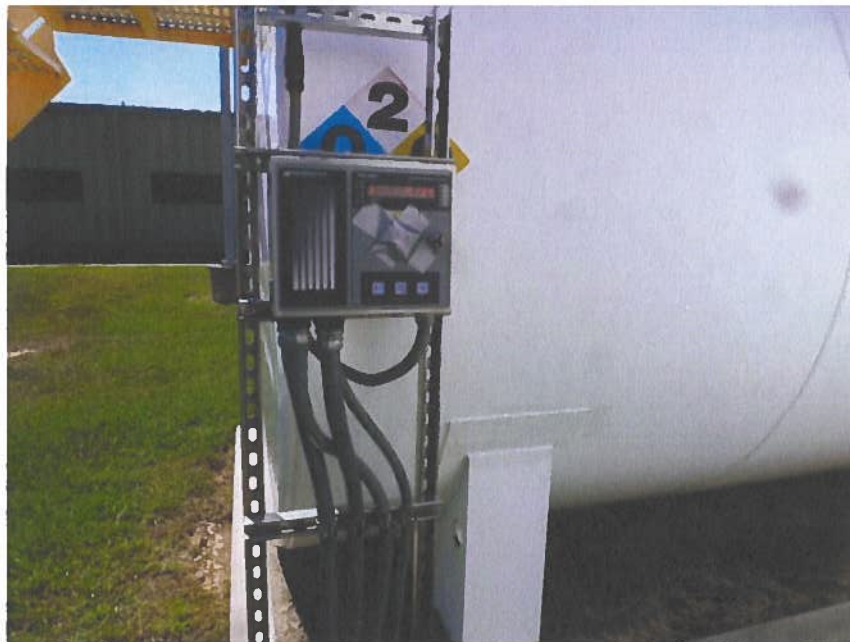
**Photograph Y- Facility Generator Diesel Tank Leak/Level Panel**
