Lower Cape Fear Water & Sewer Authority
Regular Board Meeting Minutes
October 14th, 2024

Lower Cape Fear Water & Sewer Authority Kings Bluff Regional Raw Water Supply Facilities FY 2024-2025 Annual Inspection Report

FY 2024-2025 Annual Inspection Report

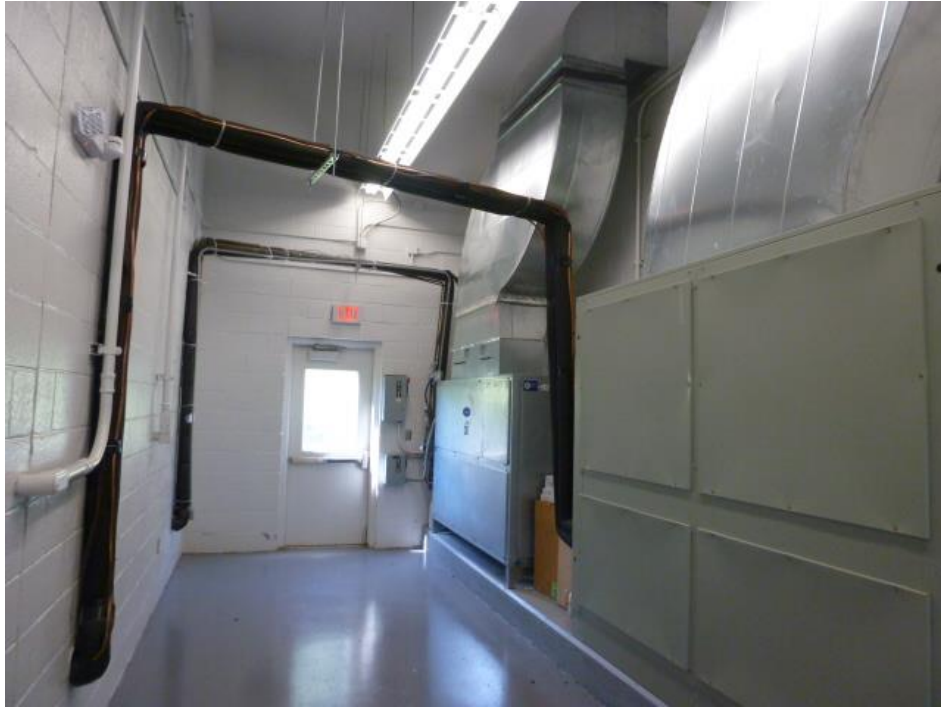
Photograph G – New Electrical Room Existing Wall Crack

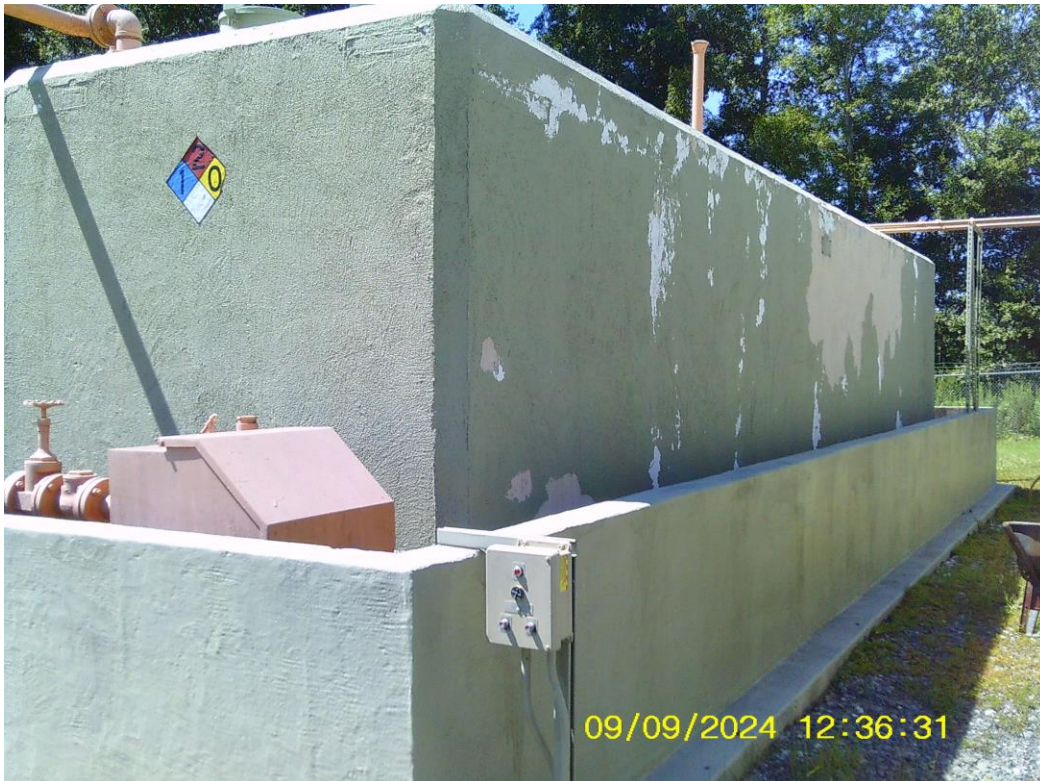
Photograph K – Diesel Storage Tank Coating Repairs

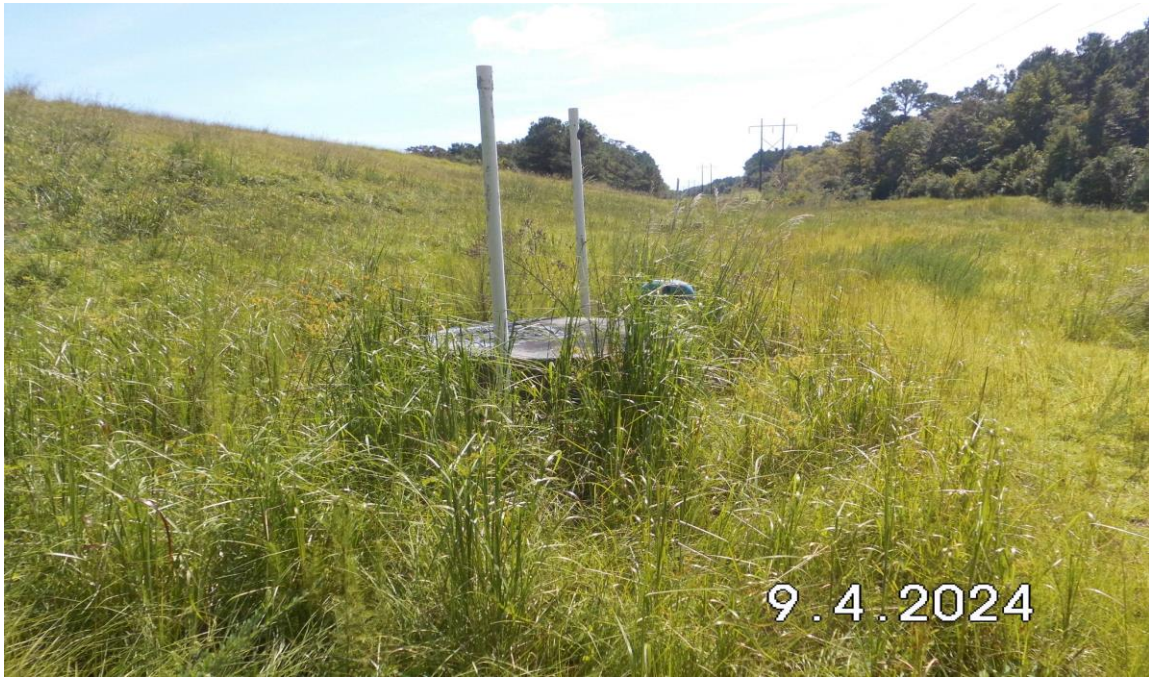
Photograph AA – Overgrown Area along Right-of-Way

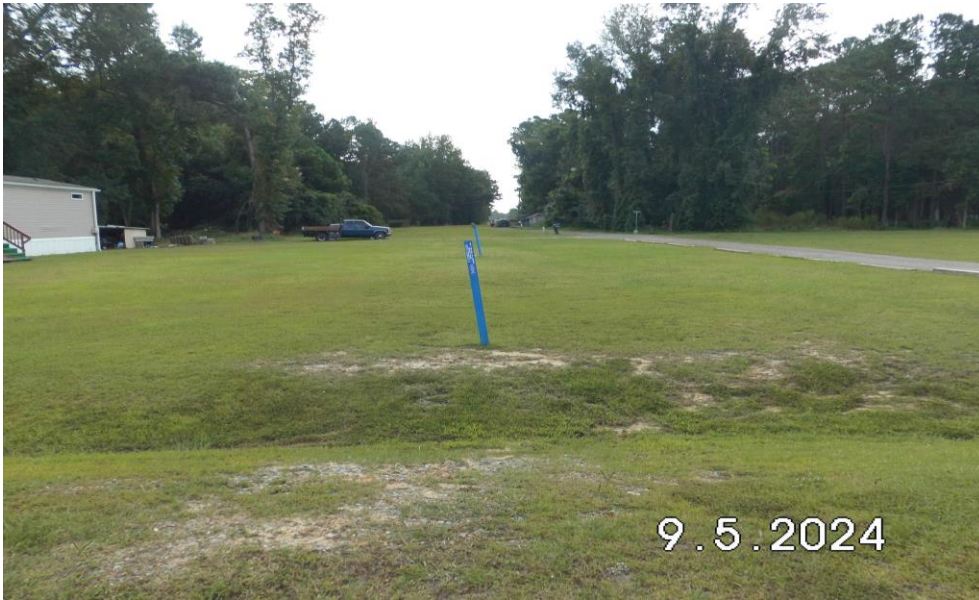
Photograph CC – New Blue Marker Post from 54" RWM project.

1. Recommend painted 2" PVC poles painted "orange" to mark each valve structure.
2. Recommend all valve structures to be re-painted "blue".
3. Additional "blue" marker posts are needed to mark valve locations.

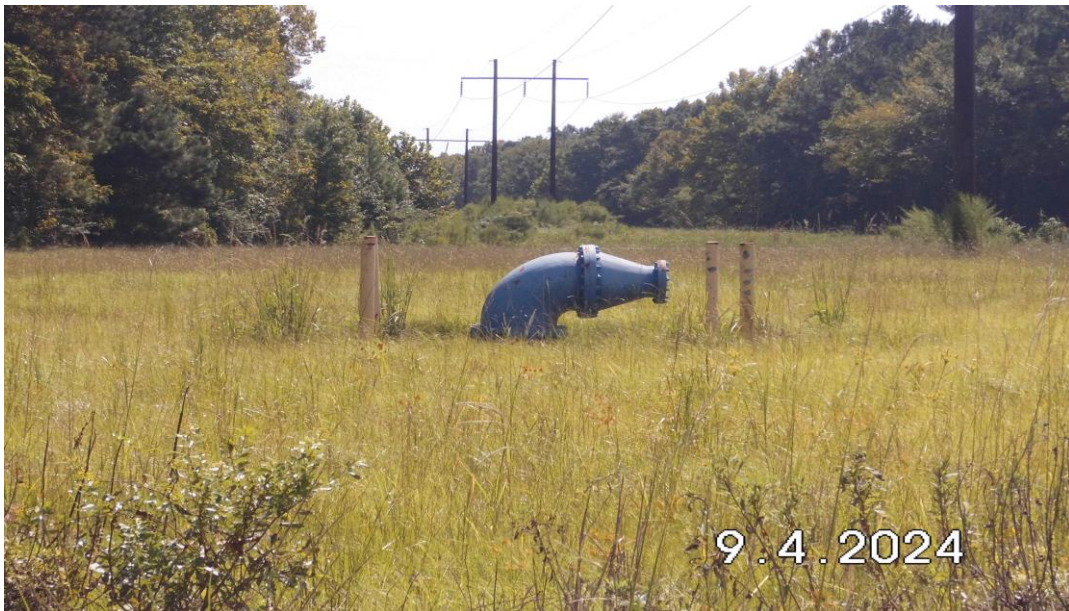
Photograph EE- Emergency Intake Pipe Adjacent to Pond behind DAK

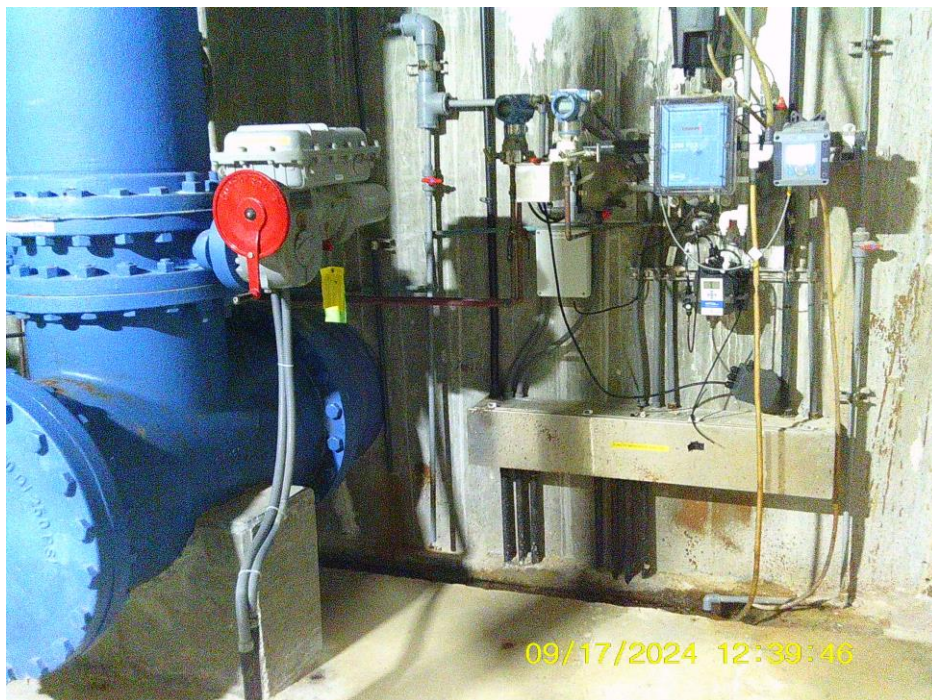
Photograph P – Filter Gallery Walls

| Facility | Satisfactory | Needs Attention | Remarks |
|---|---|---|---|
| Filter 4 | X | | Monitor wall leaks |

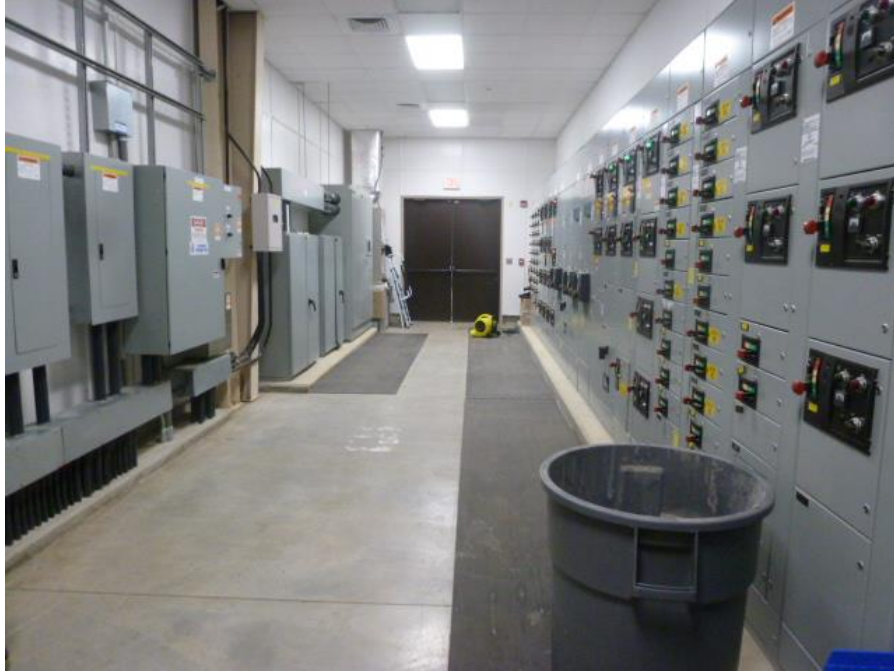
Photograph AA- Chemical Building Electrical Room

Aside from these issues, the building is in good condition. The electrical room was also inspected, and a significant amount of previously stored material has been removed. The room appeared to be in good condition, with the A/C functioning properly (see *Appendix B – Photograph AA*).
