**AGENDA**  
**Lower Cape Fear Water & Sewer Authority**  
**1107 New Pointe Boulevard, Suite # 17, Leland, North Carolina**  
**9:00 a.m. – Regular Monthly Board Meeting**  
**October 14, 2024**

- NB1** – Resolution Accepting the Lower Cape Fear Water and Sewer Authority Kings Bluff Regional Raw Water Supply Facilities FY 2024-2025 Annual Inspections Report (Tony Boahn, P.E., McKim and Creed)
- NB2** – Resolution Accepting the Lower Cape Fear Water and Sewer Authority Bladen Bluffs Regional Raw Water Supply Facilities FY 2024-2025 Annual Inspections Report (Tony Boahn, P.E., McKim and Creed)
- NB3** – Resolution of the Lower Cape Fear Water and Sewer Authority Board of Directors Establishing Criteria for a Design-Build Delivery Method and Authorizing Use of the Design-Build Delivery Method for the Kings Bluff Raw Water Pump Station Air Backwash Building and Access Walkway Replacement

## Kings Bluff Pumping Station Annual Inspection

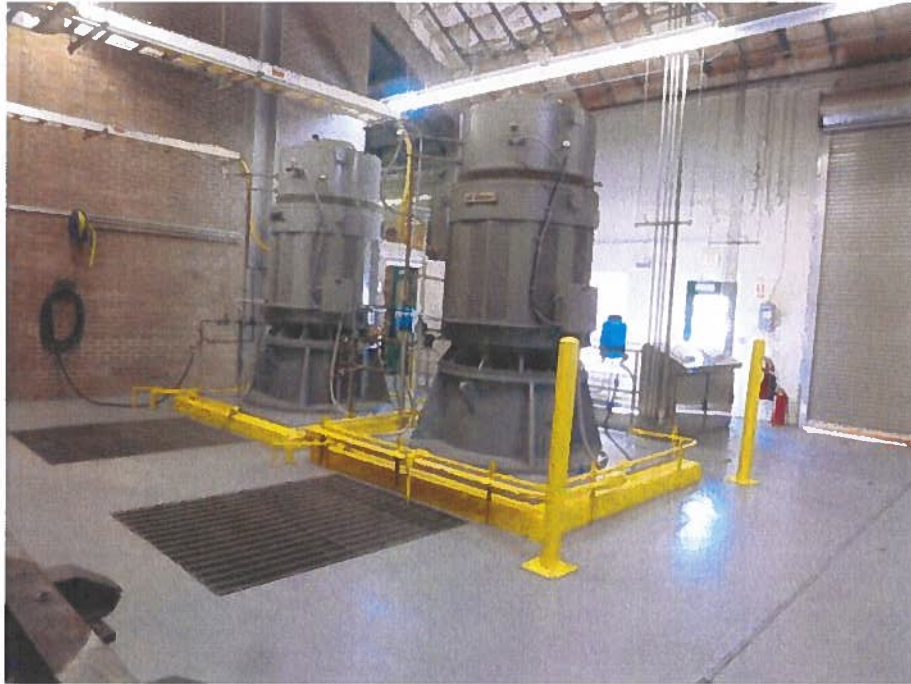
**Photograph A – Pump #4 and #5**

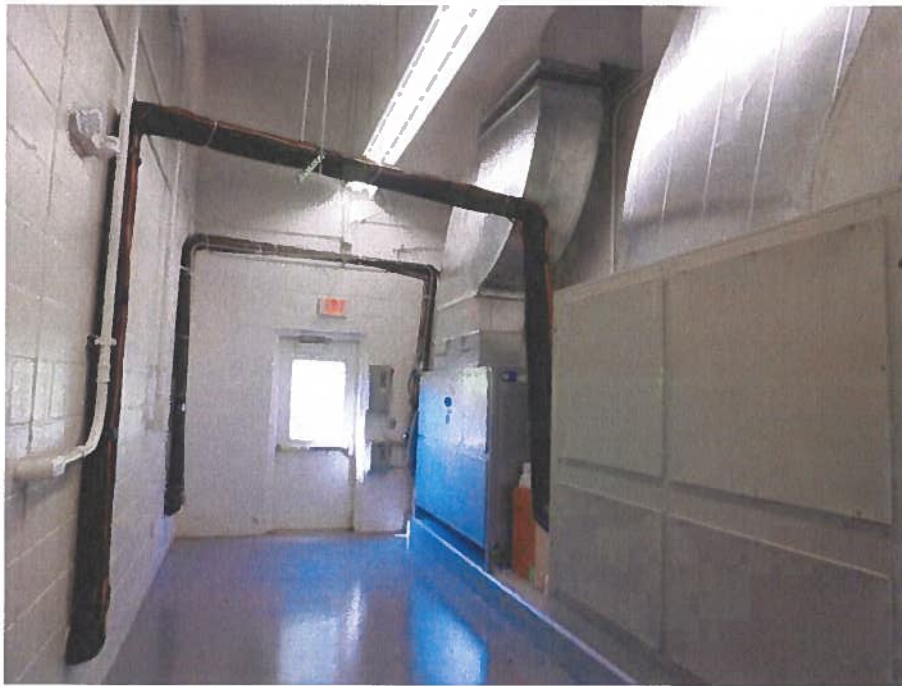
**Photograph H –Electrical HVAC Room**

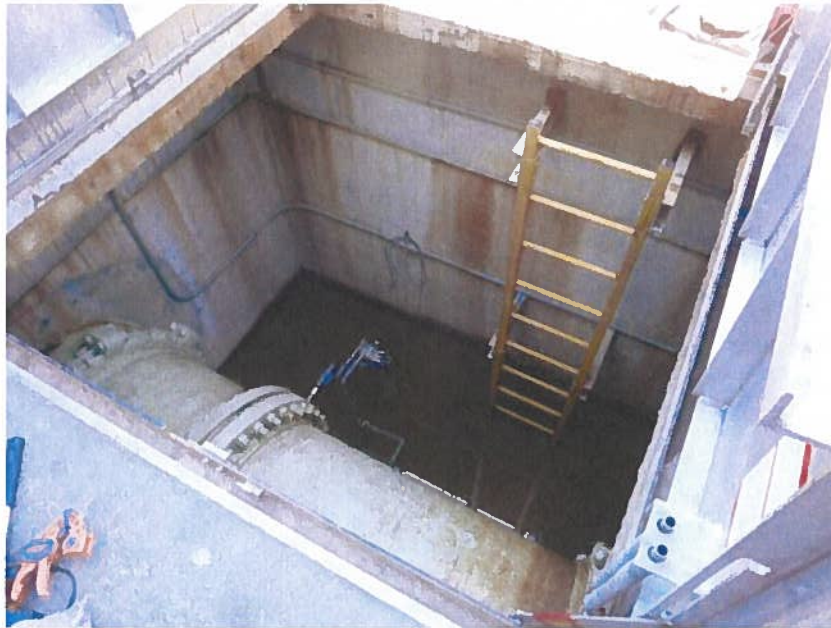
**Photograph J – Plant Effluent Meter Vault**

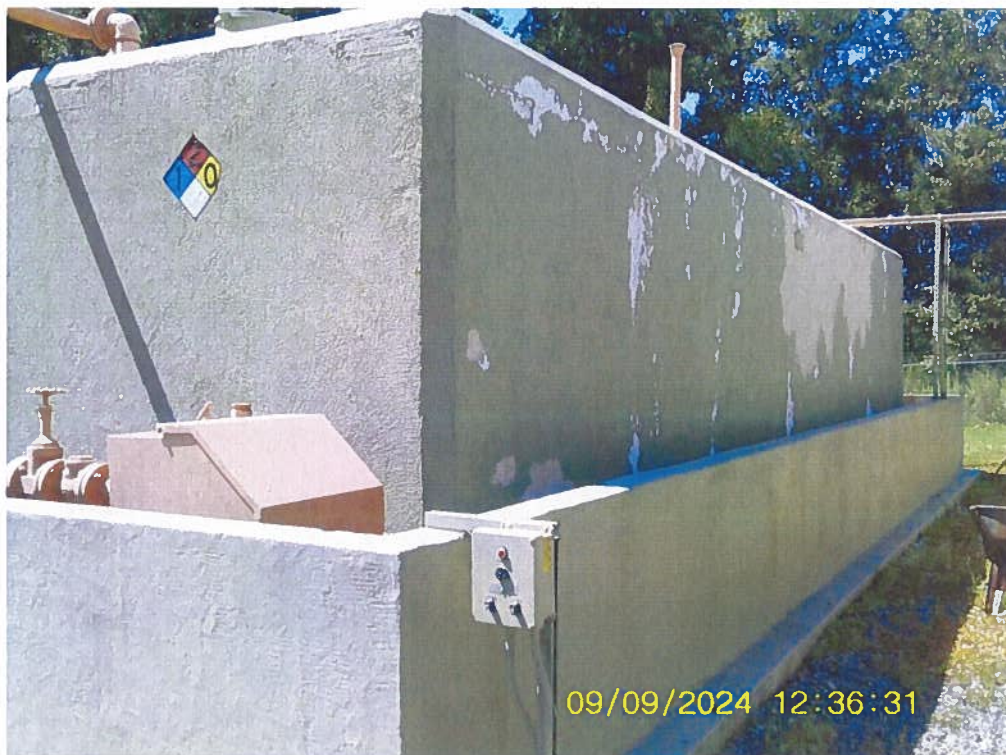
**Photograph K –Diesel Storage Tank Coating Repairs**

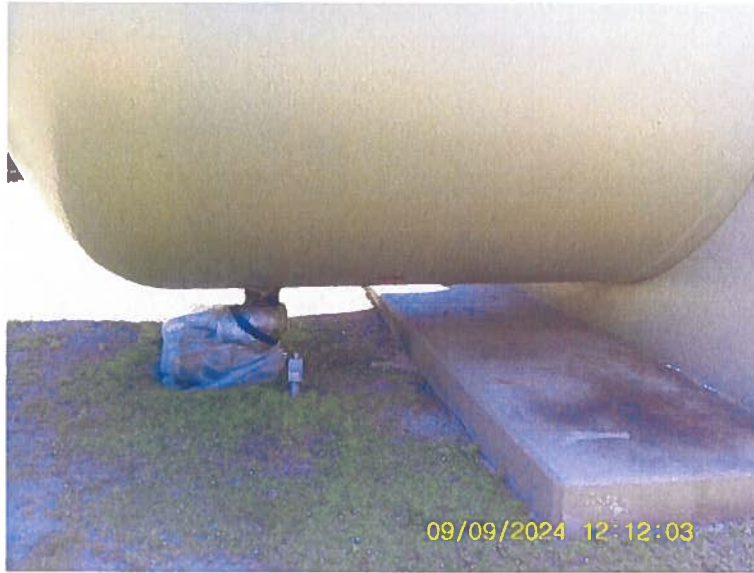
**Photograph P – Surge Tank Drain Piping**

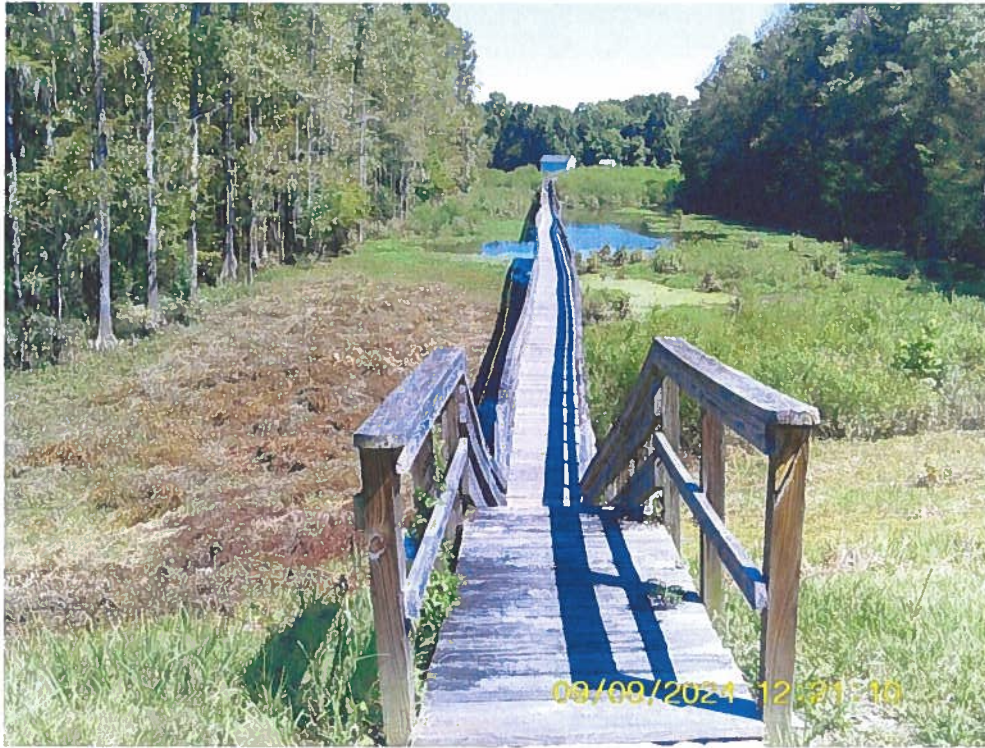
**Photograph R – Air Backwash Pier**

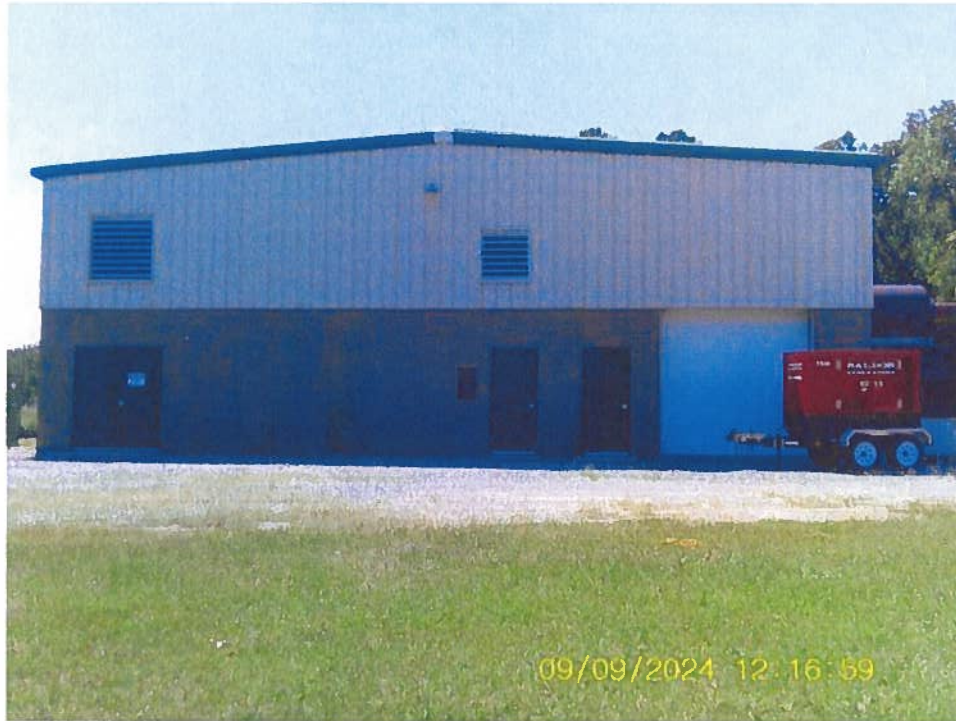
**Photograph U – Generator Building Doors Replaced**

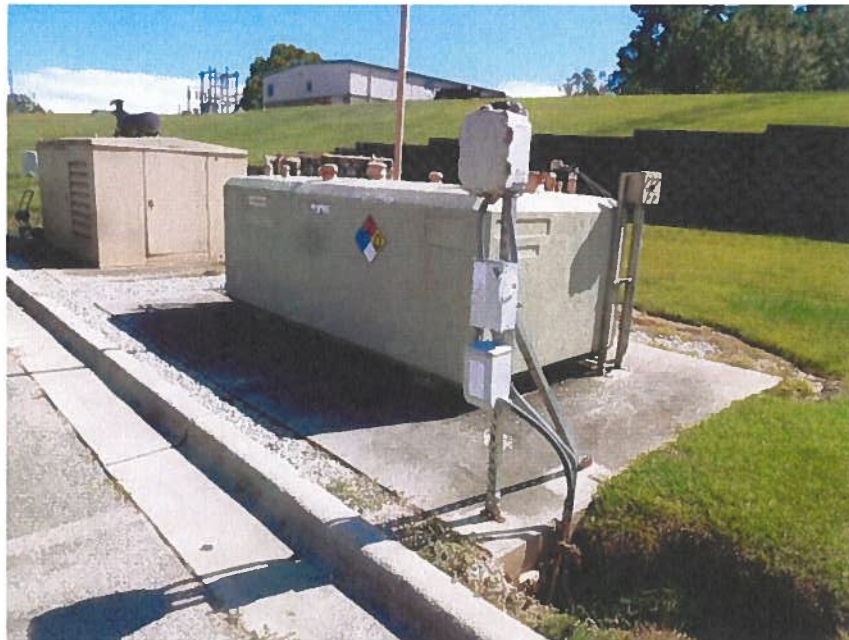
**Photograph V – Small Generator Removed from Service**

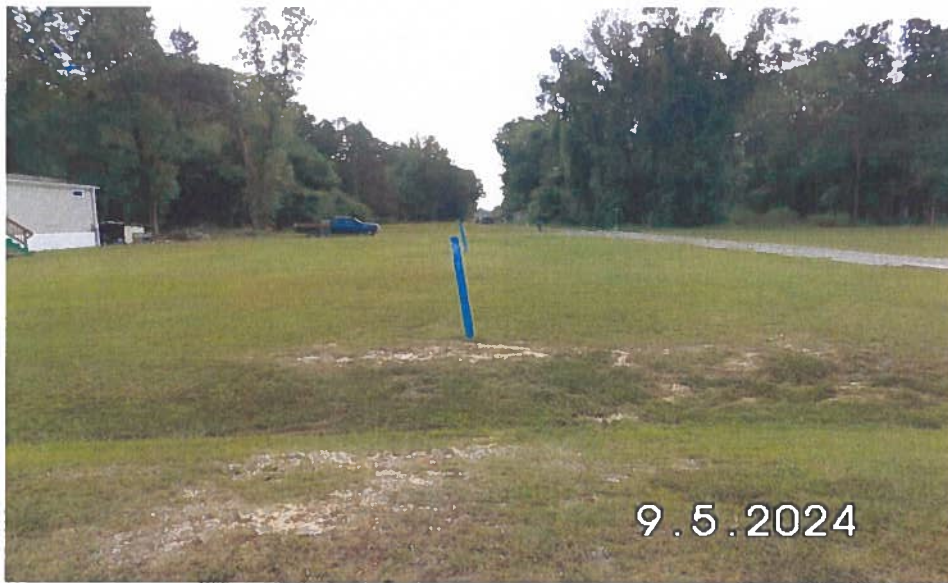
**Photograph CC – New Blue Marker Post from 54" RWM project.**

1. Recommend painted 2" PVC poles painted "orange" to mark each valve structure.
2. Recommend all valve structures to be re-painted "blue".
3. Additional "blue" marker posts are needed to mark valve locations.

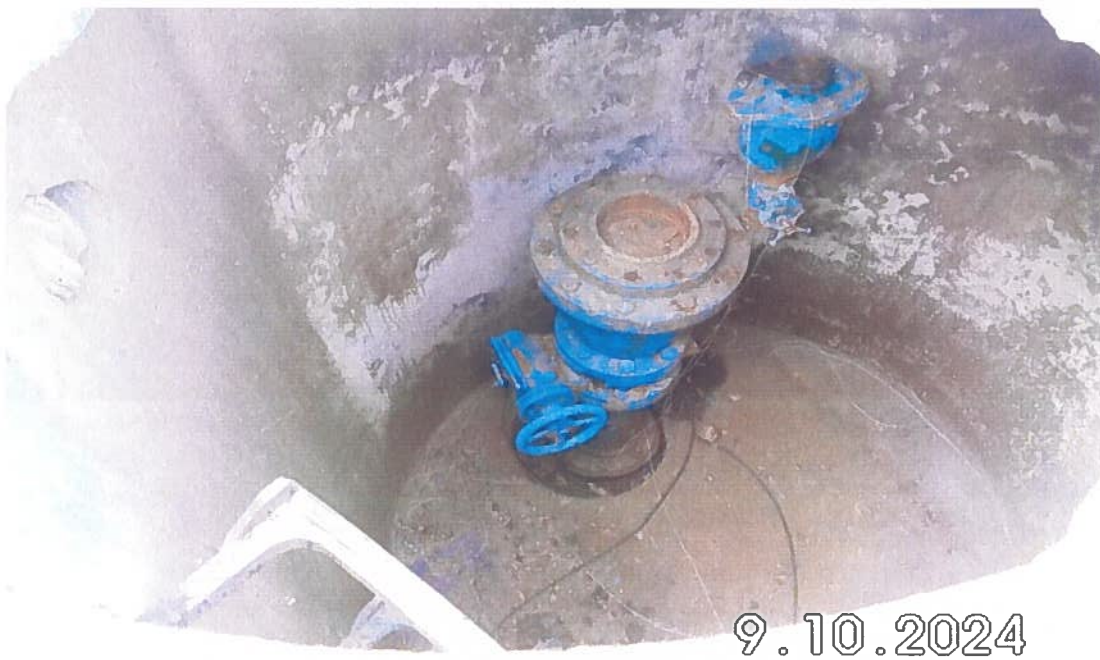
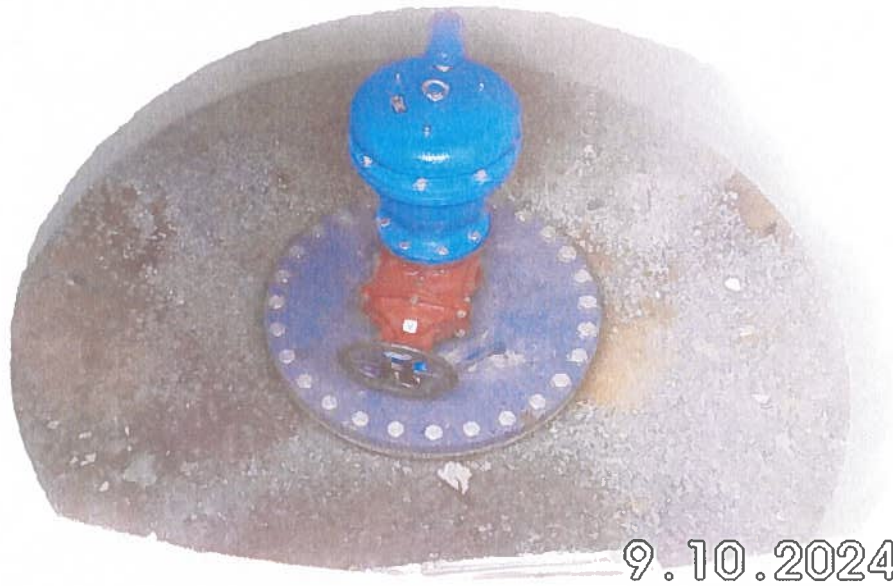
**Photograph DD – Old ARV on 48" RWM and New ARV on 54" RWM**

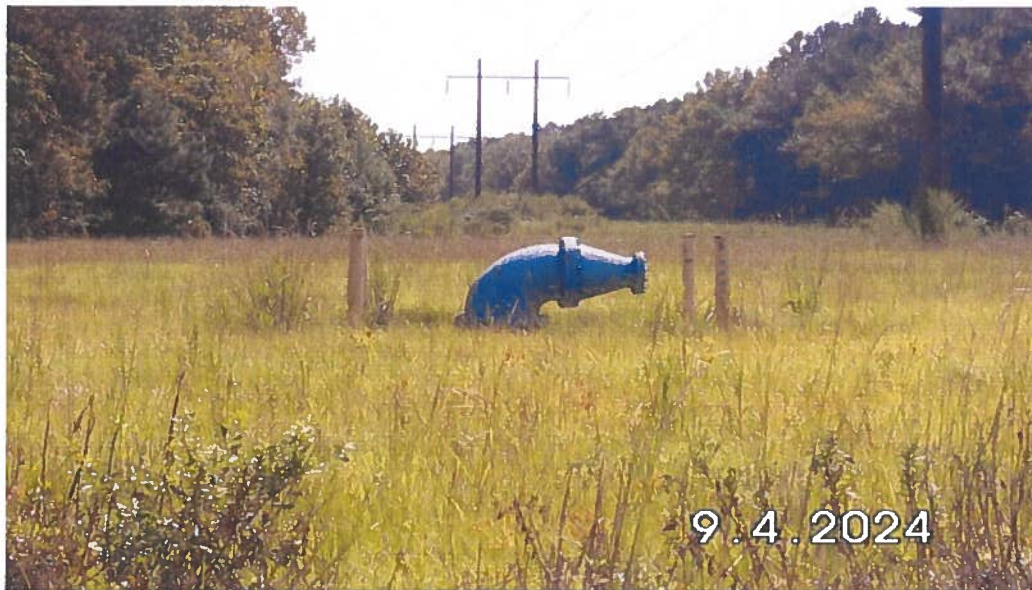
**Photograph EE- Emergency Intake Pipe Adjacent to Pond behind DAK**

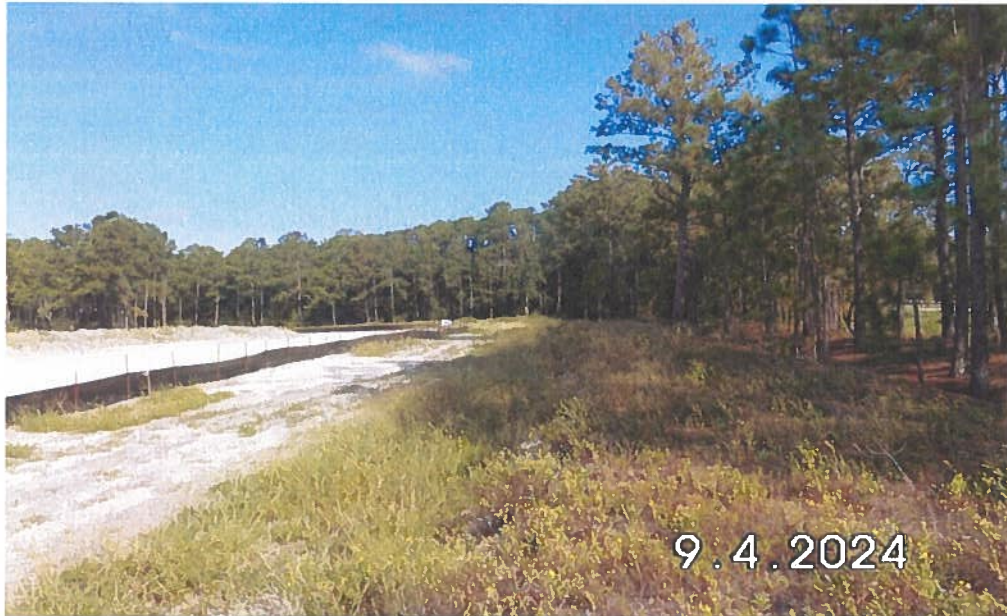
**Photograph FF- Right-of-Way at US Hwy 421 from 2019 - 48" RWM Relocation Project**

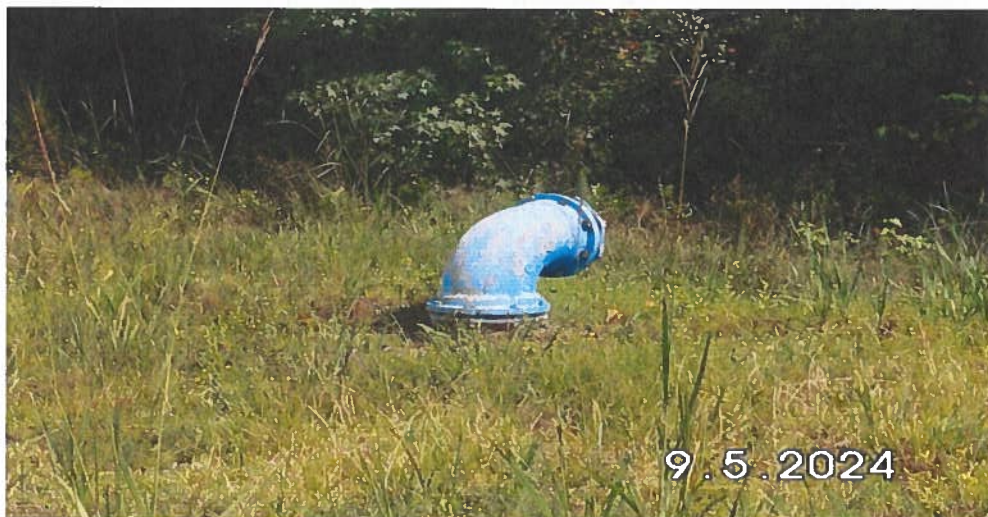
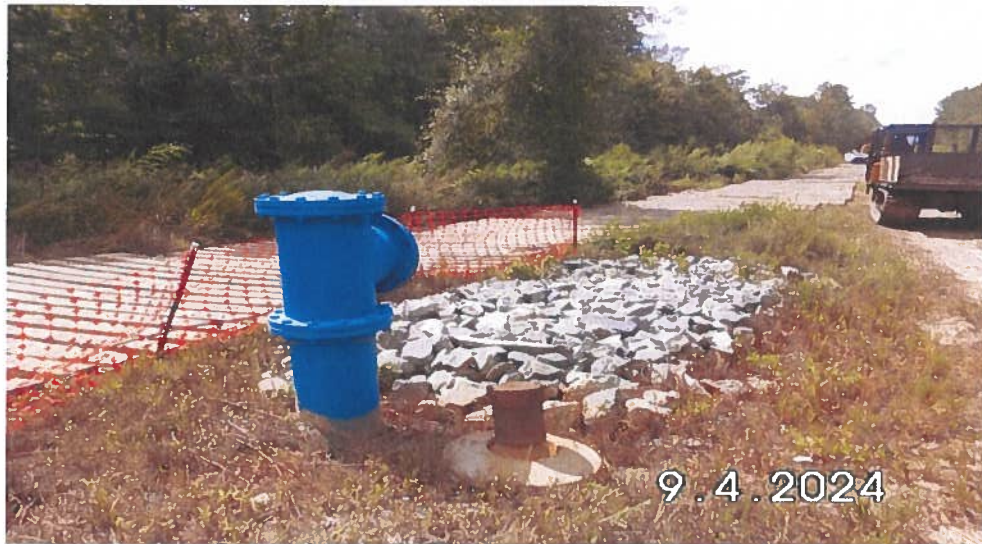
**Photograph GG- Old Blow-off on 48" RWM and new Blow-off on 54" RWM**

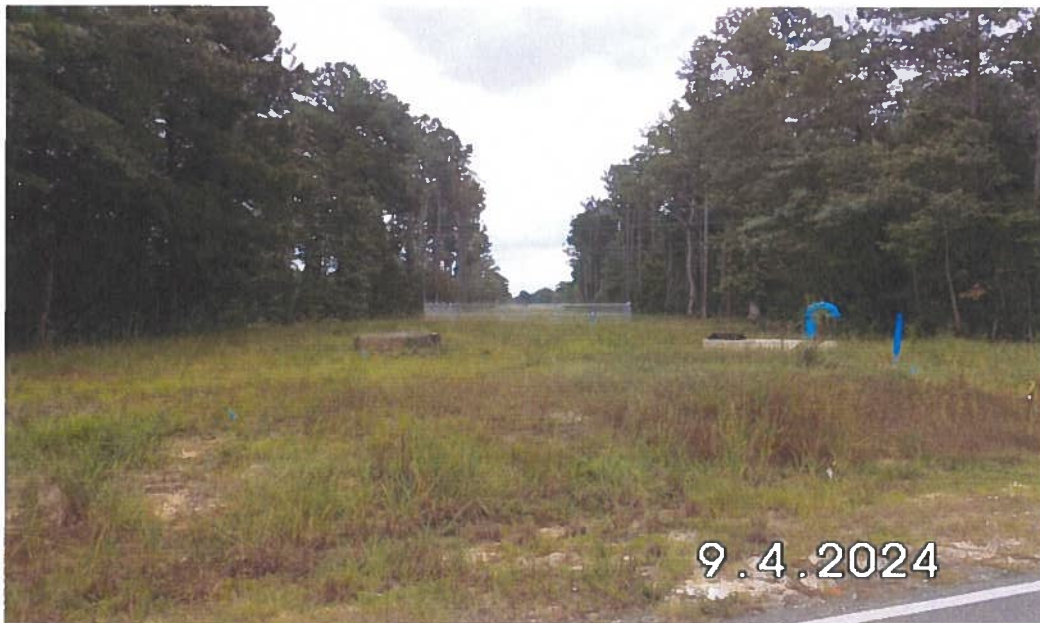
**Photograph HH- Interconnect off Blue Banks Loop Road**

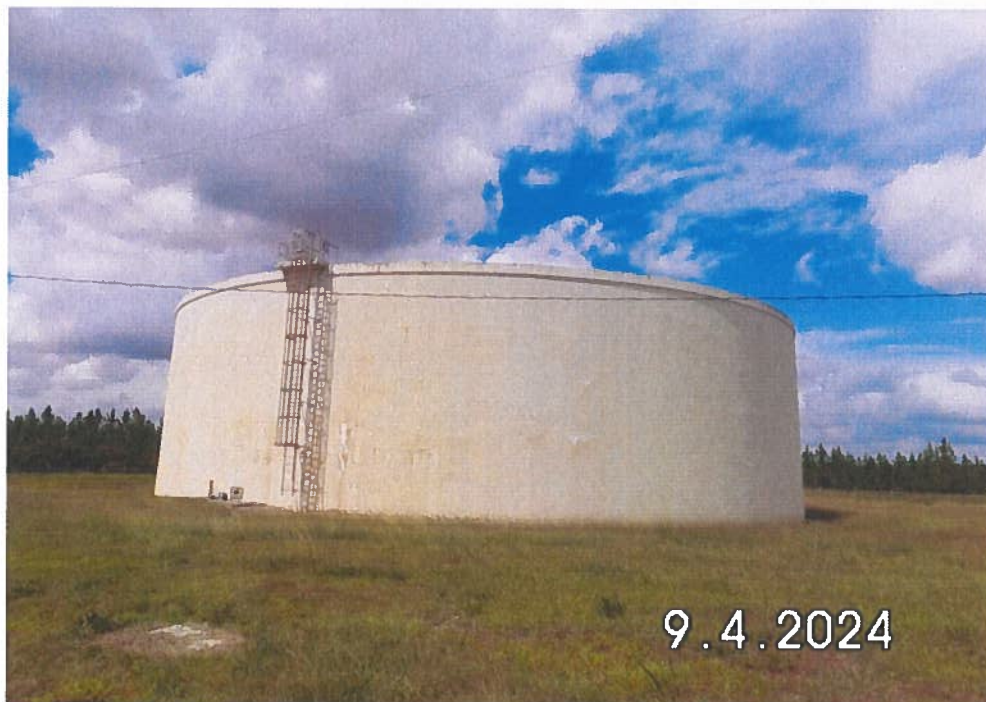
**Photograph JJ- 3 Million Gallon Ground Storage Tank**

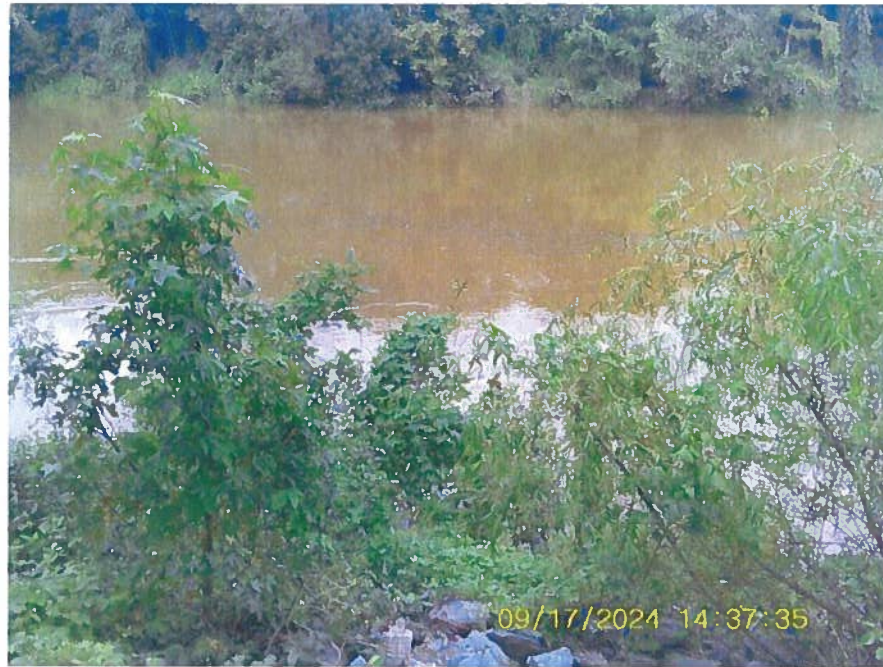
**Photograph A – Intake Location**

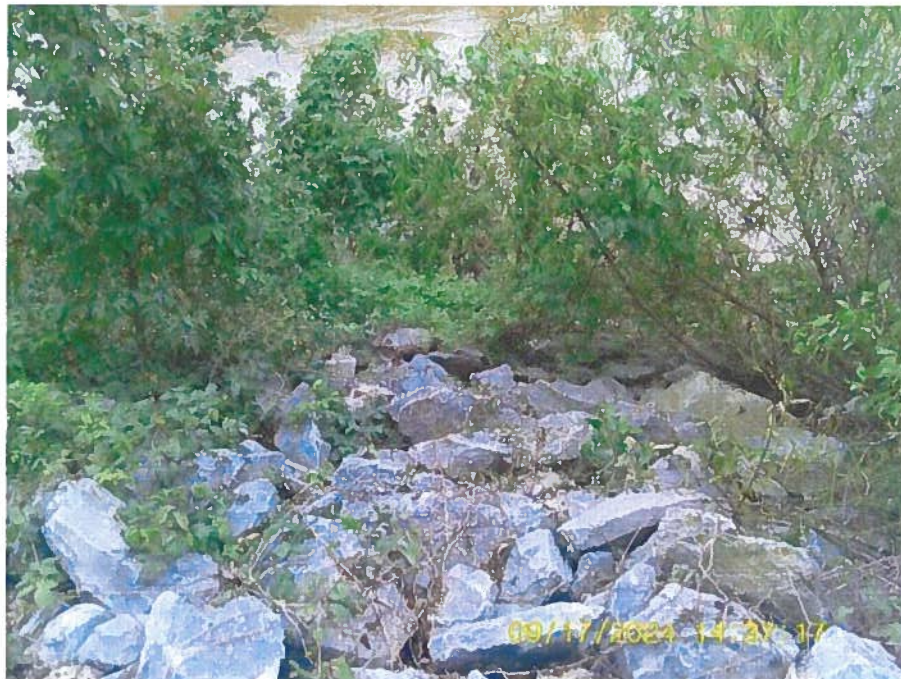
**Photograph B – Cape Fear Riverbank Restoration Project Area**

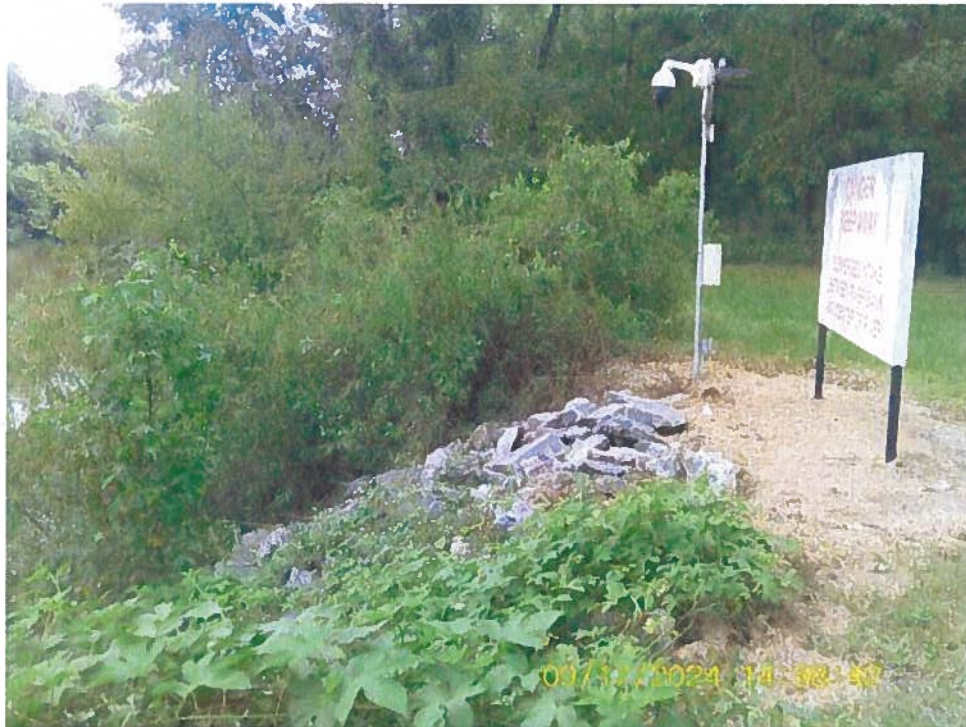
**Photograph C – River Monitoring Camera**

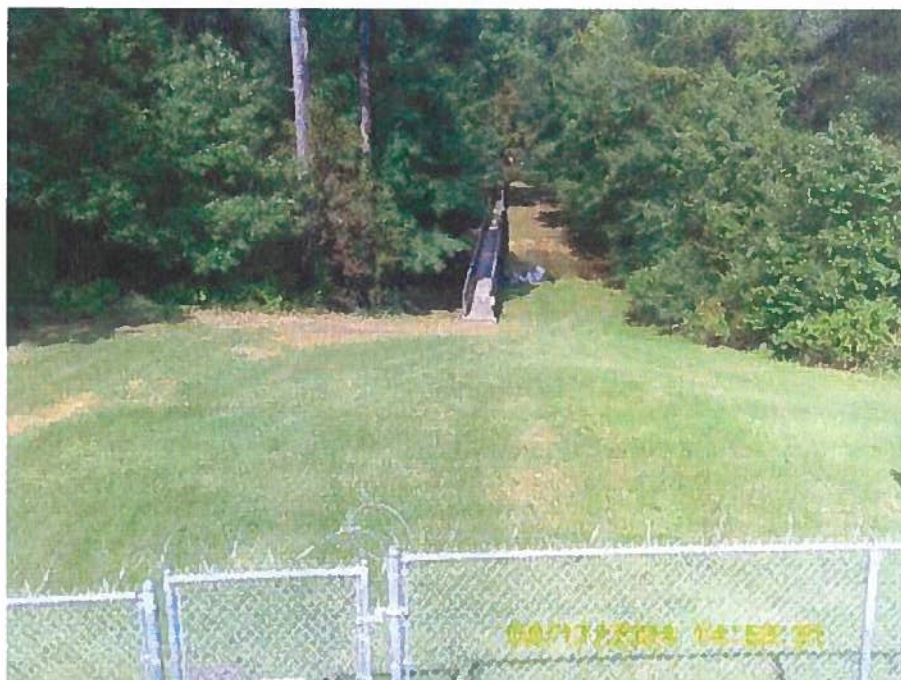
**Photograph D – River Access Walkway**

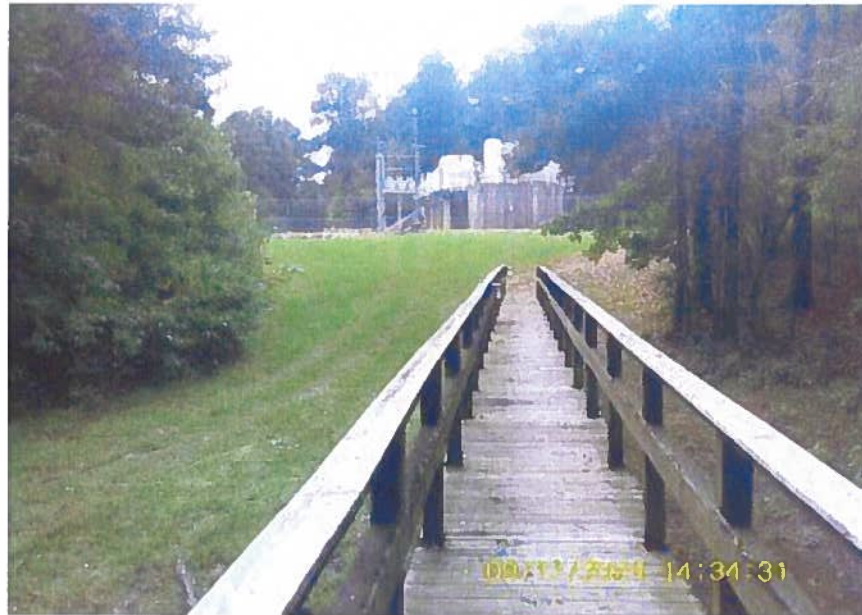
**Photograph E – River Access Walkway**

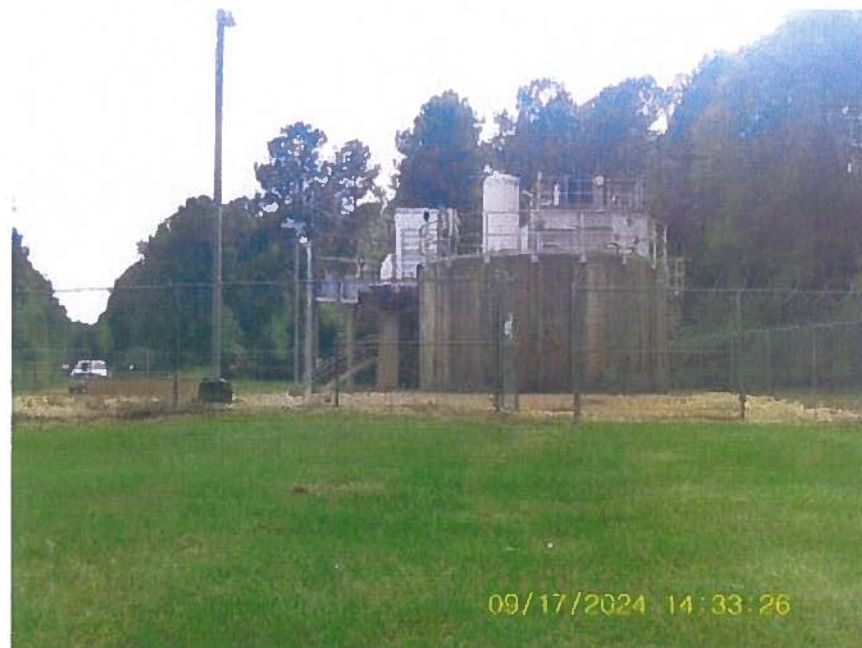
**Photograph F - Raw Water Pump Station Wet Well**

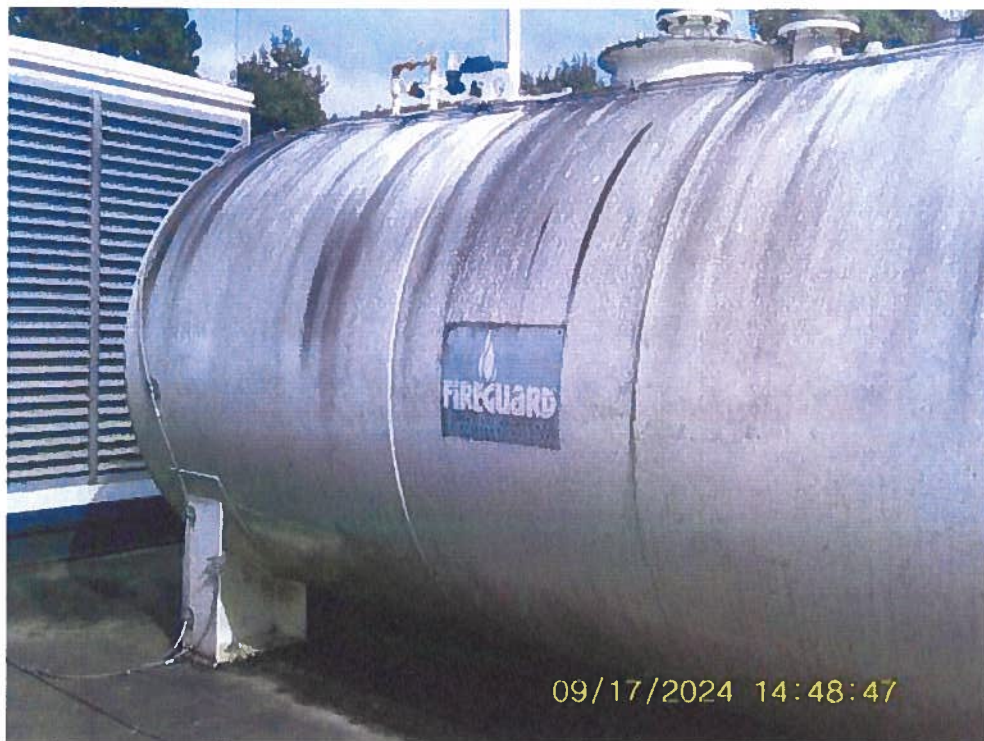
**Photograph H – Diesel Storage**

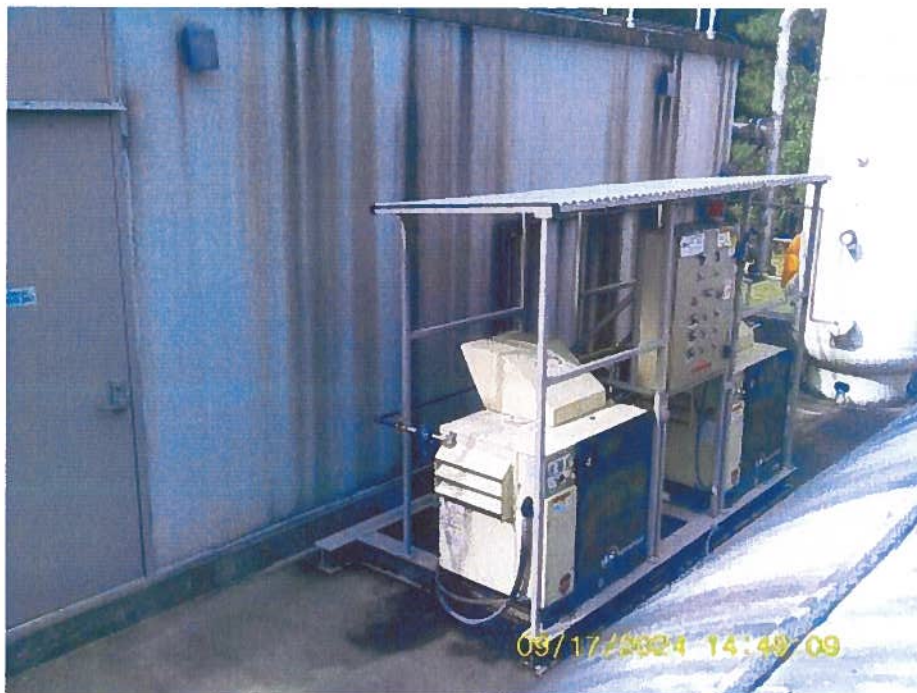
**Photograph L – Air Backwash Compressor**

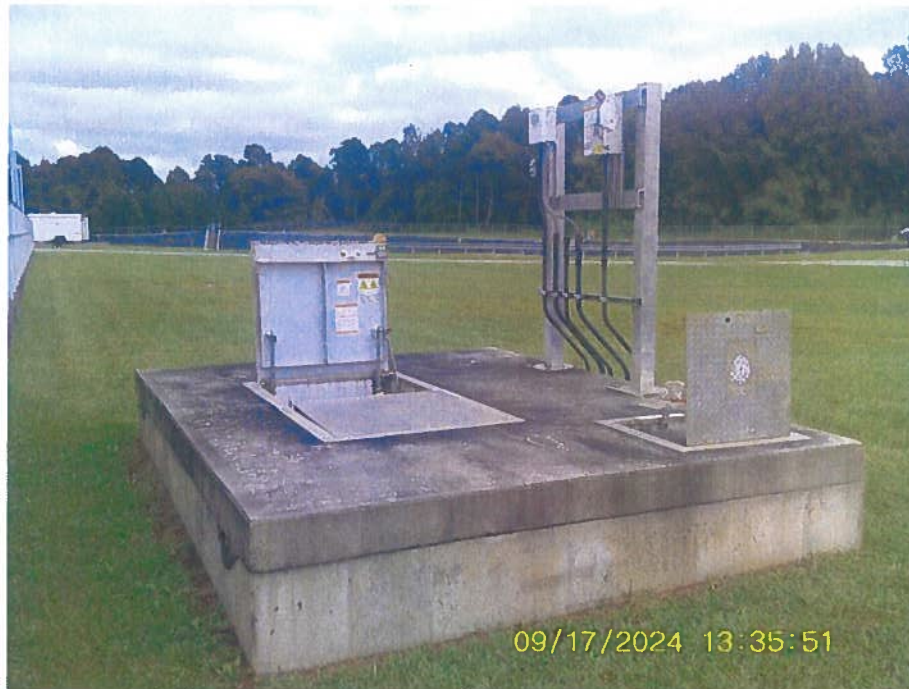
**Photograph M – Influent Flow Meter Vault**

| Meter Digital Displays | | X | Address flooding and vault leaks |

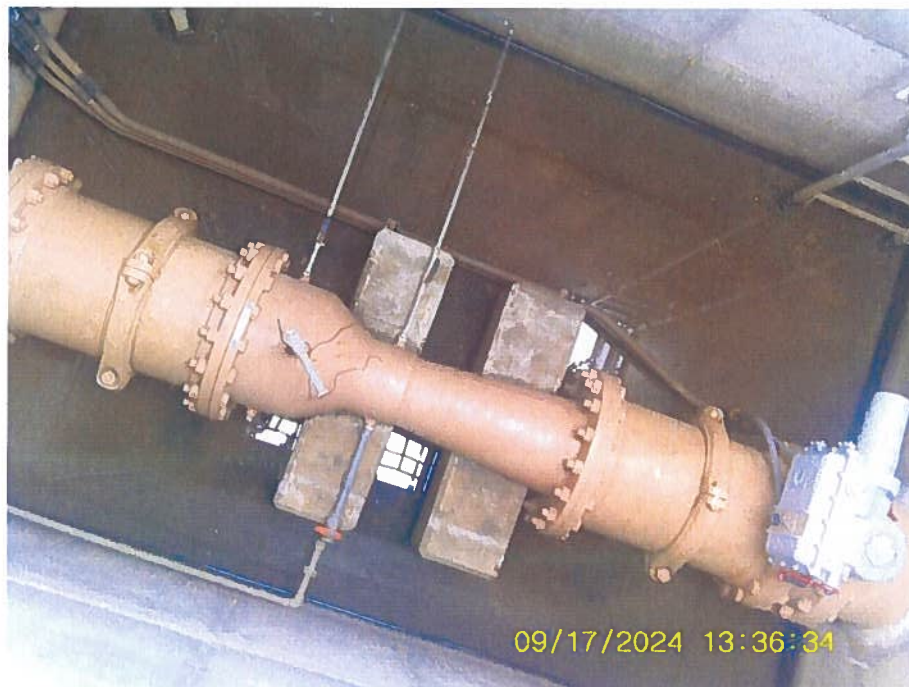
**Photograph N – Influent Flow Meter Vault**

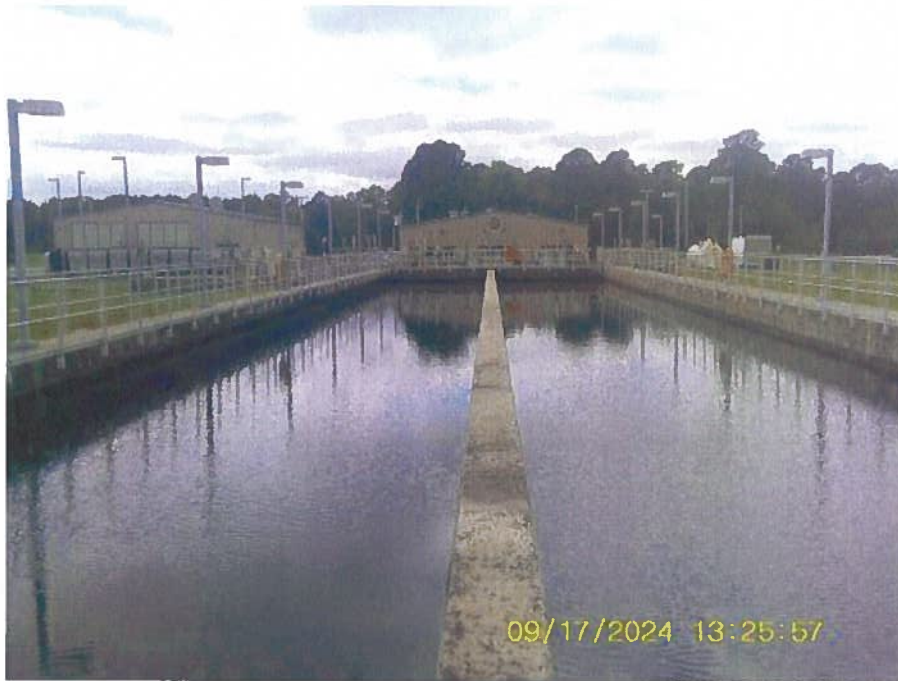
**Photograph O – Sedimentation Basins**

| Basins | X | | Make liner repair as time allows |

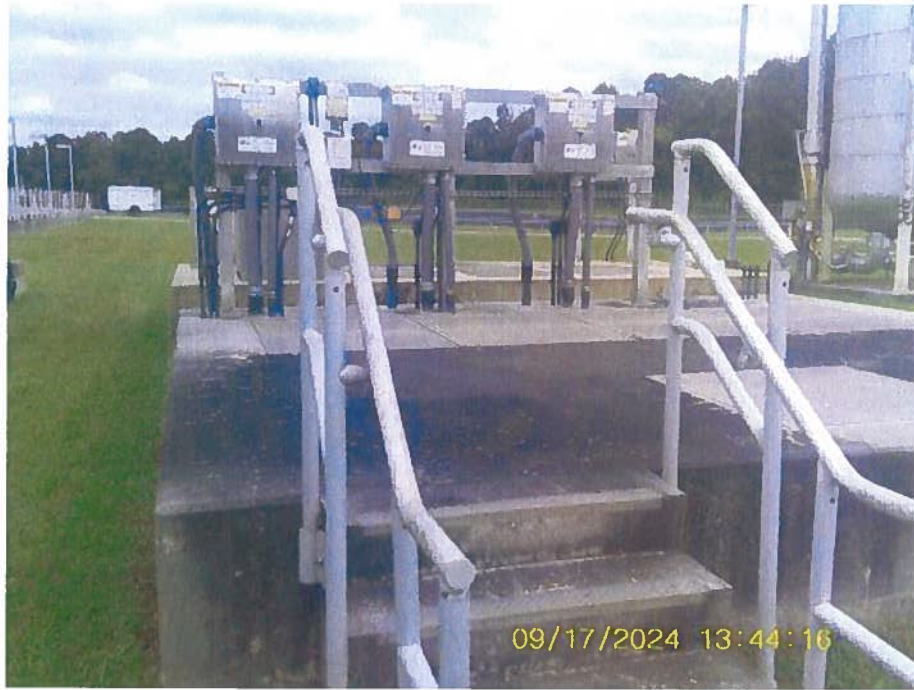
**Photograph S –Transfer Pump Station**

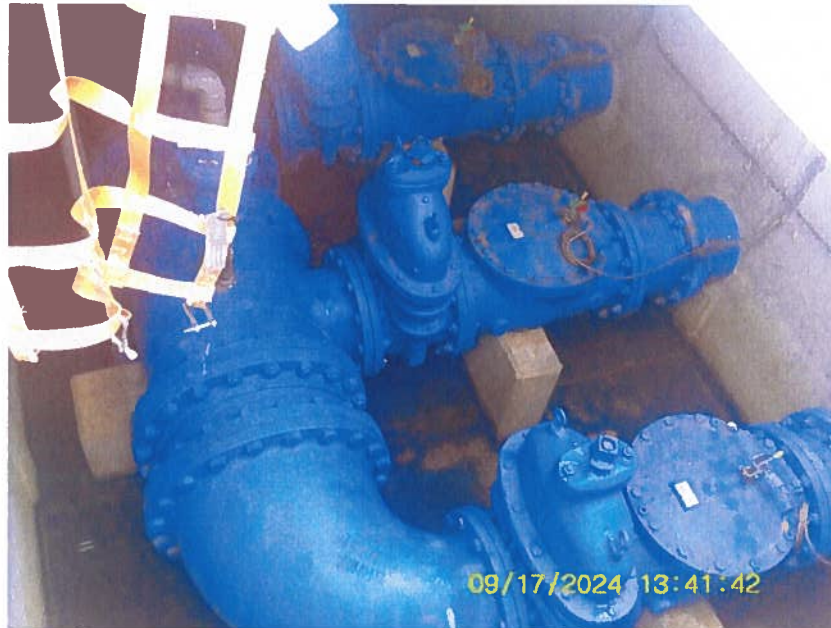
**Photograph U –Transfer Pump Station Valve Vault**

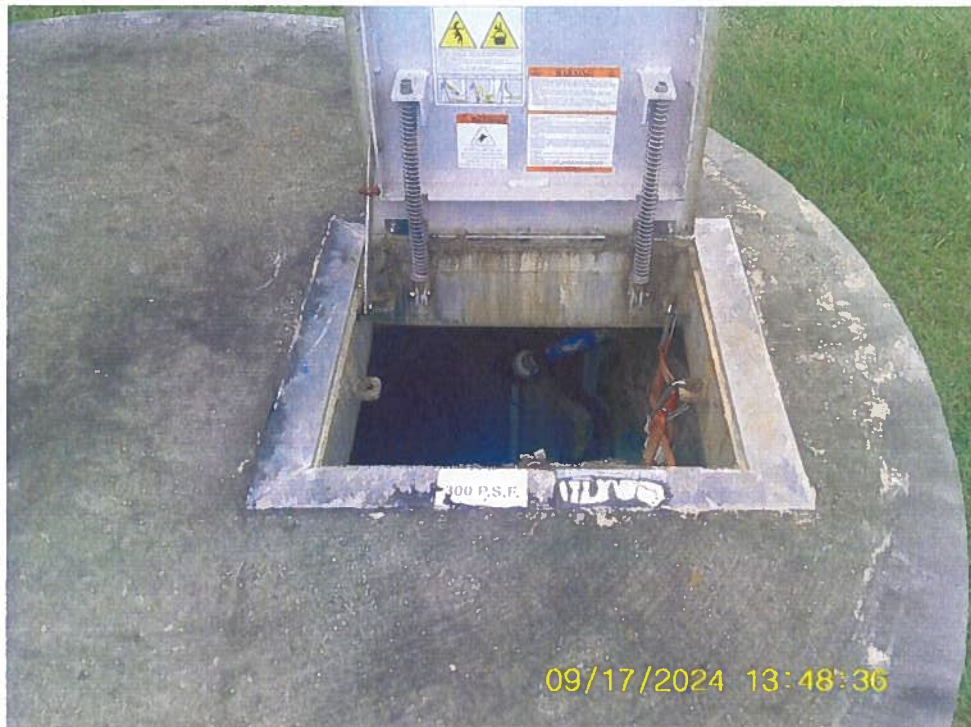
**Photograph V- Transfer Pump Station Check Valve Vault**

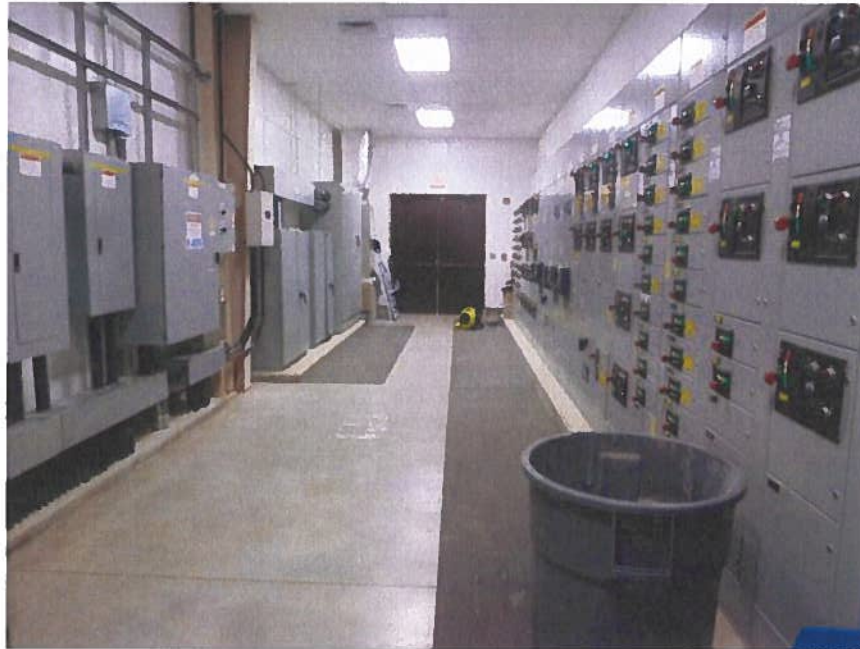
**Photograph AA- Chemical Building Electrical Room**

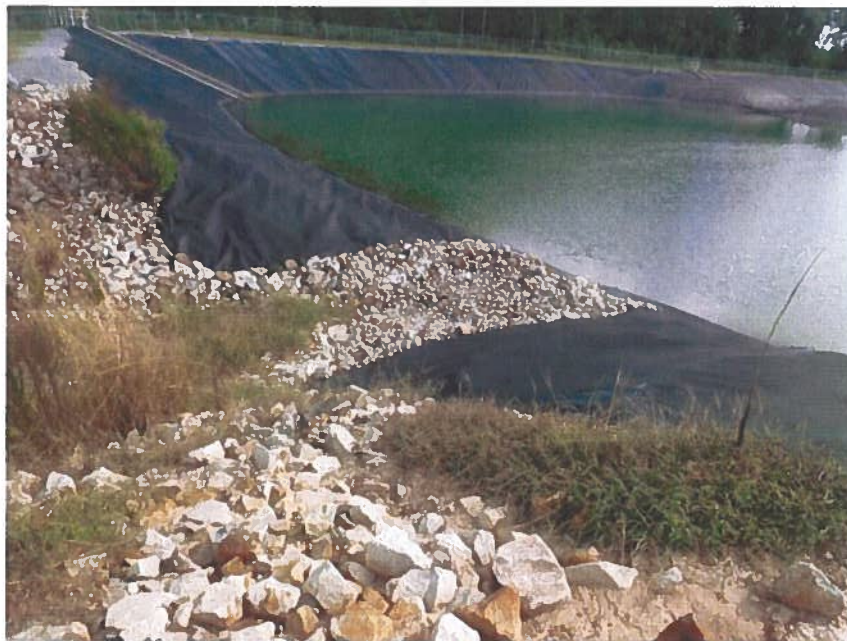
**Photograph BB- Residuals Basins**

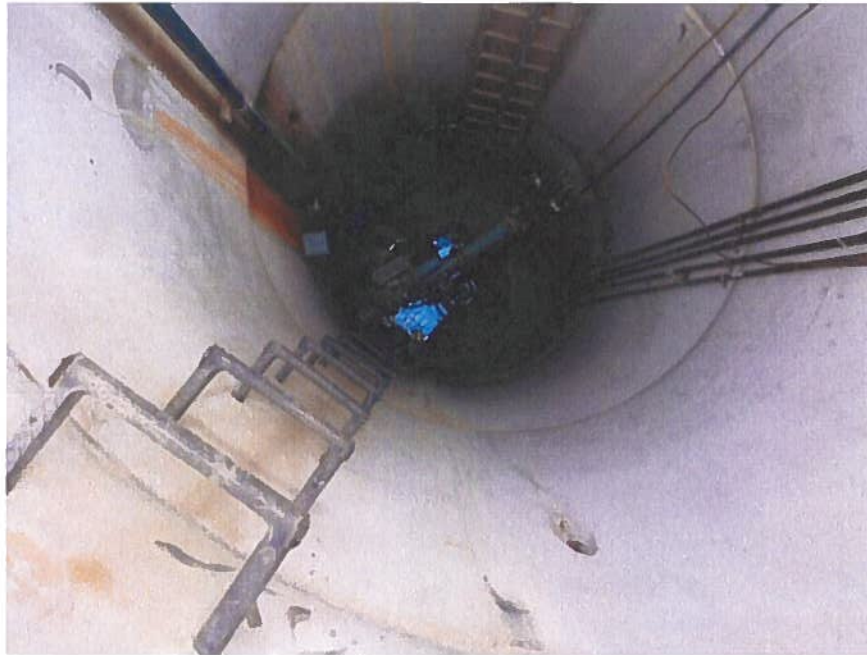
**Photograph CC- NPDES Compliance Wet Well**

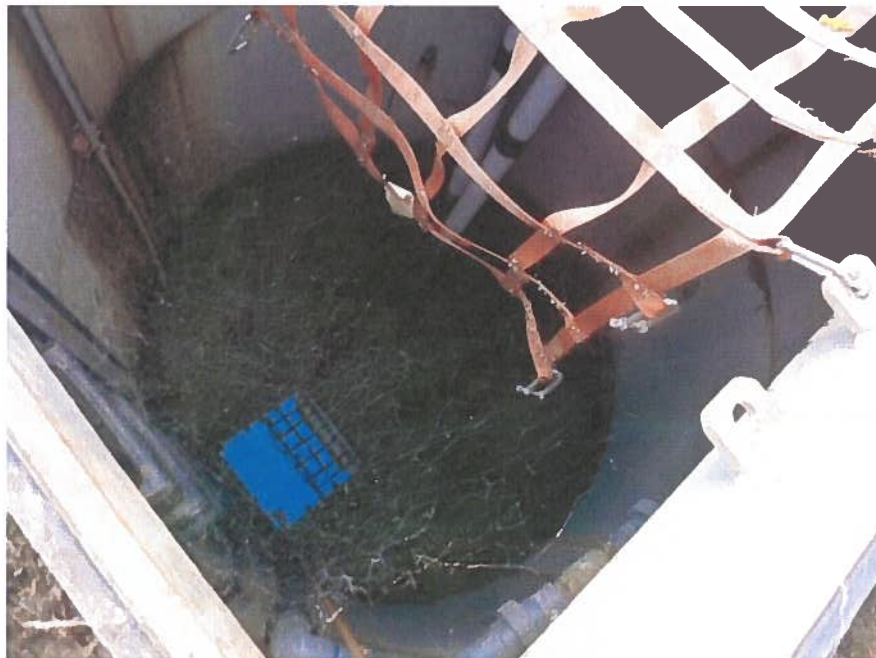
**Photograph DD- NPDES Chemical Injection Vault**
