Lower Cape Fear Water & Sewer Authority
Regular Board Meeting Minutes
October 14th, 2024

Lower Cape Fear Water & Sewer Authority Kings Bluff Regional Raw Water Supply Facilities FY 2024-2025 Annual Inspection Report

FY 2024-2025 Annual Inspection Report

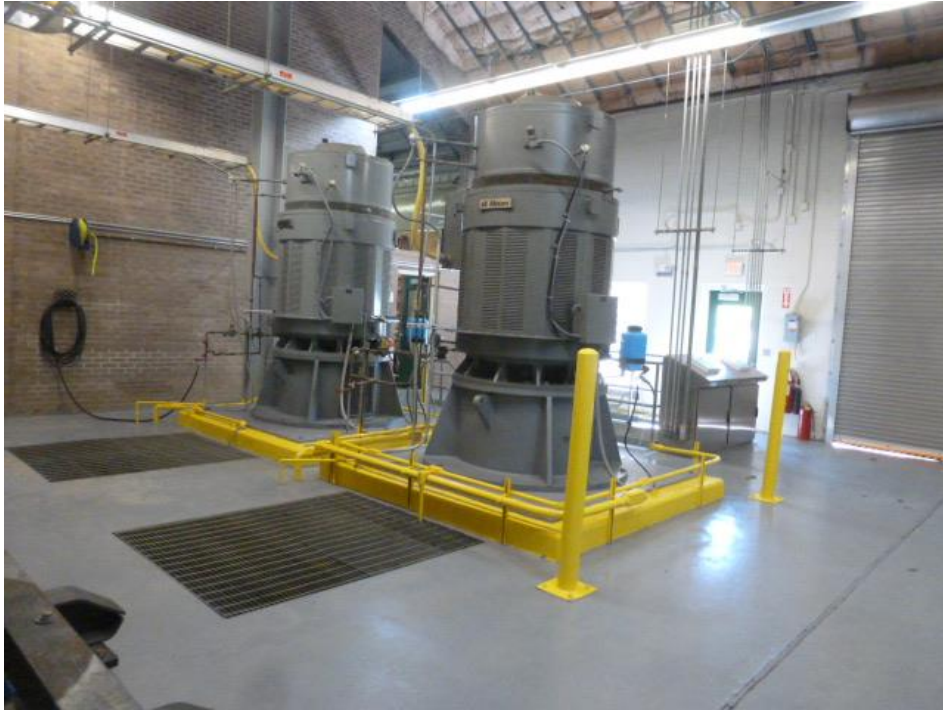
Photograph A – Pump #4 and #5

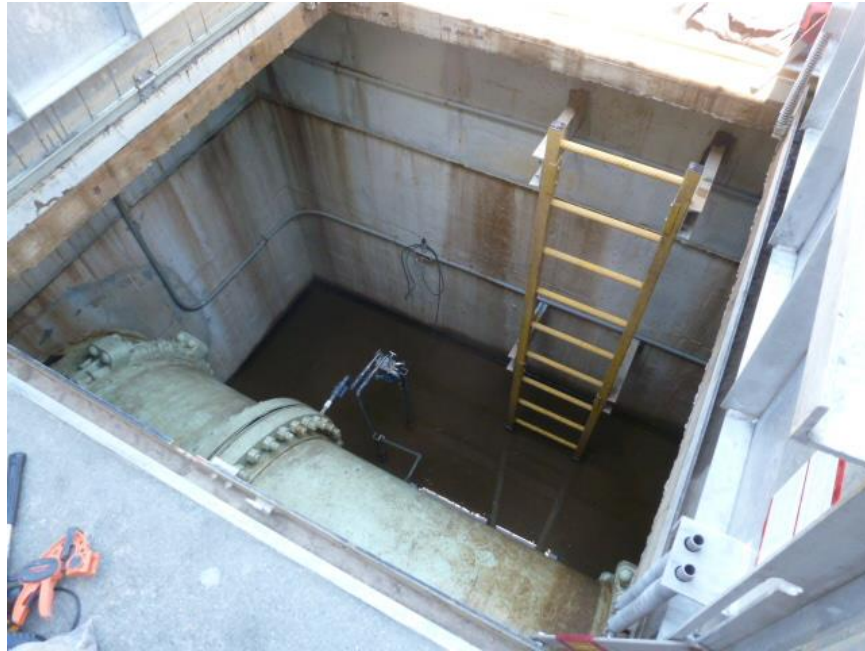
Photograph J – Plant Effluent Meter Vault

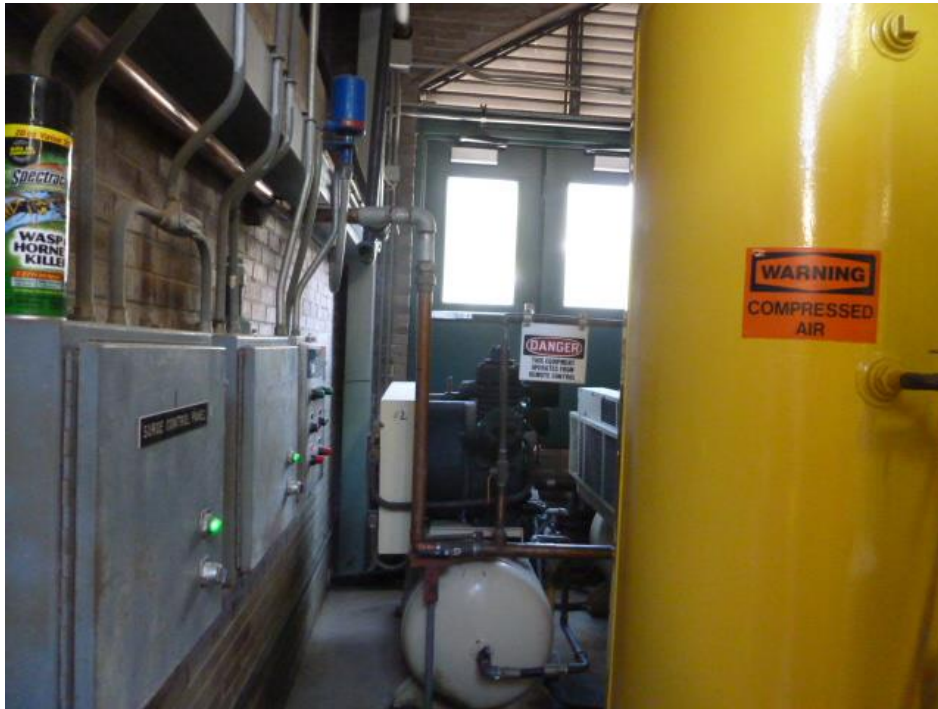
Photograph Q –Surge Tank Control Stations

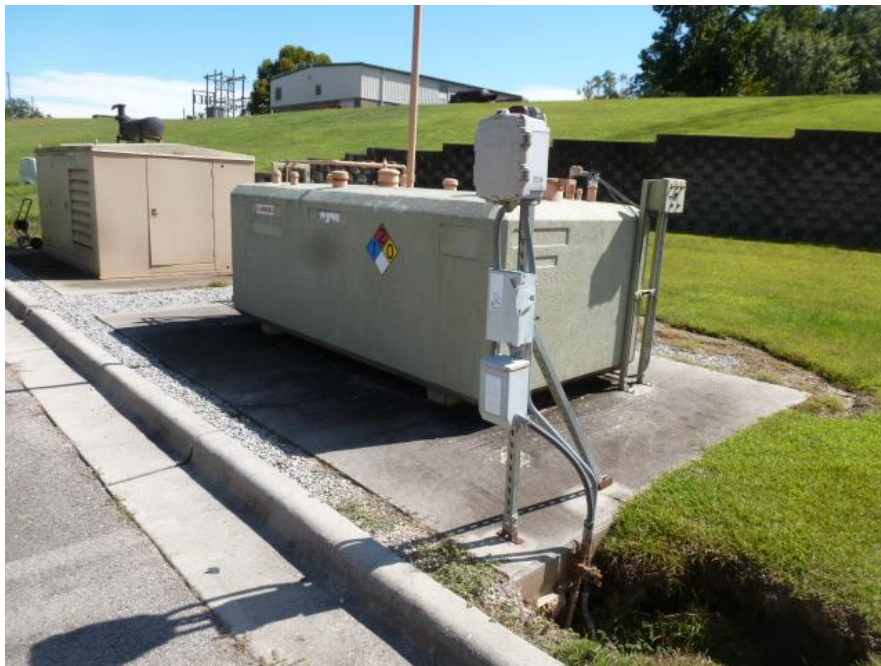
Photograph V – Small Generator Removed from Service

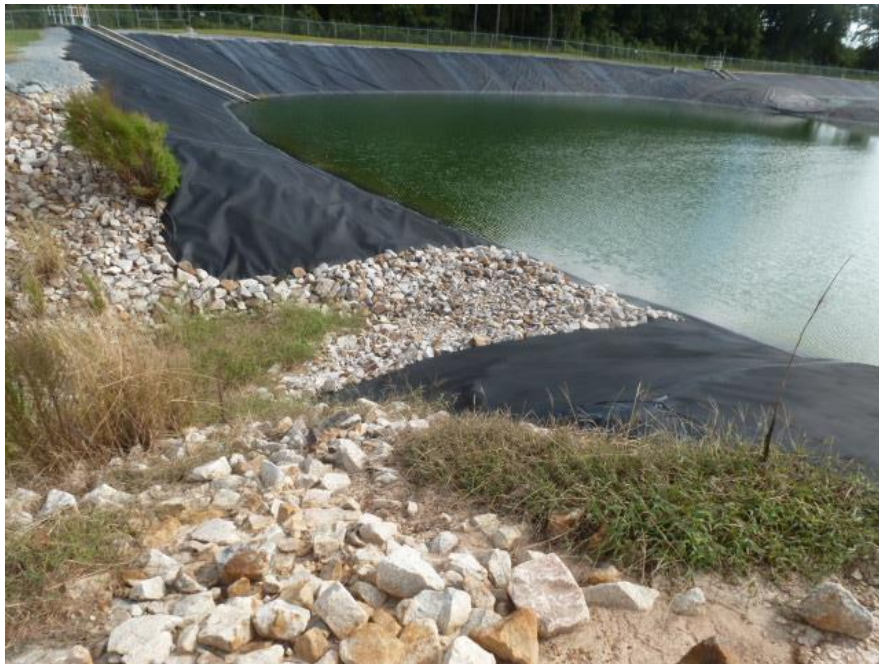
Photograph BB- Residuals Basins

During the inspection, the basins were observed to be in good condition (See *Appendix B – Photograph BB*).

Previously, staff noted a tear in the liner at an outfall connection slab. The staff had a specialist review the issue and make recommendations for correction. To date, the repair has not been made but is scheduled to be conducted in the future when the basin is out of service.

| Basins | X | | Make liner repair as time allows |
