AGENDA
Lower Cape Fear Water & Sewer Authority
1107 New Pointe Boulevard, Suite # 17, Leland, North Carolina
9:00 a.m. – Regular Monthly Board Meeting
October 13, 2025

**Lower Cape Fear Water & Sewer Authority
Kings Bluff Regional Raw Water Supply Facilities
FY 2025-2026 Annual Inspection Report**

FY 2025-2026 Annual Inspection Report

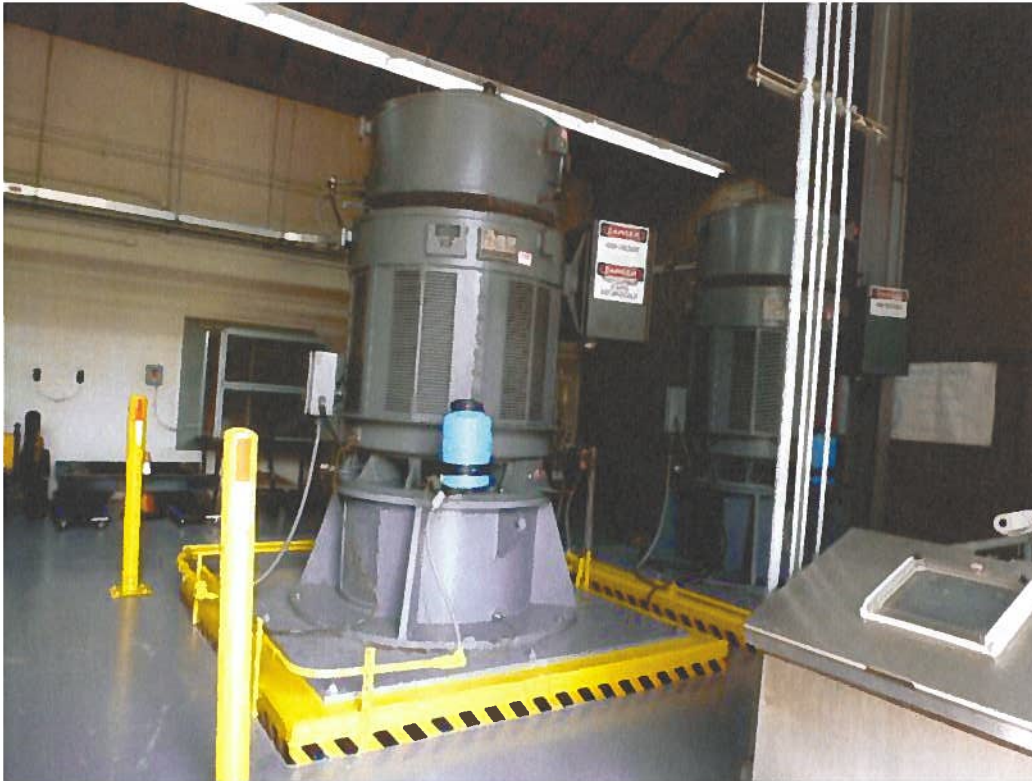
Photograph A – Pump #4 and #5

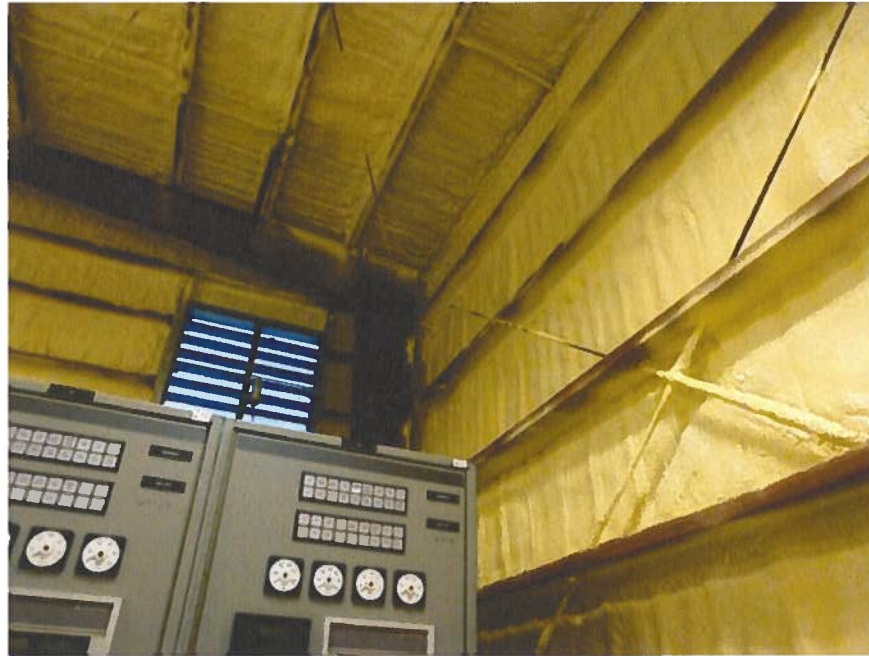
Photograph Q –Generator Room Insulation

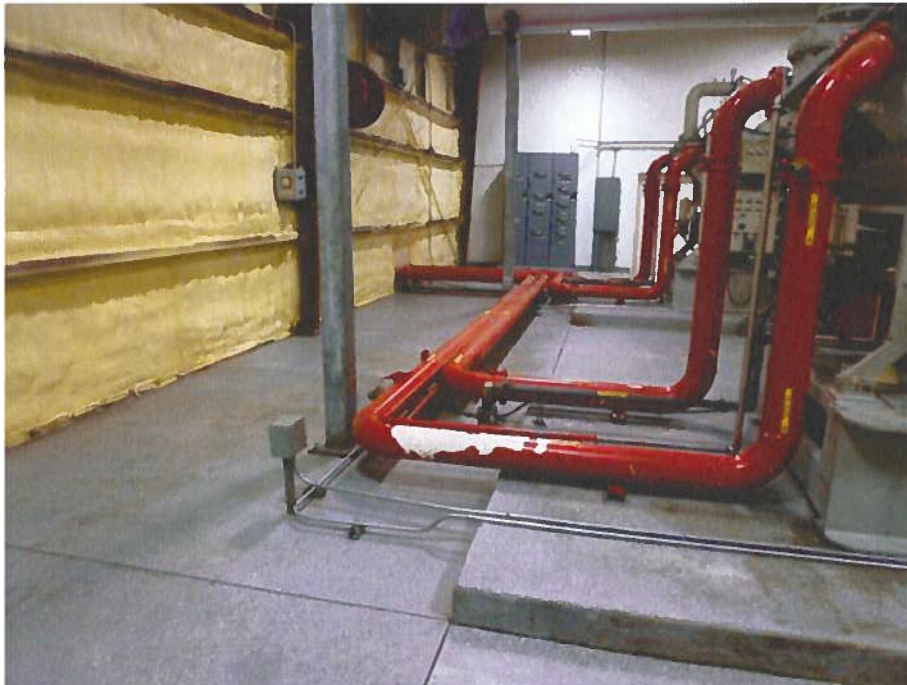
Photograph R – Generator Coolant Piping

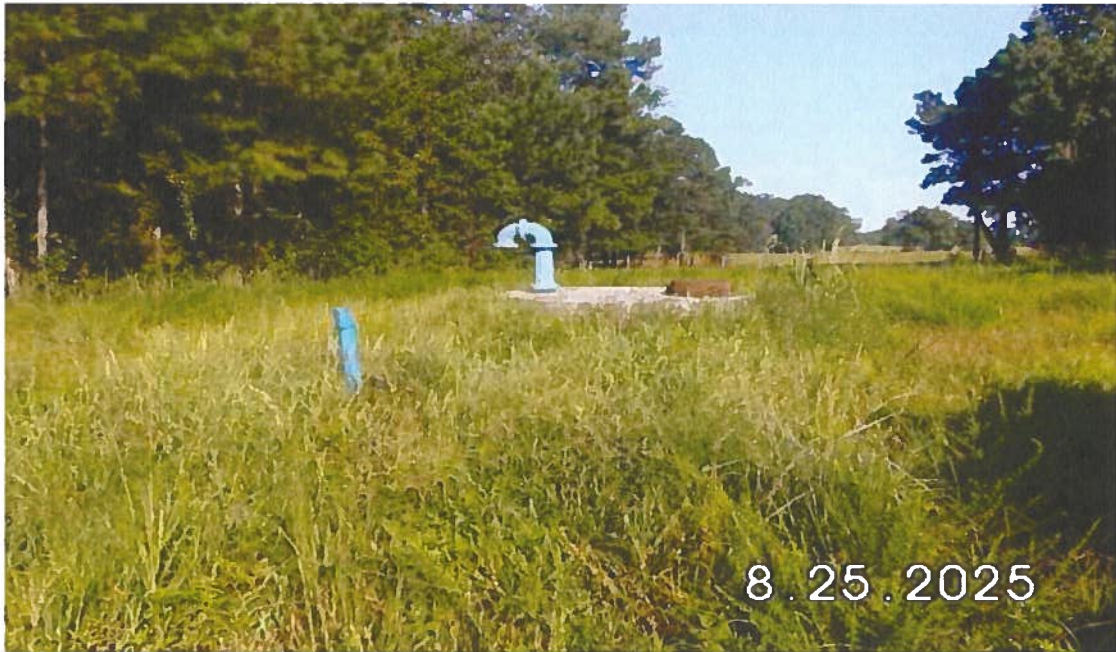
Photograph AA – ARV Structure along Right-of-Way

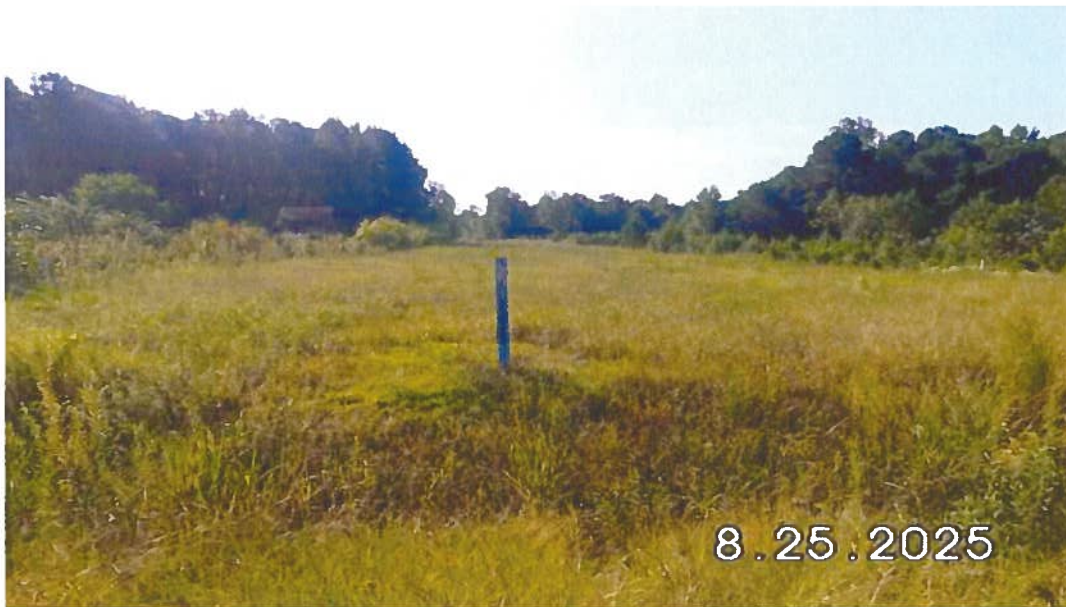
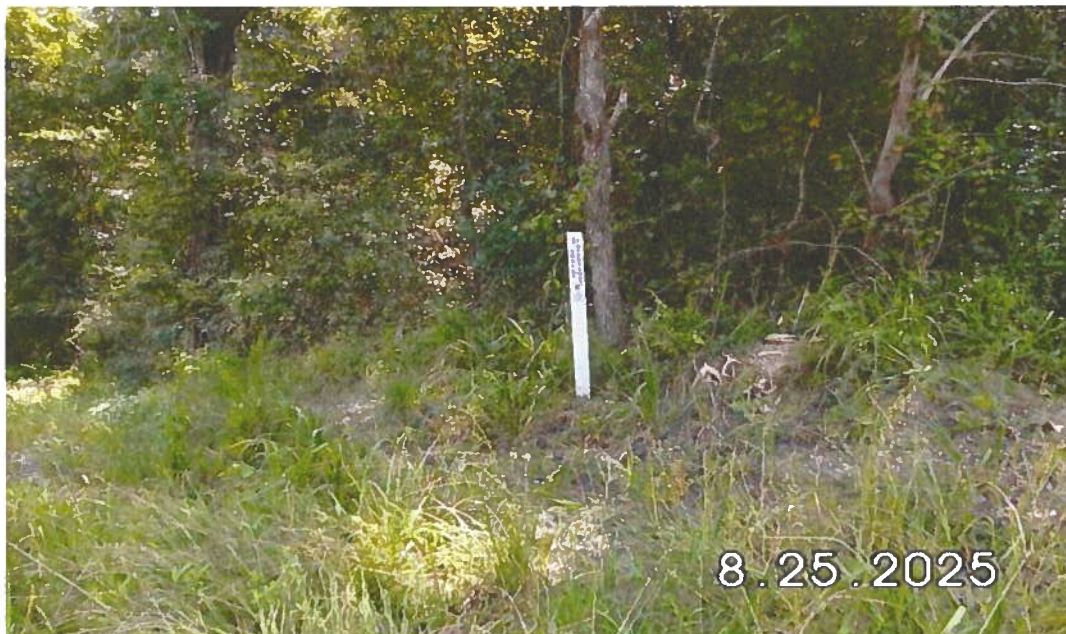
Photograph CC – New Blue Marker Post from 54" RWM project and New marker post at edge of Right-Of-Way.

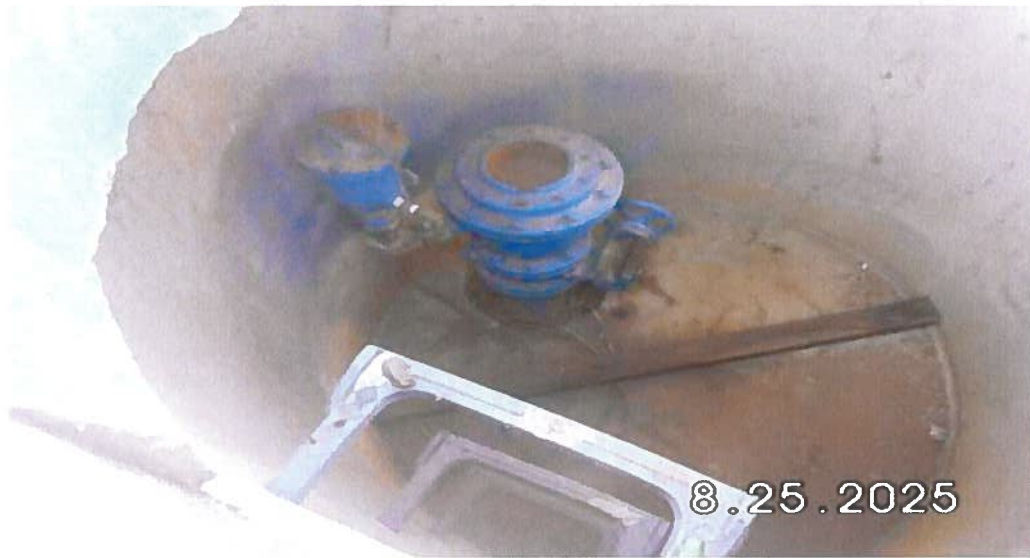
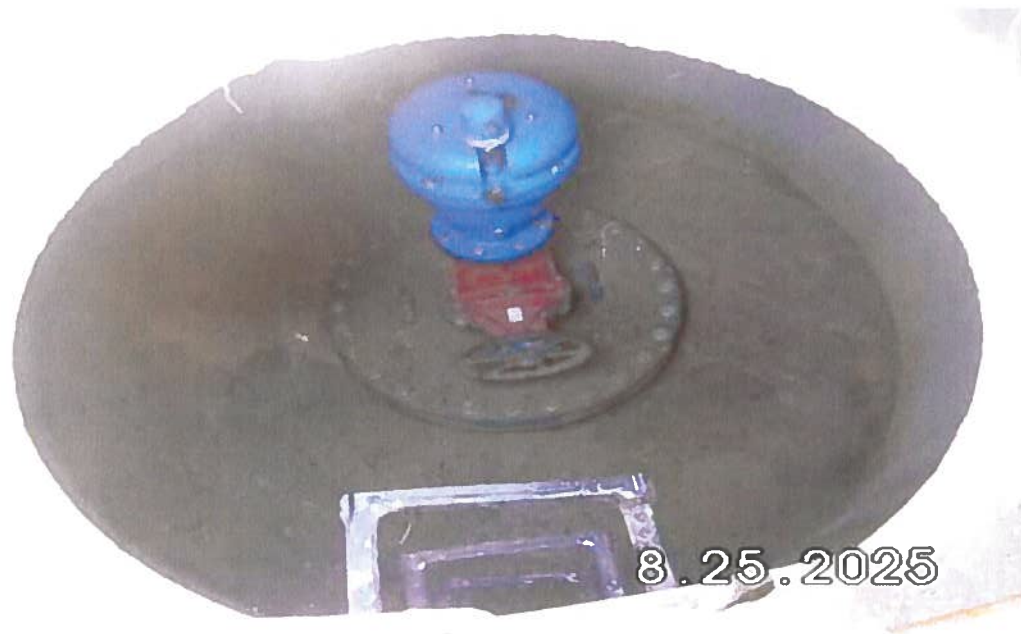
Photograph DD – Old ARV on 48" RWM and New ARV on 54" RWM

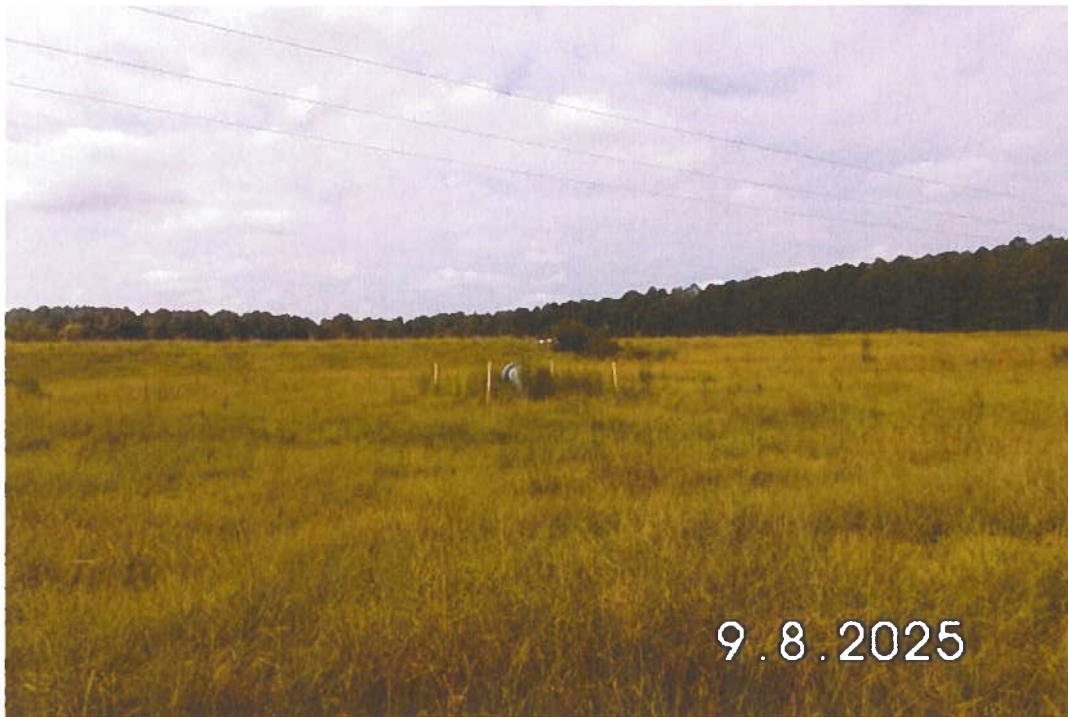
Photograph EE- Emergency Intake Pipe Adjacent to Pond behind DAK

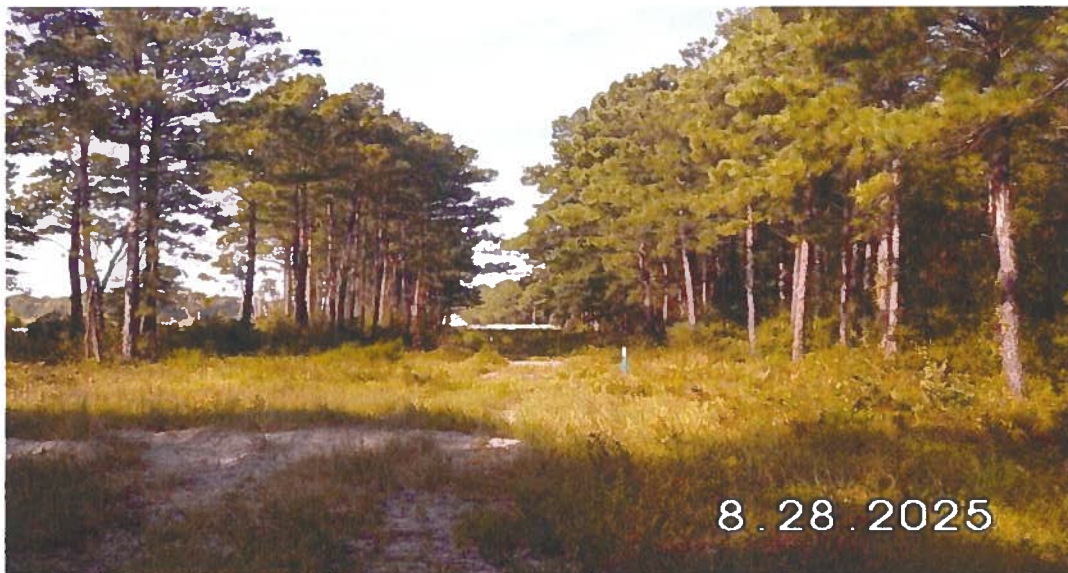
Photograph FF- Right-of-Way at US Hwy 421 from 2019 - 48" RWM Relocation Project

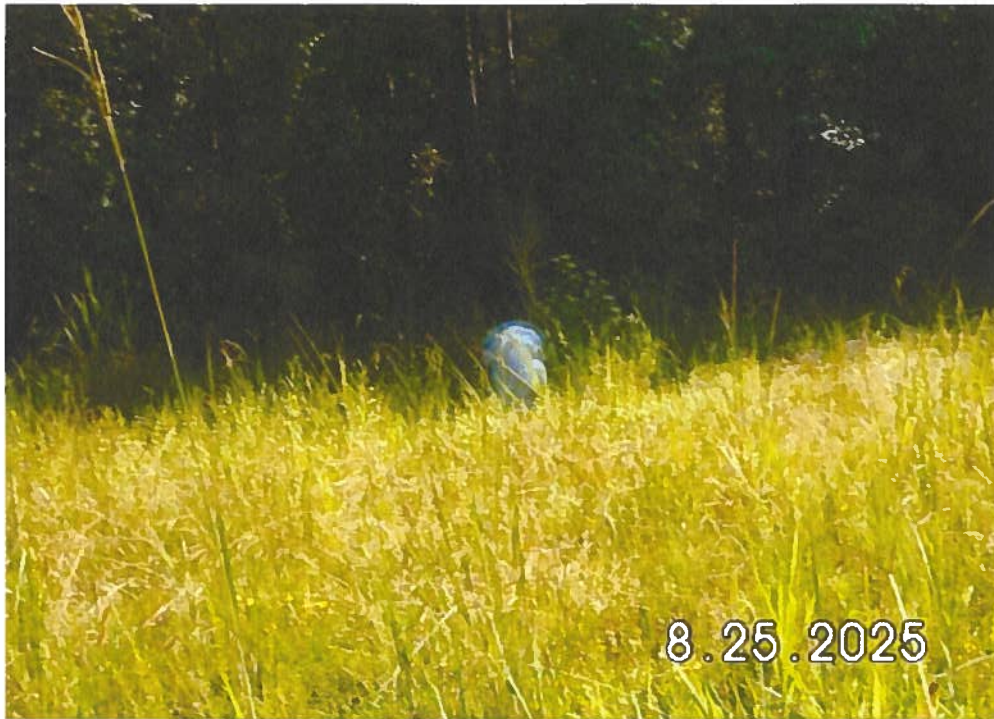
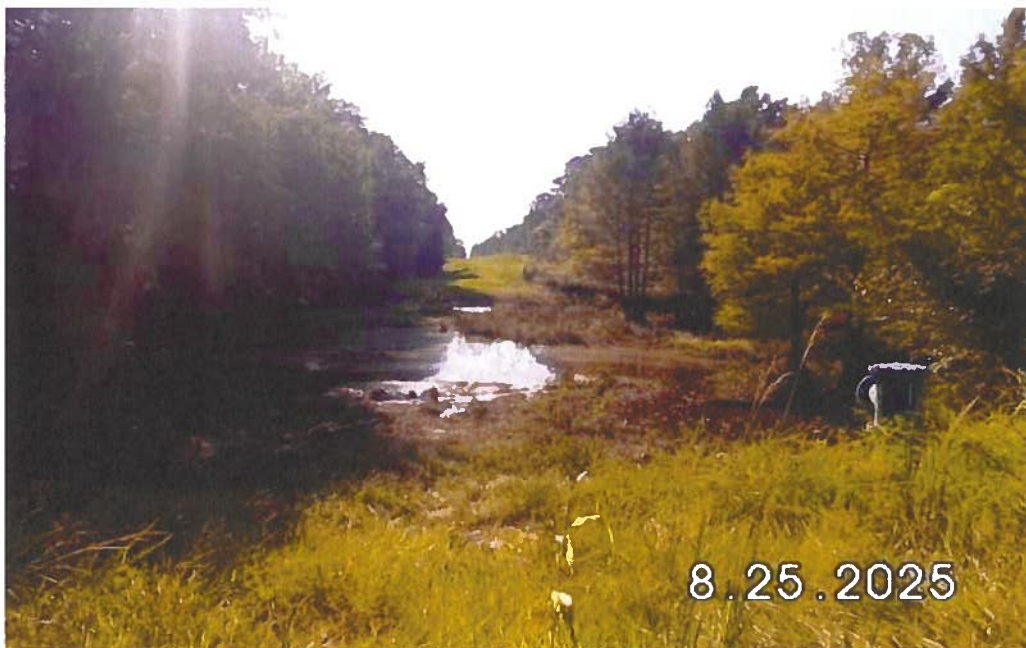
Photograph GG- Old Blow-off on 48" RWM and new Blow-off on 54" RWM

1. Recommend operation of blow-offs on an annual basis.
2. Recommend all blow-off structures on 48" RWM to be re-painted "blue" as paint has faded and deteriorated.
3. Mowing contract shall include cutting all grass away from all structures within Right-of-Way.

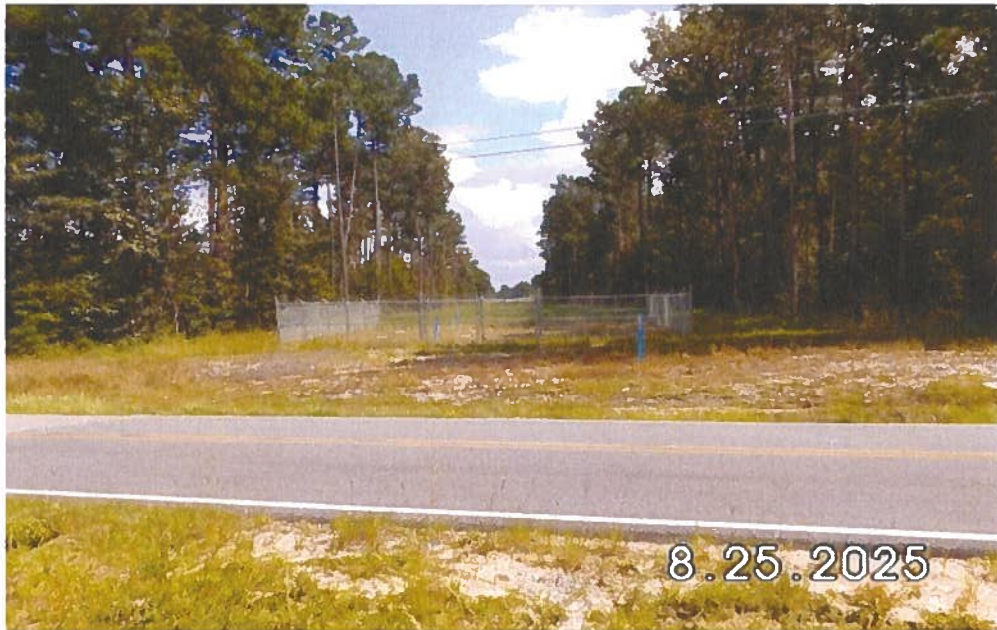
Photograph HH- Interconnect off Blue Banks Loop Road

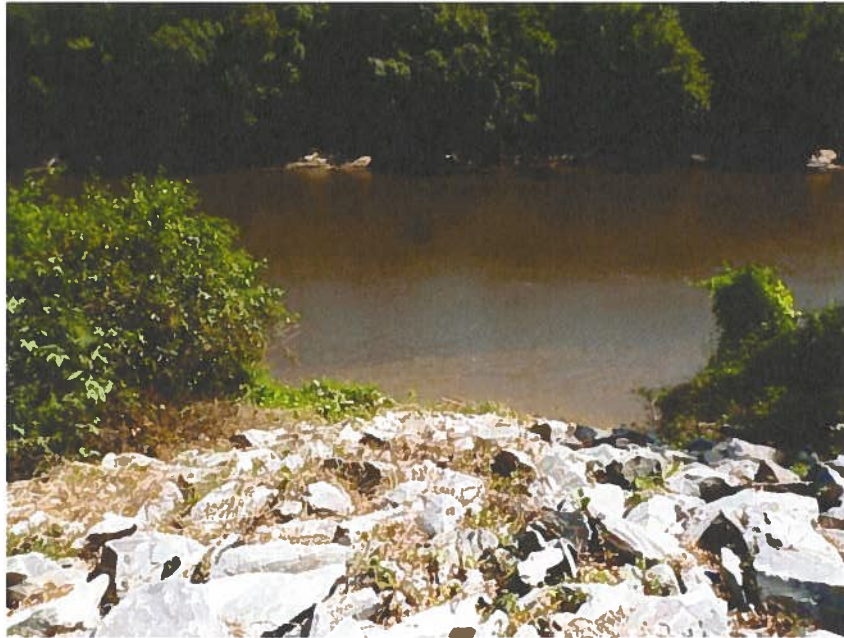
Photograph A – Intake Location

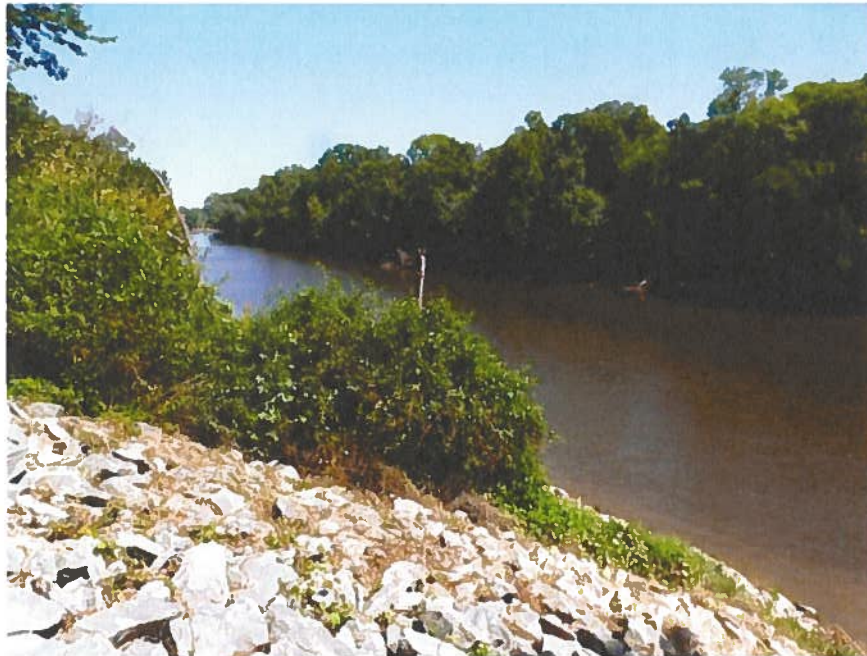
Photograph B – Cape Fear Riverbank Restoration Project Area

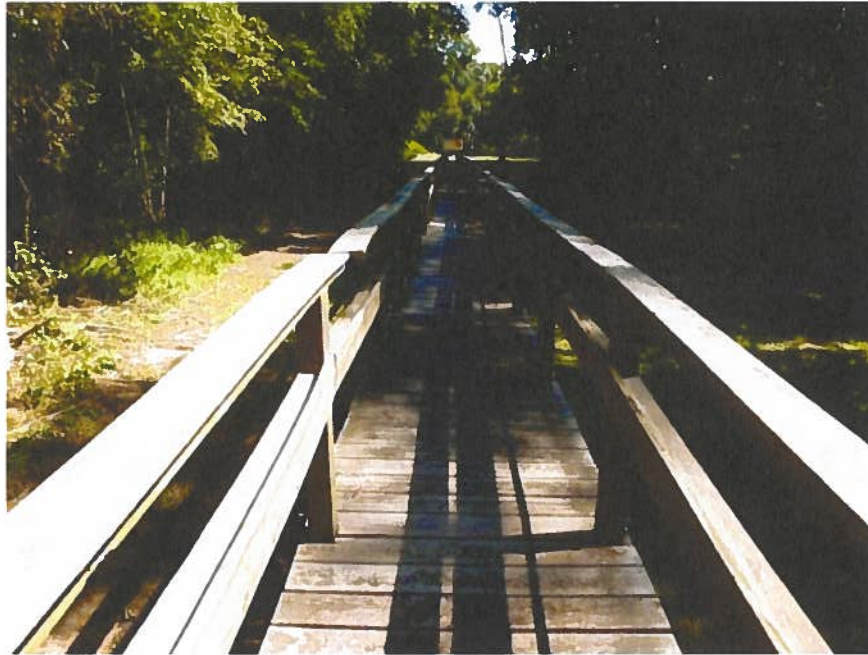
Photograph C – River Access Walkway

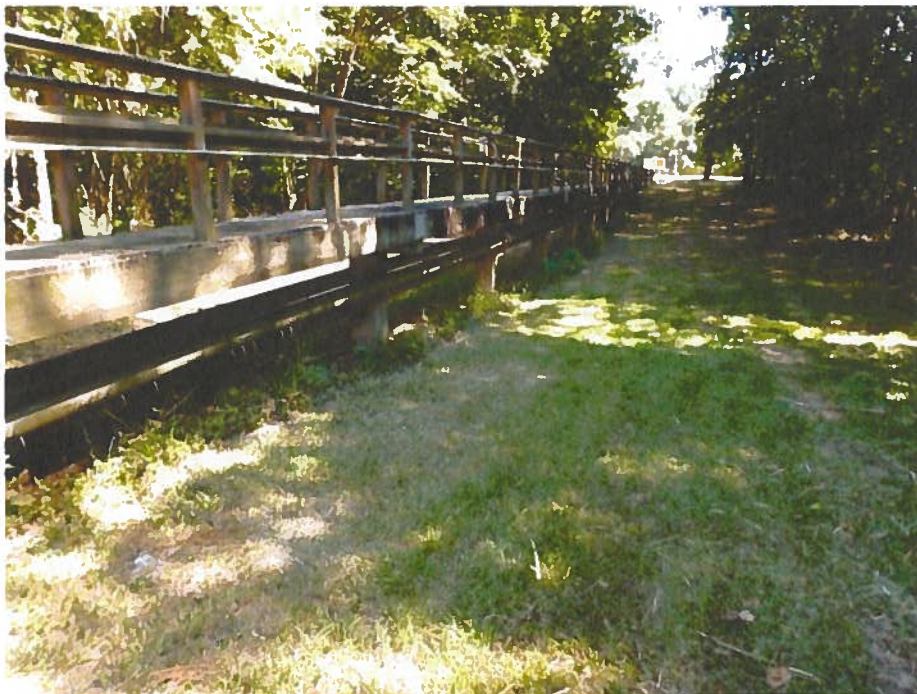
Photograph D – River Access Walkway Underside

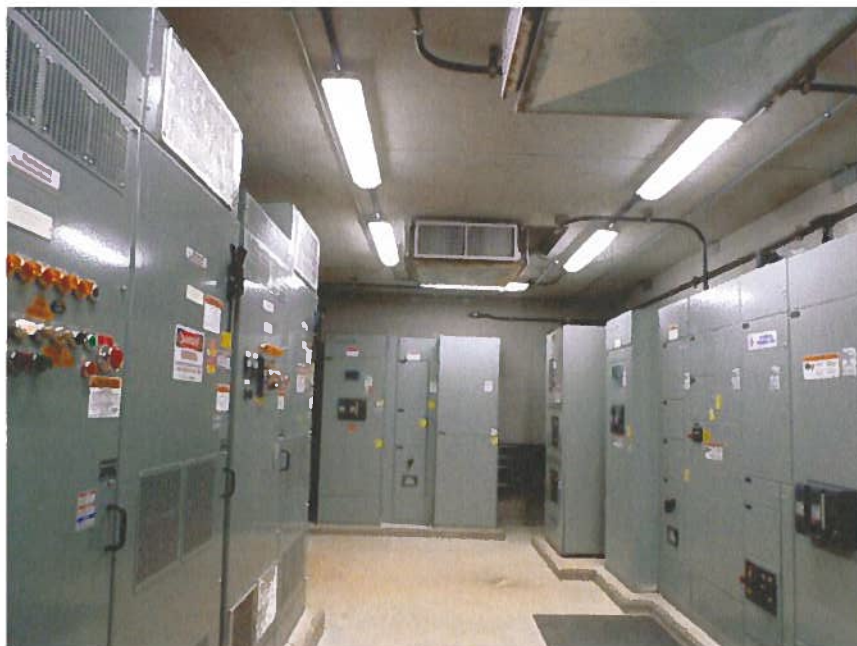
Photograph F – Raw Water Pump Station Electrical Room

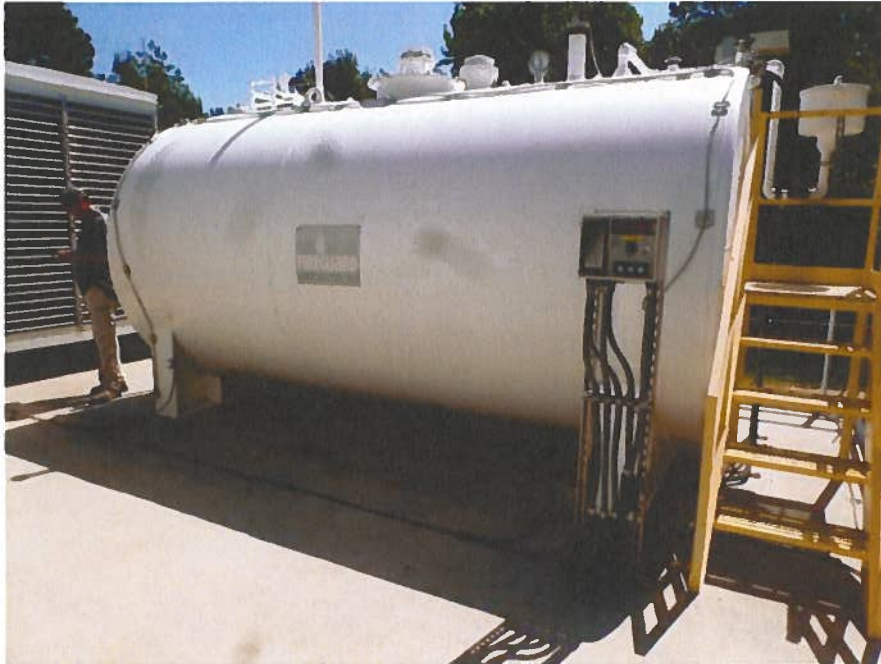
Photograph G – Raw Water Pump Station Generator Fuel Tank

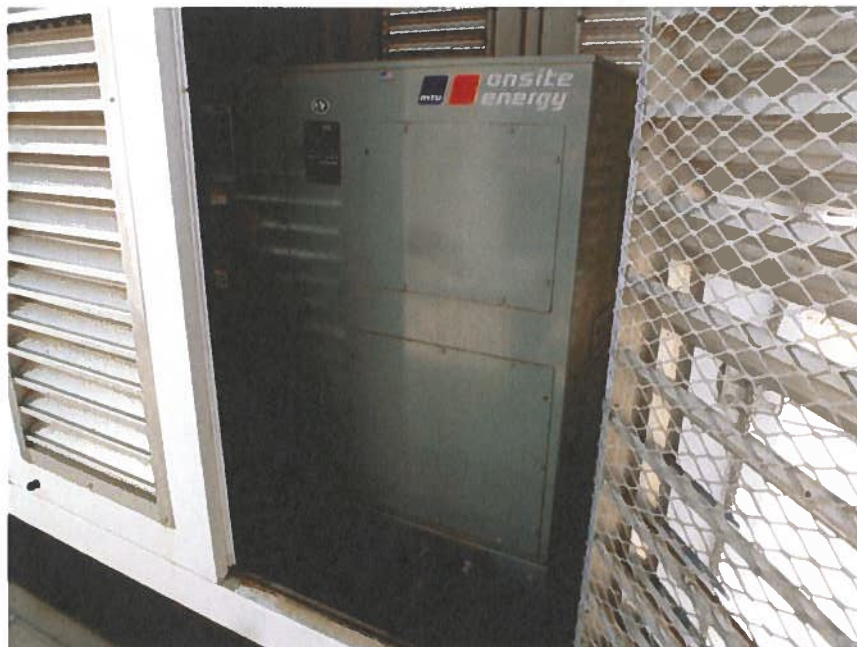
Photograph H – Raw Water Pump Station Generator ATS

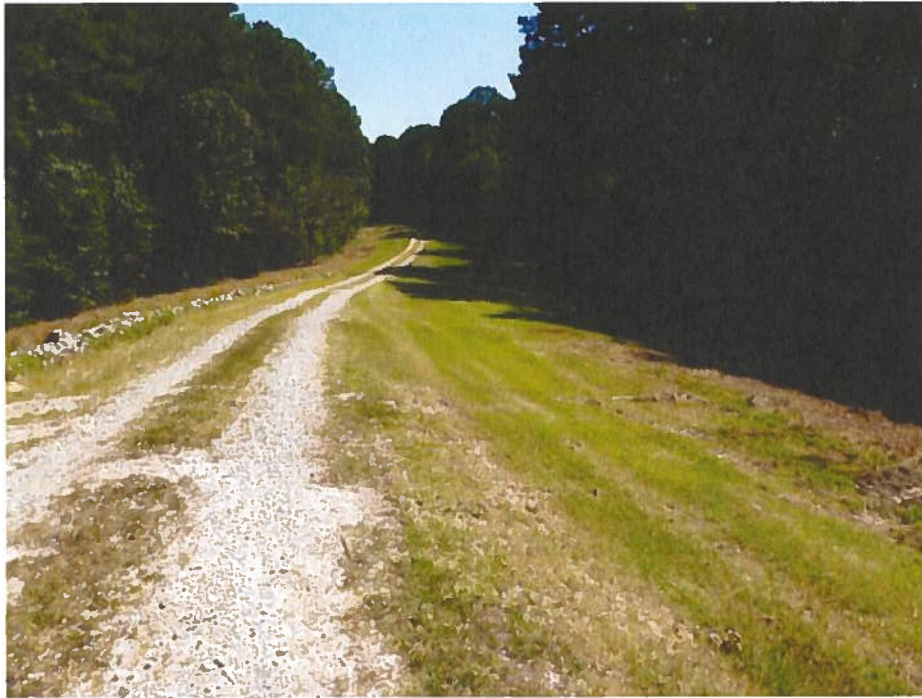
Photograph I – Raw Water Pump Station Access Road

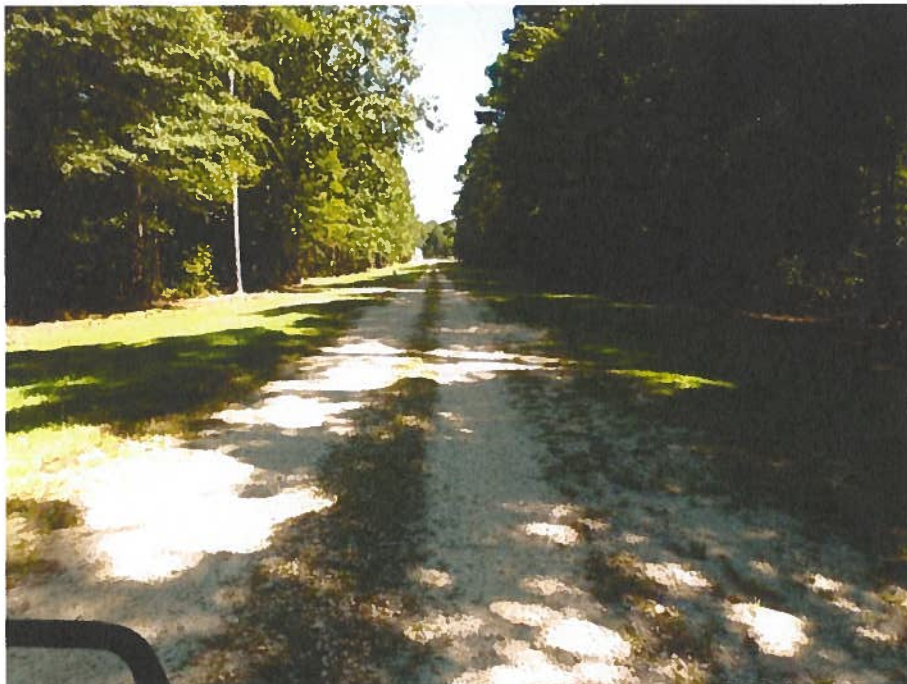
Photograph J – Raw Water Pump Station Access Road

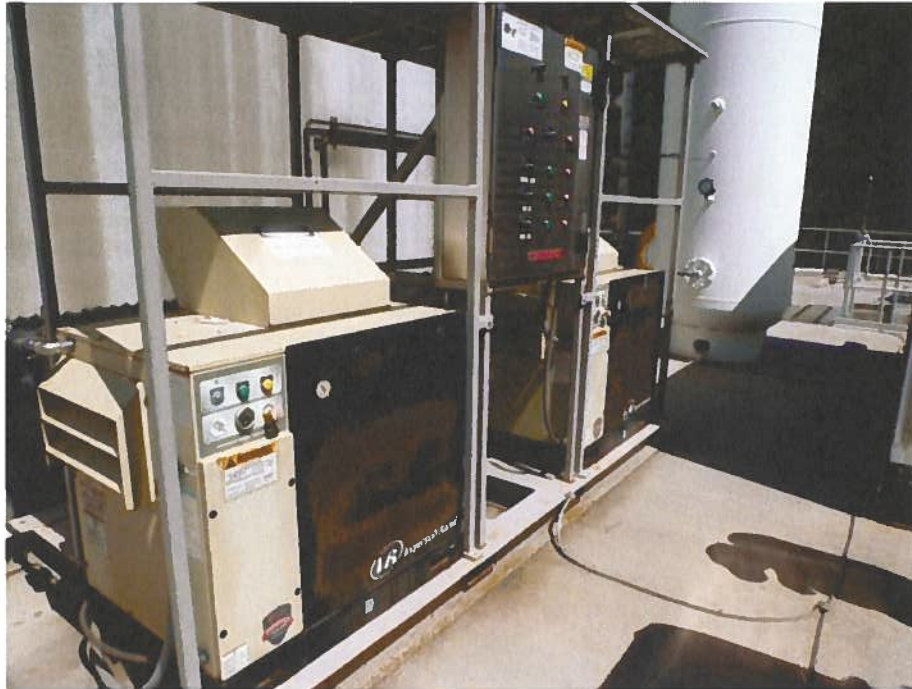
Photograph K -Raw Water Pump Station Backwash Compressor

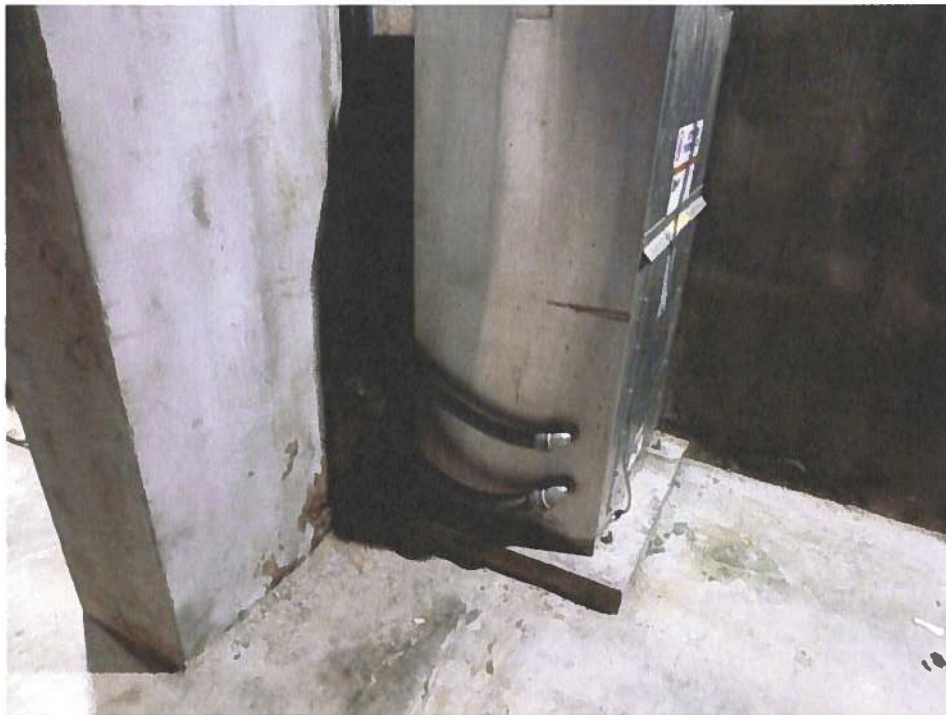
Photograph P – Filter Gallery Walls

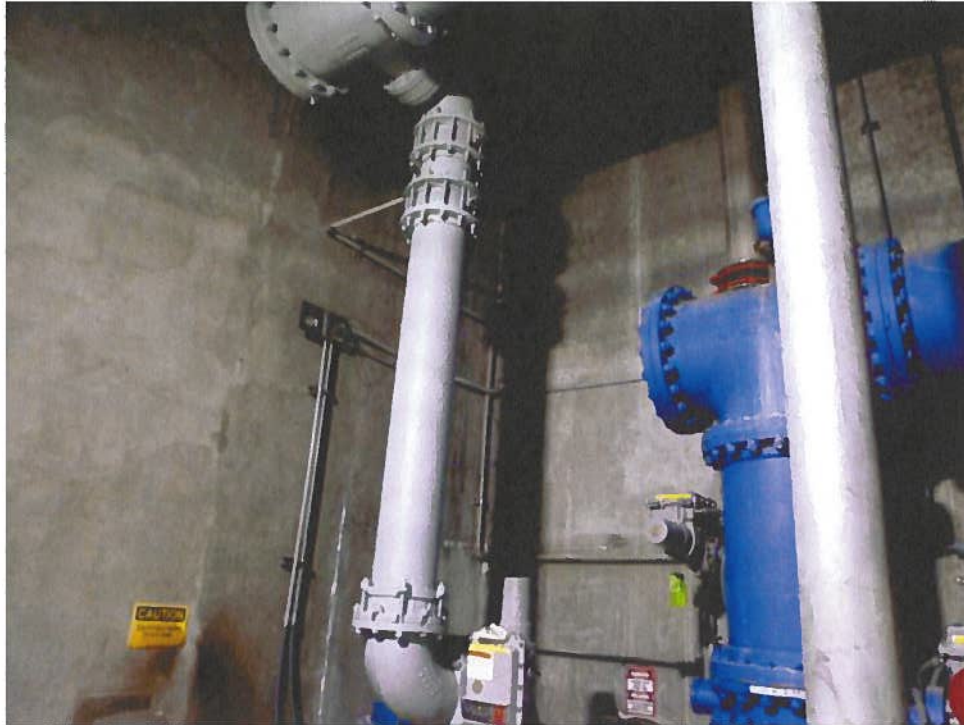
Photograph Q – Filter Gallery Walls

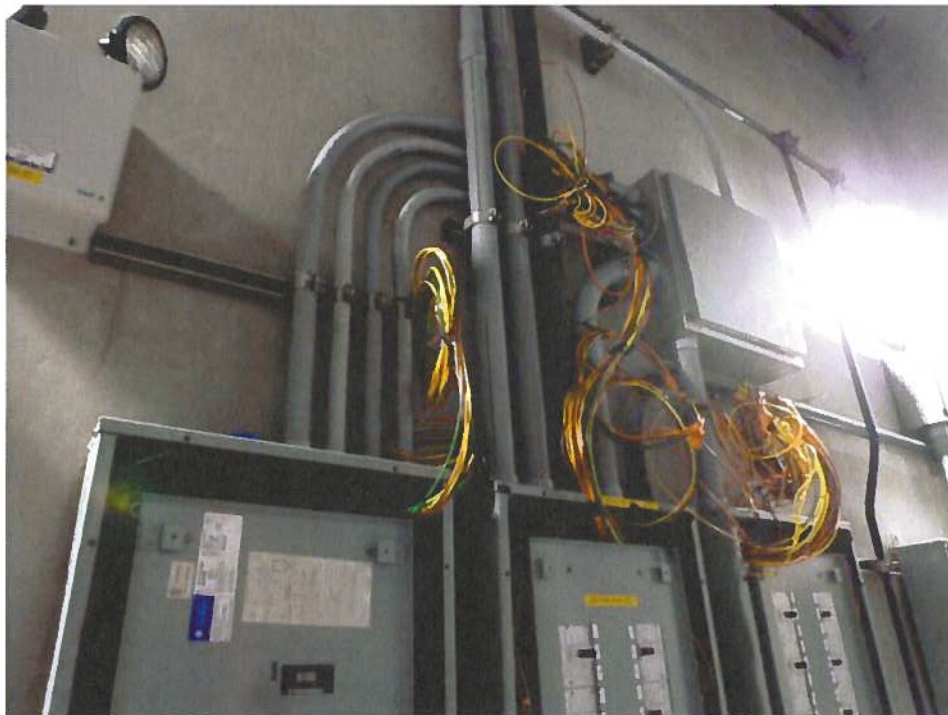
Photograph R – Filter Gallery Electrical Repairs

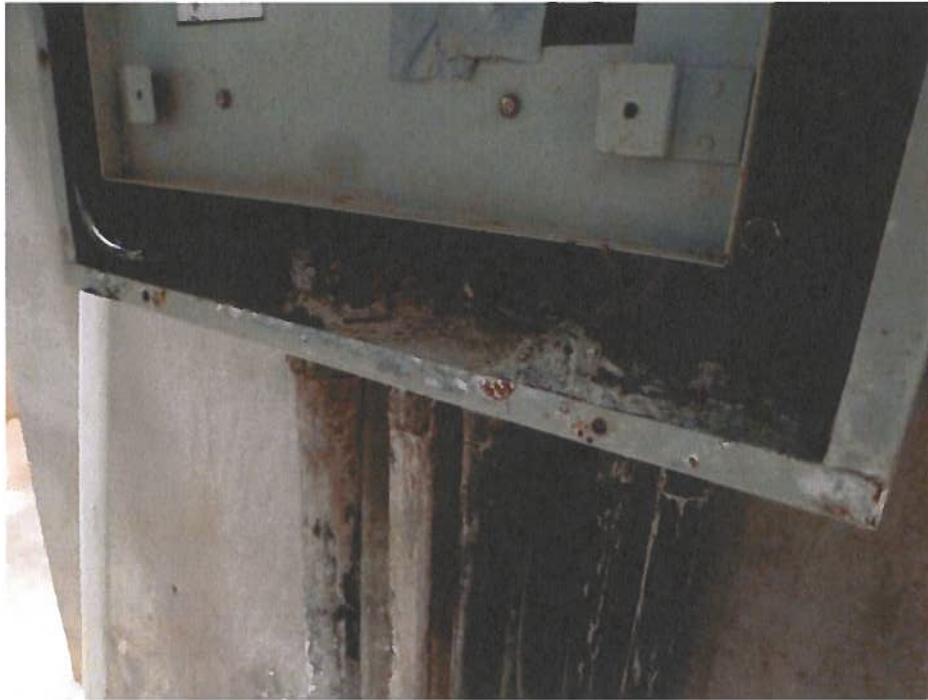
Photograph S – Filter Gallery Electrical Repairs
